# Access Compliance Report

## Public Rights-of-Way

### (Island Curb Cuts)

Intersection ID: 10020687	Main Street: BEAM_RD	Cross Street: N/A	Location: N
ADA ID: 2AB3D752108B	Curb Cut Type: MedianRefuge2	Initial Pass/Fail: Fail	Overall Compliance: No
Severity Score: 1.25			
Codes/Mitigation Info/Possible Solution		Field Measurements/Component Compliance

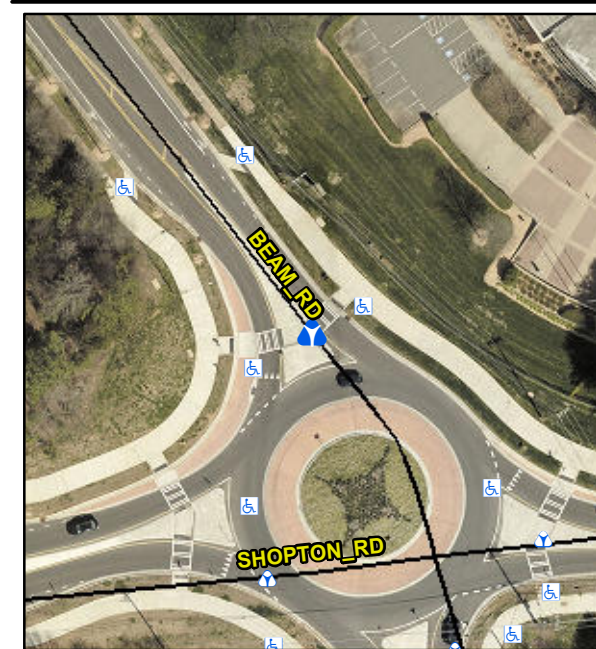
Compliance	Description	Data	Compliance	Description	Data
Yes	Refuge 1 Length (In)	112	N/A	Gutter 1 Ponding?	N/A
Yes	Refuge 1 Width (In)	120	N/A	Gutter 1 Lip Ht (In)	N/A
Yes	Refuge 1 Slope (%)	2.2	N/A	Gutter 1 Slope (%)	N/A
Yes	Refuge 1 X Slope (%)	2.4	N/A	Gutter 1 X Slope (%)	N/A
N/A	Painted X Walk1?	Yes	N/A	DWS 1 Provided?	N/A
N/A	X Walk 1 Direction	To E	N/A	DWS 1 Contrast?	N/A
N/A	X Walk 1 Width (In)	112	N/A	DWS 1 Length (In)	N/A
N/A	Road 1 Slope (%)	0.8	N/A	DWS 1 Full Width?	N/A
N/A	Road 1 X Slope (%)	1.2	N/A	DWS 1 Offset (In)	N/A
Yes	Refuge 2 Length (In)	112	N/A	Gutter 2 Ponding?	N/A
Yes	Refuge 2 Width (In)	120	N/A	Gutter 2 Lip Ht (In)	N/A
Yes	Refuge 2 Slope (%)	0.6	N/A	Gutter 2 Slope (%)	N/A
Yes	Refuge 2 X Slope (%)	1.6	N/A	Gutter 2 X Slope (%)	N/A
N/A	Painted X Walk2?	Yes	N/A	DWS 2 Provided?	N/A
N/A	X Walk 2 Direction	To W	N/A	DWS 2 Contrast?	N/A
N/A	X Walk 2 Width (In)	113	N/A	DWS 2 Length (In)	N/A

N/A	Road 2 Slope (%)	2.2	N/A	DWS 2 Full Width?	N/A
N/A	Road 2 X Slope (%)	3.0	N/A	DWS 2 Offset (In)	N/A
N/A	Refuge 3 Length (in)	N/A	N/A	Gutter 3 Ponding?	N/A
N/A	Refuge 3 Width (in)	N/A	N/A	Gutter 3 Lip Ht (in)	N/A
N/A	Refuge 3 Slope (%)	N/A	N/A	Gutter 3 Slope (%)	N/A
N/A	Refuge 3 XSlope (%)	N/A	N/A	Gutter 3 XSlope (%)	N/A
N/A	Painted X Walk3?	N/A	N/A	DWS 3 Provided?	N/A
N/A	X Walk 3 Direction	N/A	N/A	DWS 3 Contrast?	N/A
N/A	X Walk 3 Width (in)	N/A	N/A	DWS 3 Length (in)	N/A
N/A	Road 3 Slope (%)	N/A	N/A	DWS 3 Full Width?	N/A
N/A	Road 3 XSlope (%)	N/A	N/A	DWS 3 Offset (in)	N/A
Yes	Any Obstructions?	N/A	N/A	Storm Grate/Utility Hazard?	N/A
N/A	Obstruction Type		N/A	Storm Grate/Utility Type	
		N/A			N/A
N/A	Surface Condition	Good

Possible Solutions:

**Remove & Replace Entire Refuge.**

**\$ 3000.00**
