Access Compliance Report

Public Rights-of-Way

(Island Curb Cuts)

Intersection ID: 10014702	Main Street: PERIWINKLE_HILL_AV	Cross Street: N/A	Location: SW
ADA ID: 2B4231C565ED	Curb Cut Type: MedianRefuge2	Initial Pass/Fail: Fail	Overall Compliance: No
Codes/Mitigation Info/Possible Solution		Field Measurements/Component Compliance

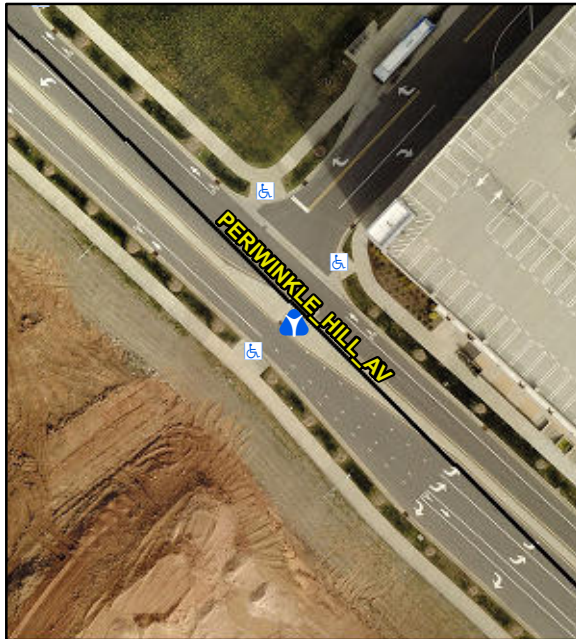
Compliance	Description	Data	Compliance	Description	Data
Yes	Refuge 1 Length (In)	83.0	N/A	Gutter 1 Ponding?	N/A
Yes	Refuge 1 Width (In)	96.0	N/A	Gutter 1 Lip Ht (In)	N/A
Yes	Refuge 1 Slope (%)	0.8	N/A	Gutter 1 Slope (%)	N/A
No	Refuge 1 X Slope (%)	5.4	N/A	Gutter 1 X Slope (%)	N/A
N/A	Painted X Walk1?	No	N/A	DWS 1 Provided?	N/A
N/A	X Walk 1 Direction	To NE	N/A	DWS 1 Contrast?	N/A
N/A	X Walk 1 Width (In)	N/A	N/A	DWS 1 Length (In)	N/A
N/A	Road 1 Slope (%)	5.2	N/A	DWS 1 Full Width?	N/A
N/A	Road 1 X Slope (%)	4.0	N/A	DWS 1 Offset (In)	N/A
Yes	Refuge 2 Length (In)	83.5	N/A	Gutter 2 Ponding?	N/A
Yes	Refuge 2 Width (In)	96.0	N/A	Gutter 2 Lip Ht (In)	N/A
Yes	Refuge 2 Slope (%)	0.7	N/A	Gutter 2 Slope (%)	N/A
Yes	Refuge 2 X Slope (%)	3.6	N/A	Gutter 2 X Slope (%)	N/A
N/A	Painted X Walk2?	No	N/A	DWS 2 Provided?	N/A
N/A	X Walk 2 Direction	To SW	N/A	DWS 2 Contrast?	N/A
N/A	X Walk 2 Width (In)	N/A	N/A	DWS 2 Length (In)	N/A

Possible Solutions:

Remove & Replace Entire Refuge.

\$ 3000.00

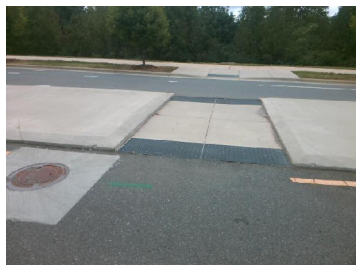
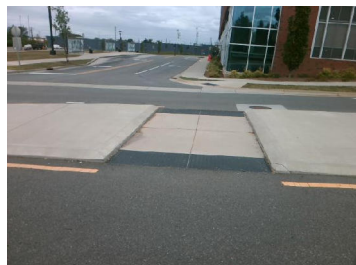
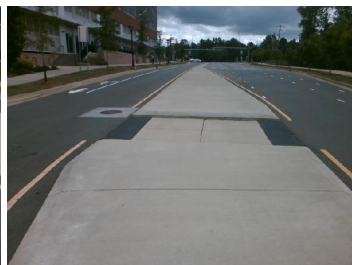
N/A	Road 2 Slope (%)	4.3	N/A	DWS 2 Full Width?	N/A
N/A	Road 2 X Slope (%)	2.1	N/A	DWS 2 Offset (In)	N/A
N/A	Refuge 3 Length (in)	N/A	N/A	Gutter 3 Ponding?	N/A
N/A	Refuge 3 Width (in)	N/A	N/A	Gutter 3 Lip Ht (in)	N/A
N/A	Refuge 3 Slope (%)	N/A	N/A	Gutter 3 Slope (%)	N/A
N/A	Refuge 3 XSlope (%)	N/A	N/A	Gutter 3 XSlope (%)	N/A
N/A	Painted X Walk3?	N/A	N/A	DWS 3 Provided?	N/A
N/A	X Walk 3 Direction	N/A	N/A	DWS 3 Contrast?	N/A
N/A	X Walk 3 Width (in)	N/A	N/A	DWS 3 Length (in)	N/A
N/A	Road 3 Slope (%)	N/A	N/A	DWS 3 Full Width?	N/A
N/A	Road 3 XSlope (%)	N/A	N/A	DWS 3 Offset (in)	N/A
Yes	Any Obstructions?	N/A	N/A	Storm Grate/Utility Hazard?	N/A
N/A	Obstruction Type		N/A	Storm Grate/Utility Type	
		N/A			N/A
N/A	Surface Condition	Good
