# Access Compliance Report

## Public Rights-of-Way

### (Island Curb Cuts)

Intersection ID: 15274	Main Street: GLEN_LAKE_DR	Cross Street: CASCADE_POINTE_BV	Location: E
ADA ID: 2C5A01E8FD57	Curb Cut Type: MedianRefuge2	Initial Pass/Fail: Fail	Overall Compliance: No
Codes/Mitigation Info/Possible Solution		Field Measurements/Component Compliance

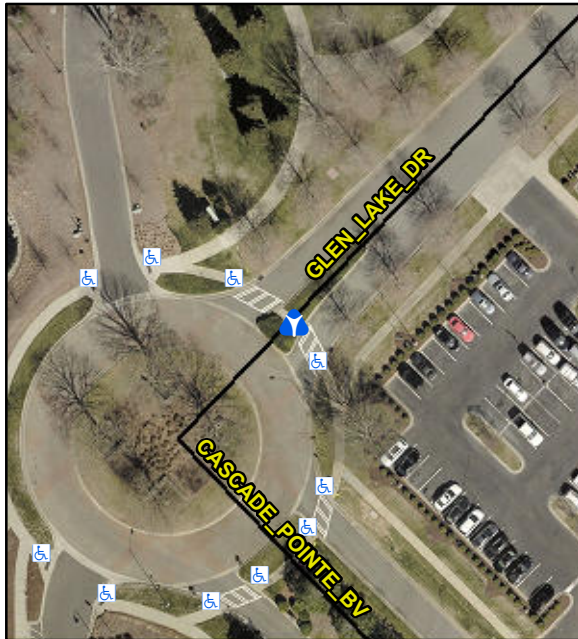
Compliance	Description	Data	Compliance	Description	Data
Yes	Refuge 1 Length (In)	86.0	N/A	Gutter 1 Ponding?	N/A
No	Refuge 1 Width (In)	59.0	N/A	Gutter 1 Lip Ht (In)	N/A
Yes	Refuge 1 Slope (%)	1.2	N/A	Gutter 1 Slope (%)	N/A
Yes	Refuge 1 X Slope (%)	2.8	N/A	Gutter 1 X Slope (%)	N/A
N/A	Painted X Walk1?	Yes	N/A	DWS 1 Provided?	N/A
N/A	X Walk 1 Direction	To SE	N/A	DWS 1 Contrast?	N/A
N/A	X Walk 1 Width (In)	106.0	N/A	DWS 1 Length (In)	N/A
N/A	Road 1 Slope (%)	2.8	N/A	DWS 1 Full Width?	N/A
N/A	Road 1 X Slope (%)	4.1	N/A	DWS 1 Offset (In)	N/A
Yes	Refuge 2 Length (In)	86.0	N/A	Gutter 2 Ponding?	N/A
No	Refuge 2 Width (In)	59.0	N/A	Gutter 2 Lip Ht (In)	N/A
Yes	Refuge 2 Slope (%)	0.3	N/A	Gutter 2 Slope (%)	N/A
Yes	Refuge 2 X Slope (%)	1.5	N/A	Gutter 2 X Slope (%)	N/A
N/A	Painted X Walk2?	Yes	N/A	DWS 2 Provided?	N/A
N/A	X Walk 2 Direction	To NW	N/A	DWS 2 Contrast?	N/A
N/A	X Walk 2 Width (In)	111.0	N/A	DWS 2 Length (In)	N/A

**Remove & Replace Entire Refuge.**

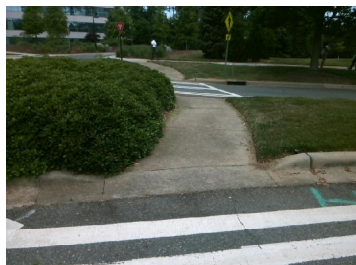
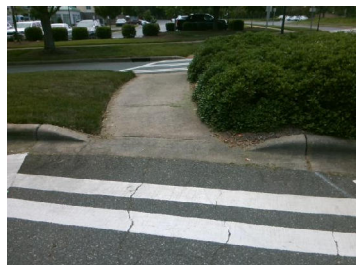
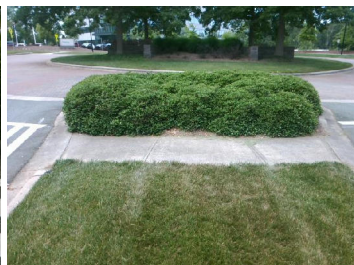
N/A	Road 2 Slope (%)	3.4	N/A	DWS 2 Full Width?	N/A
N/A	Road 2 X Slope (%)	4.5	N/A	DWS 2 Offset (In)	N/A
N/A	Refuge 3 Length (in)	N/A	N/A	Gutter 3 Ponding?	N/A
N/A	Refuge 3 Width (in)	N/A	N/A	Gutter 3 Lip Ht (in)	N/A
N/A	Refuge 3 Slope (%)	N/A	N/A	Gutter 3 Slope (%)	N/A
N/A	Refuge 3 XSlope (%)	N/A	N/A	Gutter 3 XSlope (%)	N/A
N/A	Painted X Walk3?	N/A	N/A	DWS 3 Provided?	N/A
N/A	X Walk 3 Direction	N/A	N/A	DWS 3 Contrast?	N/A
N/A	X Walk 3 Width (in)	N/A	N/A	DWS 3 Length (in)	N/A
N/A	Road 3 Slope (%)	N/A	N/A	DWS 3 Full Width?	N/A
N/A	Road 3 XSlope (%)	N/A	N/A	DWS 3 Offset (in)	N/A
Yes	Any Obstructions?	N/A	N/A	Storm Grate/Utility Hazard?	N/A
N/A	Obstruction Type		N/A	Storm Grate/Utility Type	
		N/A			N/A
N/A	Surface Condition	Good
