Access Compliance Report

Public Rights-of-Way

(Island Curb Cuts)

Intersection ID: 10024872	Main Street: DEWITT_LN	Cross Street: N/A	Location:	N/A
ADA ID: 2FD5414D3278	Curb Cut Type: MedianRefuge2	Initial Pass/Fail: Fail	Overall Compliance: No	Severity Score: 8.75
Codes/Mitigation Info/Possible Solution		Field Measurements/Component Compliance

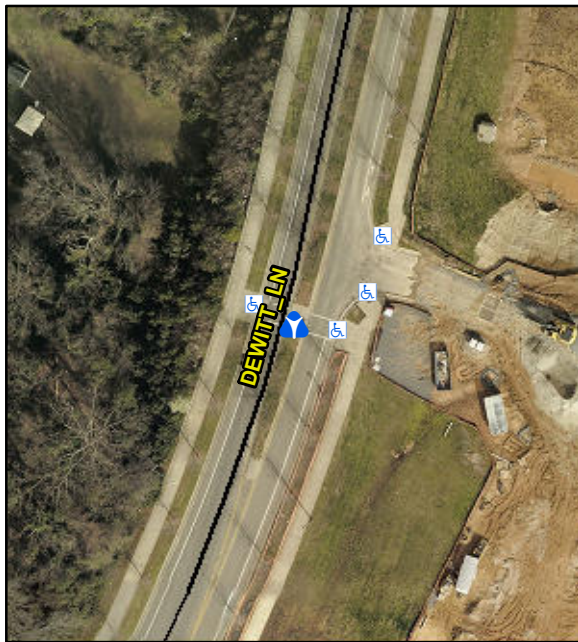
Compliance	Description	Data	Compliance	Description	Data
Yes	Refuge 1 Length (In)	48.0	N/A	Gutter 1 Ponding?	N/A
No	Refuge 1 Width (In)	48.0	N/A	Gutter 1 Lip Ht (In)	N/A
Yes	Refuge 1 Slope (%)	2.0	N/A	Gutter 1 Slope (%)	N/A
Yes	Refuge 1 X Slope (%)	2.8	N/A	Gutter 1 X Slope (%)	N/A
N/A	Painted X Walk1?	Yes	N/A	DWS 1 Provided?	N/A
N/A	X Walk 1 Direction	To E	N/A	DWS 1 Contrast?	N/A
N/A	X Walk 1 Width (In)	110.0	N/A	DWS 1 Length (In)	N/A
N/A	Road 1 Slope (%)	2.2	N/A	DWS 1 Full Width?	N/A
N/A	Road 1 X Slope (%)	1.2	N/A	DWS 1 Offset (In)	N/A
Yes	Refuge 2 Length (In)	48.0	N/A	Gutter 2 Ponding?	N/A
No	Refuge 2 Width (In)	48.0	N/A	Gutter 2 Lip Ht (In)	N/A
Yes	Refuge 2 Slope (%)	0.6	N/A	Gutter 2 Slope (%)	N/A
Yes	Refuge 2 X Slope (%)	1.4	N/A	Gutter 2 X Slope (%)	N/A
N/A	Painted X Walk2?	Yes	N/A	DWS 2 Provided?	N/A
N/A	X Walk 2 Direction	To W	N/A	DWS 2 Contrast?	N/A
N/A	X Walk 2 Width (In)	110.0	N/A	DWS 2 Length (In)	N/A

N/A	Road 2 Slope (%)	1.4	N/A	DWS 2 Full Width?	N/A
N/A	Road 2 X Slope (%)	1.3	N/A	DWS 2 Offset (In)	N/A
N/A	Refuge 3 Length (in)	N/A	N/A	Gutter 3 Ponding?	N/A
N/A	Refuge 3 Width (in)	N/A	N/A	Gutter 3 Lip Ht (in)	N/A
N/A	Refuge 3 Slope (%)	N/A	N/A	Gutter 3 Slope (%)	N/A
N/A	Refuge 3 XSlope (%)	N/A	N/A	Gutter 3 XSlope (%)	N/A
N/A	Painted X Walk3?	N/A	N/A	DWS 3 Provided?	N/A
N/A	X Walk 3 Direction	N/A	N/A	DWS 3 Contrast?	N/A
N/A	X Walk 3 Width (in)	N/A	N/A	DWS 3 Length (in)	N/A
N/A	Road 3 Slope (%)	N/A	N/A	DWS 3 Full Width?	N/A
N/A	Road 3 XSlope (%)	N/A	N/A	DWS 3 Offset (in)	N/A
Yes	Any Obstructions?	N/A	N/A	Storm Grate/Utility Hazard?	N/A
N/A	Obstruction Type		N/A	Storm Grate/Utility Type	
		N/A			N/A
N/A	Surface Condition	Good

Possible Solutions:

Remove & Replace Entire Refuge.
