Access Compliance Report

Public Rights-of-Way

(Island Curb Cuts)

Intersection ID: 10035599	Main Street: REAMES_RD	Cross Street: N/A	Location: N
ADA ID: 3294F97E0FC9	Curb Cut Type: MedianRefuge2	Initial Pass/Fail: Fail	Overall Compliance: No
Codes/Mitigation Info/Possible Solution		Field Measurements/Component Compliance	
Severity Score: 0

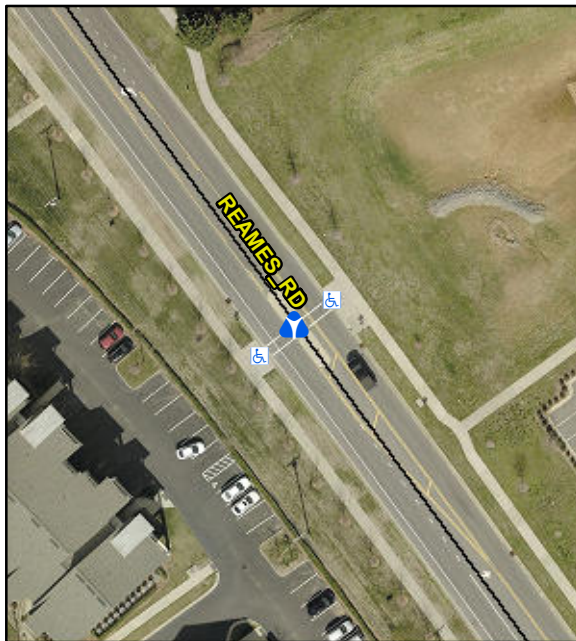
Compliance	Description	Data	Compliance	Description	Data
Yes	Refuge 1 Length (In)	48.0	N/A	Gutter 1 Ponding?	N/A
Yes	Refuge 1 Width (In)	106.0	N/A	Gutter 1 Lip Ht (In)	N/A
Yes	Refuge 1 Slope (%)	0.2	N/A	Gutter 1 Slope (%)	N/A
Yes	Refuge 1 X Slope (%)	2.7	N/A	Gutter 1 X Slope (%)	N/A
N/A	Painted X Walk1?	Yes	N/A	DWS 1 Provided?	N/A
N/A	X Walk 1 Direction	To E	N/A	DWS 1 Contrast?	N/A
N/A	X Walk 1 Width (In)	59.5	N/A	DWS 1 Length (In)	N/A
N/A	Road 1 Slope (%)	2.8	N/A	DWS 1 Full Width?	N/A
N/A	Road 1 X Slope (%)	2.4	N/A	DWS 1 Offset (In)	N/A
Yes	Refuge 2 Length (In)	48.0	N/A	Gutter 2 Ponding?	N/A
Yes	Refuge 2 Width (In)	106.0	N/A	Gutter 2 Lip Ht (In)	N/A
Yes	Refuge 2 Slope (%)	0.4	N/A	Gutter 2 Slope (%)	N/A
Yes	Refuge 2 X Slope (%)	3.3	N/A	Gutter 2 X Slope (%)	N/A
N/A	Painted X Walk2?	Yes	N/A	DWS 2 Provided?	N/A
N/A	X Walk 2 Direction	To W	N/A	DWS 2 Contrast?	N/A
N/A	X Walk 2 Width (In)	59.5	N/A	DWS 2 Length (In)	N/A

N/A	Road 2 Slope (%)	2.9	N/A	DWS 2 Full Width?	N/A
N/A	Road 2 X Slope (%)	5.9	N/A	DWS 2 Offset (In)	N/A
N/A	Refuge 3 Length (in)	N/A	N/A	Gutter 3 Ponding?	N/A
N/A	Refuge 3 Width (in)	N/A	N/A	Gutter 3 Lip Ht (in)	N/A
N/A	Refuge 3 Slope (%)	N/A	N/A	Gutter 3 Slope (%)	N/A
N/A	Refuge 3 XSlope (%)	N/A	N/A	Gutter 3 XSlope (%)	N/A
N/A	Painted X Walk3?	N/A	N/A	DWS 3 Provided?	N/A
N/A	X Walk 3 Direction	N/A	N/A	DWS 3 Contrast?	N/A
N/A	X Walk 3 Width (in)	N/A	N/A	DWS 3 Length (in)	N/A
N/A	Road 3 Slope (%)	N/A	N/A	DWS 3 Full Width?	N/A
N/A	Road 3 XSlope (%)	N/A	N/A	DWS 3 Offset (in)	N/A
Yes	Any Obstructions?	N/A	N/A	Storm Grate/Utility Hazard?	N/A
N/A	Obstruction Type		N/A	Storm Grate/Utility Type	
		N/A			N/A
N/A	Surface Condition	Good

Possible Solutions:

Remove & Replace Entire Refuge.
