Access Compliance Report

Public Rights-of-Way

(Island Curb Cuts)

Intersection ID: 17555	Main Street: E_WOODLAWN_RD	Cross Street: OLD_PINEVILLE_RD	Location: SE
ADA ID: 3438874B4FEA	Curb Cut Type: IslandRefuge3	Initial Pass/Fail: Fail	Overall Compliance: No
		Severity Score: 60

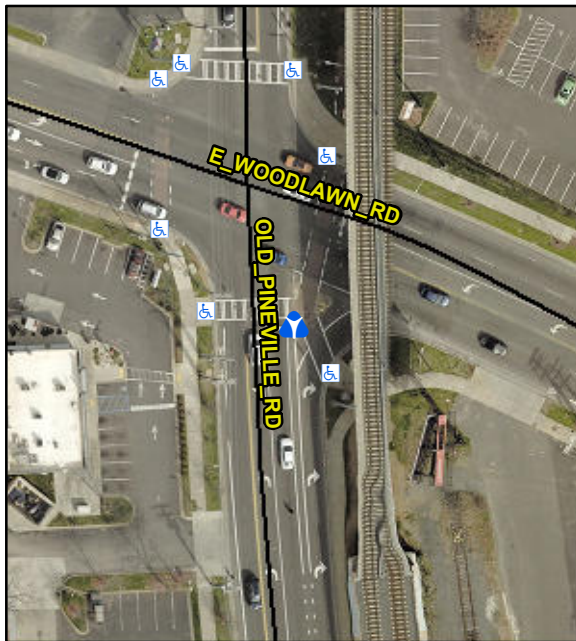
Compliance	Description	Data	Compliance	Description	Data
Yes	Refuge 1 Length (In)	42.0	N/A	Gutter 1 Ponding?	N/A
Yes	Refuge 1 Width (In)	118.5	N/A	Gutter 1 Lip Ht (In)	N/A
Yes	Refuge 1 Slope (%)	0.7	N/A	Gutter 1 Slope (%)	N/A
Yes	Refuge 1 X Slope (%)	1.0	N/A	Gutter 1 X Slope (%)	N/A
N/A	Painted X Walk1?	No	N/A	DWS 1 Provided?	N/A
N/A	X Walk 1 Direction	To W	N/A	DWS 1 Contrast?	N/A
N/A	X Walk 1 Width (In)	N/A	N/A	DWS 1 Length (In)	N/A
N/A	Road 1 Slope (%)	1.2	N/A	DWS 1 Full Width?	N/A
N/A	Road 1 X Slope (%)	0.1	N/A	DWS 1 Offset (In)	N/A
Yes	Refuge 2 Length (In)	53.0	N/A	Gutter 2 Ponding?	N/A
Yes	Refuge 2 Width (In)	104.0	N/A	Gutter 2 Lip Ht (In)	N/A
No	Refuge 2 Slope (%)	8.9	N/A	Gutter 2 Slope (%)	N/A
Yes	Refuge 2 X Slope (%)	2.8	N/A	Gutter 2 X Slope (%)	N/A
N/A	Painted X Walk2?	No	N/A	DWS 2 Provided?	N/A
N/A	X Walk 2 Direction	To S	N/A	DWS 2 Contrast?	N/A
N/A	X Walk 2 Width (In)	N/A	N/A	DWS 2 Length (In)	N/A

N/A	Road 2 Slope (%)	0.2	N/A	DWS 2 Full Width?	N/A
N/A	Road 2 X Slope (%)	2.0	N/A	DWS 2 Offset (In)	N/A
Yes	Refuge 3 Length (in)	93.0	N/A	Gutter 3 Ponding?	N/A
Yes	Refuge 3 Width (in)	123.0	N/A	Gutter 3 Lip Ht (in)	N/A
Yes	Refuge 3 Slope (%)	3.8	N/A	Gutter 3 Slope (%)	N/A
Yes	Refuge 3 XSlope (%)	0.1	N/A	Gutter 3 XSlope (%)	N/A
N/A	Painted X Walk3?	Yes	N/A	DWS 3 Provided?	N/A
N/A	X Walk 3 Direction	To N	N/A	DWS 3 Contrast?	N/A
N/A	X Walk 3 Width (in)	114.0	N/A	DWS 3 Length (in)	N/A
N/A	Road 3 Slope (%)	1.6	N/A	DWS 3 Full Width?	N/A
N/A	Road 3 XSlope (%)	1.9	N/A	DWS 3 Offset (in)	N/A
Yes	Any Obstructions?	N/A	N/A	Storm Grate/Utility Hazard?	N/A
N/A	Obstruction Type		N/A	Storm Grate/Utility Type	
		N/A			N/A
N/A	Surface Condition	Good

Remove & Replace Entire Refuge.

Total Cost: \$ 3000.00
