Access Compliance Report

Public Rights-of-Way

(Island Curb Cuts)

Intersection ID: 13442	Main Street: MORRIS_FIELD_DR	Cross Street: AIRPORT_CENTER_PY	Location: E
ADA ID: 34539770C904	Curb Cut Type: MedianRefuge2	Initial Pass/Fail: Fail	Overall Compliance: No
Codes/Mitigation Info/Possible Solution		Field Measurements/Component Compliance

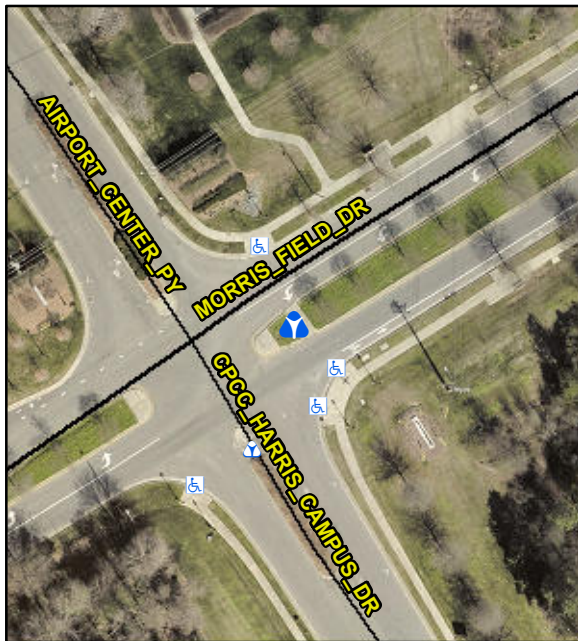
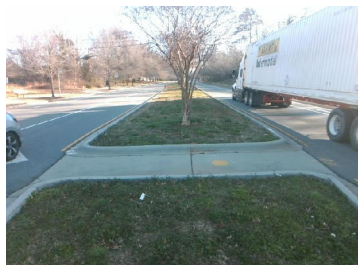
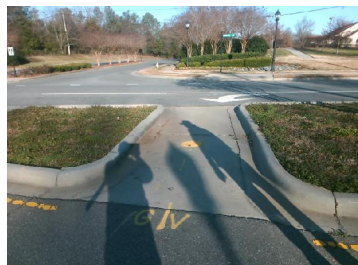
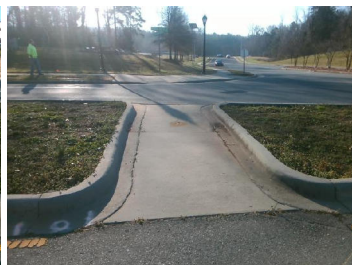
Compliance	Description	Data	Compliance	Description	Data
Yes	Refuge 1 Length (In)	112.5	N/A	Gutter 1 Ponding?	N/A
No	Refuge 1 Width (In)	59.0	N/A	Gutter 1 Lip Ht (In)	N/A
Yes	Refuge 1 Slope (%)	1.0	N/A	Gutter 1 Slope (%)	N/A
Yes	Refuge 1 X Slope (%)	1.9	N/A	Gutter 1 X Slope (%)	N/A
N/A	Painted X Walk1?	No	N/A	DWS 1 Provided?	N/A
N/A	X Walk 1 Direction	To N	N/A	DWS 1 Contrast?	N/A
N/A	X Walk 1 Width (In)	N/A	N/A	DWS 1 Length (In)	N/A
N/A	Road 1 Slope (%)	2.6	N/A	DWS 1 Full Width?	N/A
N/A	Road 1 X Slope (%)	2.6	N/A	DWS 1 Offset (In)	N/A
Yes	Refuge 2 Length (In)	112.5	N/A	Gutter 2 Ponding?	N/A
No	Refuge 2 Width (In)	59.0	N/A	Gutter 2 Lip Ht (In)	N/A
Yes	Refuge 2 Slope (%)	1.8	N/A	Gutter 2 Slope (%)	N/A
Yes	Refuge 2 X Slope (%)	2.0	N/A	Gutter 2 X Slope (%)	N/A
N/A	Painted X Walk2?	No	N/A	DWS 2 Provided?	N/A
N/A	X Walk 2 Direction	To S	N/A	DWS 2 Contrast?	N/A
N/A	X Walk 2 Width (In)	N/A	N/A	DWS 2 Length (In)	N/A

N/A	Road 2 Slope (%)	1.6	N/A	DWS 2 Full Width?	N/A
N/A	Road 2 X Slope (%)	4.7	N/A	DWS 2 Offset (In)	N/A
N/A	Refuge 3 Length (in)	N/A	N/A	Gutter 3 Ponding?	N/A
N/A	Refuge 3 Width (in)	N/A	N/A	Gutter 3 Lip Ht (in)	N/A
N/A	Refuge 3 Slope (%)	N/A	N/A	Gutter 3 Slope (%)	N/A
N/A	Refuge 3 XSlope (%)	N/A	N/A	Gutter 3 XSlope (%)	N/A
N/A	Painted X Walk3?	N/A	N/A	DWS 3 Provided?	N/A
N/A	X Walk 3 Direction	N/A	N/A	DWS 3 Contrast?	N/A
N/A	X Walk 3 Width (in)	N/A	N/A	DWS 3 Length (in)	N/A
N/A	Road 3 Slope (%)	N/A	N/A	DWS 3 Full Width?	N/A
N/A	Road 3 XSlope (%)	N/A	N/A	DWS 3 Offset (in)	N/A
Yes	Any Obstructions?	N/A	N/A	Storm Grate/Utility Hazard?	N/A
N/A	Obstruction Type		N/A	Storm Grate/Utility Type	
			N/A		N/A
N/A	Surface Condition	Good

Possible Solutions:

Remove & Replace Entire Refuge.
