Access Compliance Report

Public Rights-of-Way

(Island Curb Cuts)

Intersection ID: 13600	Main Street: 3RD-4TH_CONNECTOR_ST	Cross Street: E_4TH_ST	Location: NW
ADA ID: 375C0C7DA4CD	Curb Cut Type: IslandRefuge3	Initial Pass/Fail: Fail	Overall Compliance: No
Severity Score: 47.5			
Codes/Mitigation Info/Possible Solution		Field Measurements/Component Compliance

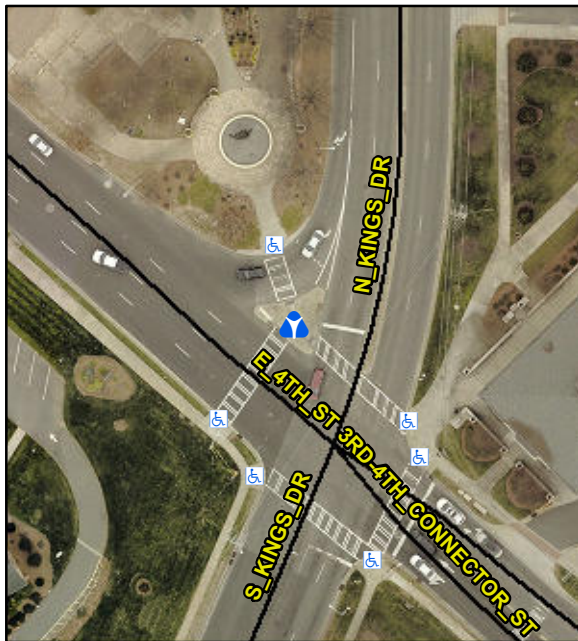
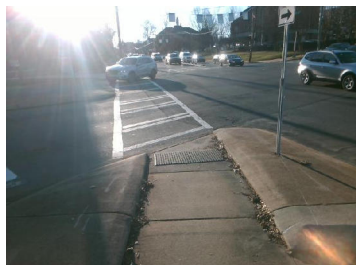
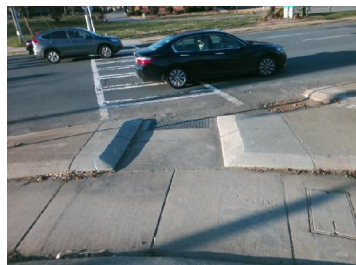
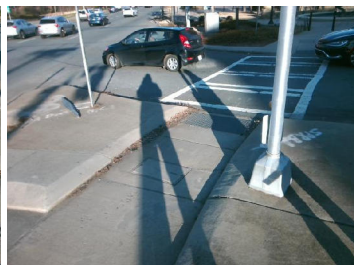
Compliance	Description	Data	Compliance	Description	Data
Yes	Refuge 1 Length (In)	113.0	N/A	Gutter 1 Ponding?	N/A
Yes	Refuge 1 Width (In)	60.0	N/A	Gutter 1 Lip Ht (In)	N/A
Yes	Refuge 1 Slope (%)	1.6	N/A	Gutter 1 Slope (%)	N/A
Yes	Refuge 1 X Slope (%)	2.1	N/A	Gutter 1 X Slope (%)	N/A
N/A	Painted X Walk1?	Yes	N/A	DWS 1 Provided?	N/A
N/A	X Walk 1 Direction	To SE	N/A	DWS 1 Contrast?	N/A
N/A	X Walk 1 Width (In)	88.0	N/A	DWS 1 Length (In)	N/A
N/A	Road 1 Slope (%)	1.6	N/A	DWS 1 Full Width?	N/A
N/A	Road 1 X Slope (%)	1.9	N/A	DWS 1 Offset (In)	N/A
Yes	Refuge 2 Length (In)	86.0	N/A	Gutter 2 Ponding?	N/A
Yes	Refuge 2 Width (In)	60.0	N/A	Gutter 2 Lip Ht (In)	N/A
No	Refuge 2 Slope (%)	5.4	N/A	Gutter 2 Slope (%)	N/A
Yes	Refuge 2 X Slope (%)	1.7	N/A	Gutter 2 X Slope (%)	N/A
N/A	Painted X Walk2?	Yes	N/A	DWS 2 Provided?	N/A
N/A	X Walk 2 Direction	To SW	N/A	DWS 2 Contrast?	N/A
N/A	X Walk 2 Width (In)	112.0	N/A	DWS 2 Length (In)	N/A

N/A	Road 2 Slope (%)	3.3	N/A	DWS 2 Full Width?	N/A
N/A	Road 2 X Slope (%)	2.5	N/A	DWS 2 Offset (In)	N/A
Yes	Refuge 3 Length (in)	133.0	N/A	Gutter 3 Ponding?	N/A
Yes	Refuge 3 Width (in)	60.0	N/A	Gutter 3 Lip Ht (in)	N/A
Yes	Refuge 3 Slope (%)	2.5	N/A	Gutter 3 Slope (%)	N/A
Yes	Refuge 3 XSlope (%)	0.9	N/A	Gutter 3 XSlope (%)	N/A
N/A	Painted X Walk3?	Yes	N/A	DWS 3 Provided?	N/A
N/A	X Walk 3 Direction	To NW	N/A	DWS 3 Contrast?	N/A
N/A	X Walk 3 Width (in)	108.0	N/A	DWS 3 Length (in)	N/A
N/A	Road 3 Slope (%)	2.0	N/A	DWS 3 Full Width?	N/A
N/A	Road 3 XSlope (%)	6.2	N/A	DWS 3 Offset (in)	N/A
Yes	Any Obstructions?	N/A	N/A	Storm Grate/Utility Hazard?	N/A
N/A	Obstruction Type		N/A	Storm Grate/Utility Type	
			N/A		N/A
N/A	Surface Condition	Good

Possible Solutions:

Remove & Replace Entire Refuge.

Total Cost: \$ 3000.00
