# Access Compliance Report

## Public Rights-of-Way

### (Island Curb Cuts)

Intersection ID: 52583	Main Street: NEW_RENAISSANCE_WY	Cross Street: BURNETTE_AV	Location:	N/A
ADA ID: 390667EAAA39	Curb Cut Type: MedianRefuge2	Initial Pass/Fail: Fail	Overall Compliance: No	Severity Score: 25
Codes/Mitigation Info/Possible Solution		Field Measurements/Component Compliance

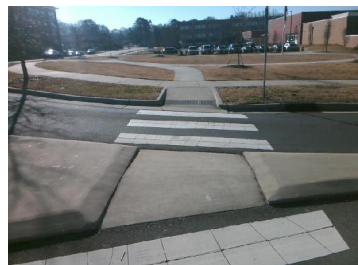
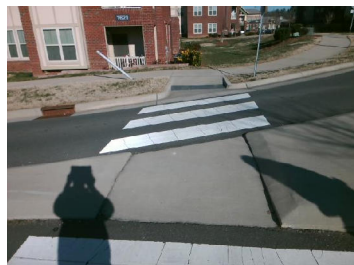
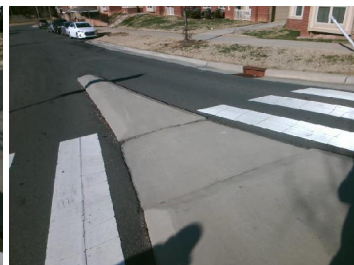
Compliance	Description	Data	Compliance	Description	Data
No	Refuge 1 Length (In)	31.5	N/A	Gutter 1 Ponding?	N/A
Yes	Refuge 1 Width (In)	74.0	N/A	Gutter 1 Lip Ht (In)	N/A
No	Refuge 1 Slope (%)	6.8	N/A	Gutter 1 Slope (%)	N/A
No	Refuge 1 X Slope (%)	6.2	N/A	Gutter 1 X Slope (%)	N/A
N/A	Painted X Walk1?	Yes	N/A	DWS 1 Provided?	N/A
N/A	X Walk 1 Direction	To SE	N/A	DWS 1 Contrast?	N/A
N/A	X Walk 1 Width (In)	120.0	N/A	DWS 1 Length (In)	N/A
N/A	Road 1 Slope (%)	5.2	N/A	DWS 1 Full Width?	N/A
N/A	Road 1 X Slope (%)	4.4	N/A	DWS 1 Offset (In)	N/A
No	Refuge 2 Length (In)	31.5	N/A	Gutter 2 Ponding?	N/A
Yes	Refuge 2 Width (In)	74.0	N/A	Gutter 2 Lip Ht (In)	N/A
Yes	Refuge 2 Slope (%)	2.9	N/A	Gutter 2 Slope (%)	N/A
No	Refuge 2 X Slope (%)	6.4	N/A	Gutter 2 X Slope (%)	N/A
N/A	Painted X Walk2?	Yes	N/A	DWS 2 Provided?	N/A
N/A	X Walk 2 Direction	To NW	N/A	DWS 2 Contrast?	N/A
N/A	X Walk 2 Width (In)	120.0	N/A	DWS 2 Length (In)	N/A

N/A	Road 2 Slope (%)	6.3	N/A	DWS 2 Full Width?	N/A
N/A	Road 2 X Slope (%)	1.3	N/A	DWS 2 Offset (In)	N/A
N/A	Refuge 3 Length (in)	N/A	N/A	Gutter 3 Ponding?	N/A
N/A	Refuge 3 Width (in)	N/A	N/A	Gutter 3 Lip Ht (in)	N/A
N/A	Refuge 3 Slope (%)	N/A	N/A	Gutter 3 Slope (%)	N/A
N/A	Refuge 3 XSlope (%)	N/A	N/A	Gutter 3 XSlope (%)	N/A
N/A	Painted X Walk3?	N/A	N/A	DWS 3 Provided?	N/A
N/A	X Walk 3 Direction	N/A	N/A	DWS 3 Contrast?	N/A
N/A	X Walk 3 Width (in)	N/A	N/A	DWS 3 Length (in)	N/A
N/A	Road 3 Slope (%)	N/A	N/A	DWS 3 Full Width?	N/A
N/A	Road 3 XSlope (%)	N/A	N/A	DWS 3 Offset (in)	N/A
Yes	Any Obstructions?	N/A	N/A	Storm Grate/Utility Hazard?	N/A
N/A	Obstruction Type		N/A	Storm Grate/Utility Type	
		N/A			N/A
N/A	Surface Condition	Good

**Remove & Replace Entire Refuge.**
