# Access Compliance Report

## Public Rights-of-Way

### (Island Curb Cuts)

Intersection ID: 53413	Main Street: GOLF_LINKS_DR	Cross Street: WAVERLY_WALK_AV	Location: NE
ADA ID: 3C7B0FD86278	Curb Cut Type: MedianRefuge2	Initial Pass/Fail: Fail	Overall Compliance: No
Severity Score: 0			
Codes/Mitigation Info/Possible Solution		Field Measurements/Component Compliance

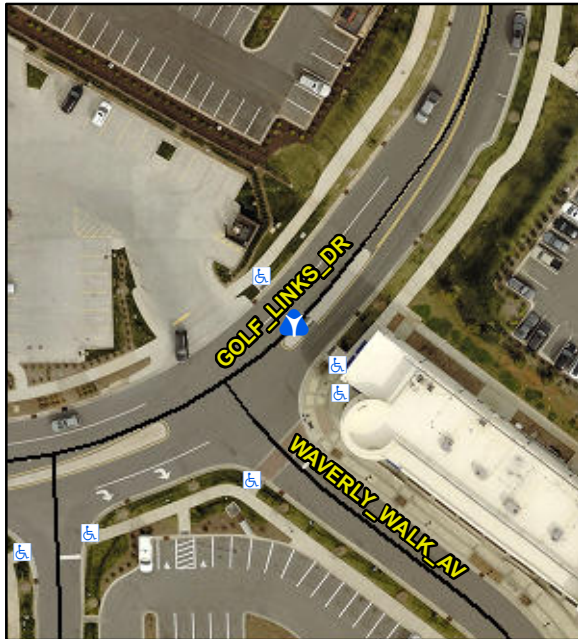
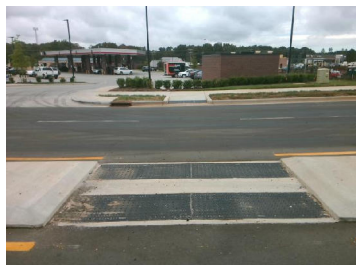
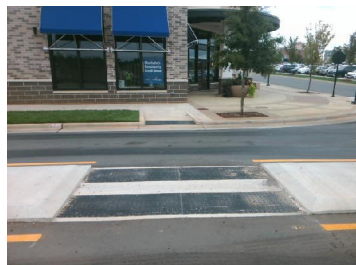
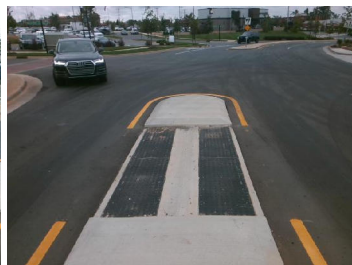
Compliance	Description	Data	Compliance	Description	Data
Yes	Refuge 1 Length (In)	36.0	N/A	Gutter 1 Ponding?	N/A
Yes	Refuge 1 Width (In)	121.0	N/A	Gutter 1 Lip Ht (In)	N/A
Yes	Refuge 1 Slope (%)	0.4	N/A	Gutter 1 Slope (%)	N/A
Yes	Refuge 1 X Slope (%)	3.5	N/A	Gutter 1 X Slope (%)	N/A
N/A	Painted X Walk1?	No	N/A	DWS 1 Provided?	N/A
N/A	X Walk 1 Direction	To NW	N/A	DWS 1 Contrast?	N/A
N/A	X Walk 1 Width (In)	N/A	N/A	DWS 1 Length (In)	N/A
N/A	Road 1 Slope (%)	1.8	N/A	DWS 1 Full Width?	N/A
N/A	Road 1 X Slope (%)	0.8	N/A	DWS 1 Offset (In)	N/A
Yes	Refuge 2 Length (In)	36.0	N/A	Gutter 2 Ponding?	N/A
Yes	Refuge 2 Width (In)	121.0	N/A	Gutter 2 Lip Ht (In)	N/A
Yes	Refuge 2 Slope (%)	0.5	N/A	Gutter 2 Slope (%)	N/A
Yes	Refuge 2 X Slope (%)	4.1	N/A	Gutter 2 X Slope (%)	N/A
N/A	Painted X Walk2?	No	N/A	DWS 2 Provided?	N/A
N/A	X Walk 2 Direction	To SE	N/A	DWS 2 Contrast?	N/A
N/A	X Walk 2 Width (In)	N/A	N/A	DWS 2 Length (In)	N/A

N/A	Road 2 Slope (%)	1.7	N/A	DWS 2 Full Width?	N/A
N/A	Road 2 X Slope (%)	4.0	N/A	DWS 2 Offset (In)	N/A
N/A	Refuge 3 Length (in)	N/A	N/A	Gutter 3 Ponding?	N/A
N/A	Refuge 3 Width (in)	N/A	N/A	Gutter 3 Lip Ht (in)	N/A
N/A	Refuge 3 Slope (%)	N/A	N/A	Gutter 3 Slope (%)	N/A
N/A	Refuge 3 XSlope (%)	N/A	N/A	Gutter 3 XSlope (%)	N/A
N/A	Painted X Walk3?	N/A	N/A	DWS 3 Provided?	N/A
N/A	X Walk 3 Direction	N/A	N/A	DWS 3 Contrast?	N/A
N/A	X Walk 3 Width (in)	N/A	N/A	DWS 3 Length (in)	N/A
N/A	Road 3 Slope (%)	N/A	N/A	DWS 3 Full Width?	N/A
N/A	Road 3 XSlope (%)	N/A	N/A	DWS 3 Offset (in)	N/A
Yes	Any Obstructions?	N/A	N/A	Storm Grate/Utility Hazard?	N/A
N/A	Obstruction Type		N/A	Storm Grate/Utility Type	
		N/A			N/A
N/A	Surface Condition	Good

**Remove & Replace Entire Refuge.**
