# Access Compliance Report

## Public Rights-of-Way

### (Island Curb Cuts)

Intersection ID: 27333	Main Street: BALLANTYNE_MEDICAL_PL	Cross Street: BRIXHAM_HILL_AV	Location: E
ADA ID: 3DA8838D8081	Curb Cut Type: MedianRefuge2	Initial Pass/Fail: Fail	Overall Compliance: No
Codes/Mitigation Info/Possible Solution		Field Measurements/Component Compliance

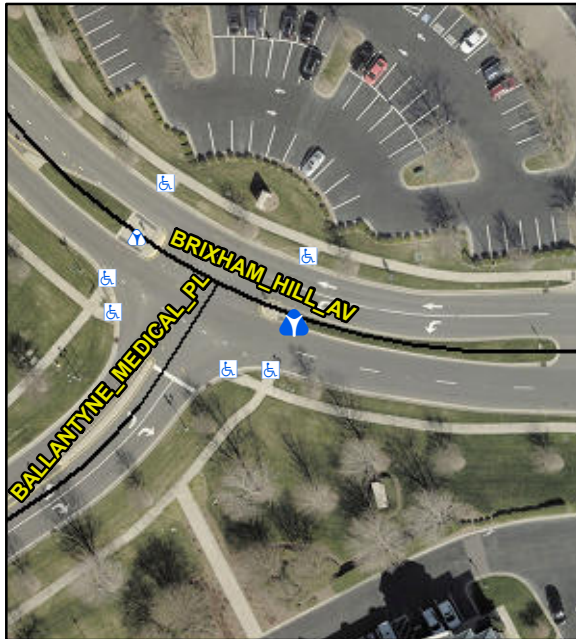
Compliance	Description	Data	Compliance	Description	Data
Yes	Refuge 1 Length (In)	41.5	N/A	Gutter 1 Ponding?	N/A
Yes	Refuge 1 Width (In)	168.0	N/A	Gutter 1 Lip Ht (In)	N/A
Yes	Refuge 1 Slope (%)	4.1	N/A	Gutter 1 Slope (%)	N/A
Yes	Refuge 1 X Slope (%)	4.0	N/A	Gutter 1 X Slope (%)	N/A
N/A	Painted X Walk1?	No	N/A	DWS 1 Provided?	N/A
N/A	X Walk 1 Direction	To N	N/A	DWS 1 Contrast?	N/A
N/A	X Walk 1 Width (In)	N/A	N/A	DWS 1 Length (In)	N/A
N/A	Road 1 Slope (%)	1.4	N/A	DWS 1 Full Width?	N/A
N/A	Road 1 X Slope (%)	6.9	N/A	DWS 1 Offset (In)	N/A
Yes	Refuge 2 Length (In)	41.5	N/A	Gutter 2 Ponding?	N/A
Yes	Refuge 2 Width (In)	168.0	N/A	Gutter 2 Lip Ht (In)	N/A
Yes	Refuge 2 Slope (%)	3.5	N/A	Gutter 2 Slope (%)	N/A
Yes	Refuge 2 X Slope (%)	1.7	N/A	Gutter 2 X Slope (%)	N/A
N/A	Painted X Walk2?	No	N/A	DWS 2 Provided?	N/A
N/A	X Walk 2 Direction	To S	N/A	DWS 2 Contrast?	N/A
N/A	X Walk 2 Width (In)	N/A	N/A	DWS 2 Length (In)	N/A

N/A	Road 2 Slope (%)	2.1	N/A	DWS 2 Full Width?	N/A
N/A	Road 2 X Slope (%)	4.5	N/A	DWS 2 Offset (In)	N/A
N/A	Refuge 3 Length (in)	N/A	N/A	Gutter 3 Ponding?	N/A
N/A	Refuge 3 Width (in)	N/A	N/A	Gutter 3 Lip Ht (in)	N/A
N/A	Refuge 3 Slope (%)	N/A	N/A	Gutter 3 Slope (%)	N/A
N/A	Refuge 3 XSlope (%)	N/A	N/A	Gutter 3 XSlope (%)	N/A
N/A	Painted X Walk3?	N/A	N/A	DWS 3 Provided?	N/A
N/A	X Walk 3 Direction	N/A	N/A	DWS 3 Contrast?	N/A
N/A	X Walk 3 Width (in)	N/A	N/A	DWS 3 Length (in)	N/A
N/A	Road 3 Slope (%)	N/A	N/A	DWS 3 Full Width?	N/A
N/A	Road 3 XSlope (%)	N/A	N/A	DWS 3 Offset (in)	N/A
Yes	Any Obstructions?	N/A	N/A	Storm Grate/Utility Hazard?	N/A
N/A	Obstruction Type		N/A	Storm Grate/Utility Type	
		N/A			N/A
N/A	Surface Condition	Good

**Remove & Replace Entire Refuge.**
