Access Compliance Report

Public Rights-of-Way

(Island Curb Cuts)

Intersection ID: 51510	Main Street: KENILWORTH_AV	Cross Street: PEARL_PARK_WY	Location: SW
ADA ID: 3DC69C5F26F6	Curb Cut Type: MedianRefuge2	Initial Pass/Fail: Fail	Overall Compliance: No
Codes/Mitigation Info/Possible Solution		Field Measurements/Component Compliance

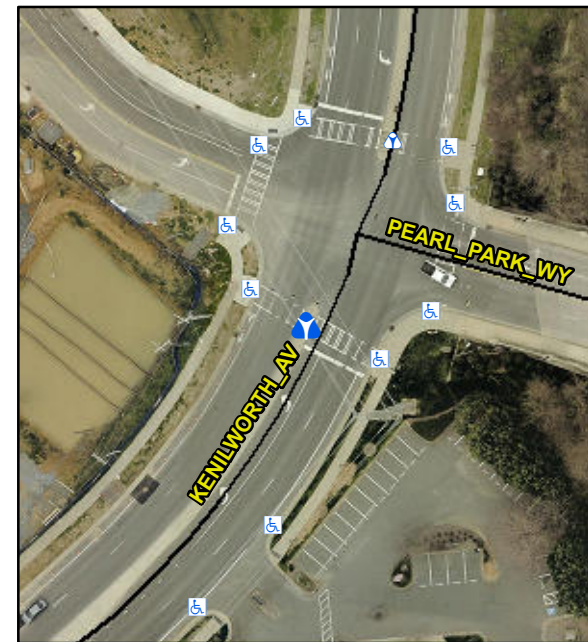
Compliance	Description	Data	Compliance	Description	Data
No	Refuge 1 Length (In)	35.5	N/A	Gutter 1 Ponding?	N/A
Yes	Refuge 1 Width (In)	99.0	N/A	Gutter 1 Lip Ht (In)	N/A
Yes	Refuge 1 Slope (%)	0.1	N/A	Gutter 1 Slope (%)	N/A
Yes	Refuge 1 X Slope (%)	2.9	N/A	Gutter 1 X Slope (%)	N/A
N/A	Painted X Walk1?	Yes	N/A	DWS 1 Provided?	N/A
N/A	X Walk 1 Direction	To SE	N/A	DWS 1 Contrast?	N/A
N/A	X Walk 1 Width (In)	110.0	N/A	DWS 1 Length (In)	N/A
N/A	Road 1 Slope (%)	1.4	N/A	DWS 1 Full Width?	N/A
N/A	Road 1 X Slope (%)	0.4	N/A	DWS 1 Offset (In)	N/A
No	Refuge 2 Length (In)	35.5	N/A	Gutter 2 Ponding?	N/A
Yes	Refuge 2 Width (In)	99.0	N/A	Gutter 2 Lip Ht (In)	N/A
Yes	Refuge 2 Slope (%)	2.3	N/A	Gutter 2 Slope (%)	N/A
Yes	Refuge 2 X Slope (%)	3.3	N/A	Gutter 2 X Slope (%)	N/A
N/A	Painted X Walk2?	Yes	N/A	DWS 2 Provided?	N/A
N/A	X Walk 2 Direction	To NW	N/A	DWS 2 Contrast?	N/A
N/A	X Walk 2 Width (In)	111.0	N/A	DWS 2 Length (In)	N/A

N/A	Road 2 Slope (%)	2.0	N/A	DWS 2 Full Width?	N/A
N/A	Road 2 X Slope (%)	2.9	N/A	DWS 2 Offset (In)	N/A
N/A	Refuge 3 Length (in)	N/A	N/A	Gutter 3 Ponding?	N/A
N/A	Refuge 3 Width (in)	N/A	N/A	Gutter 3 Lip Ht (in)	N/A
N/A	Refuge 3 Slope (%)	N/A	N/A	Gutter 3 Slope (%)	N/A
N/A	Refuge 3 XSlope (%)	N/A	N/A	Gutter 3 XSlope (%)	N/A
N/A	Painted X Walk3?	N/A	N/A	DWS 3 Provided?	N/A
N/A	X Walk 3 Direction	N/A	N/A	DWS 3 Contrast?	N/A
N/A	X Walk 3 Width (in)	N/A	N/A	DWS 3 Length (in)	N/A
N/A	Road 3 Slope (%)	N/A	N/A	DWS 3 Full Width?	N/A
N/A	Road 3 XSlope (%)	N/A	N/A	DWS 3 Offset (in)	N/A
Yes	Any Obstructions?	N/A	N/A	Storm Grate/Utility Hazard?	N/A
N/A	Obstruction Type		N/A	Storm Grate/Utility Type	
		N/A			N/A
N/A	Surface Condition	Good

Possible Solutions:

Remove & Replace Entire Refuge.

Total Cost: \$ 3000.00
