# Access Compliance Report

## Public Rights-of-Way

### (Island Curb Cuts)

| Intersection ID: 27610 | Main Street: JOHNSTON_RD | Cross Street: JOHN_J_DELANEY_DR | Location: SE |

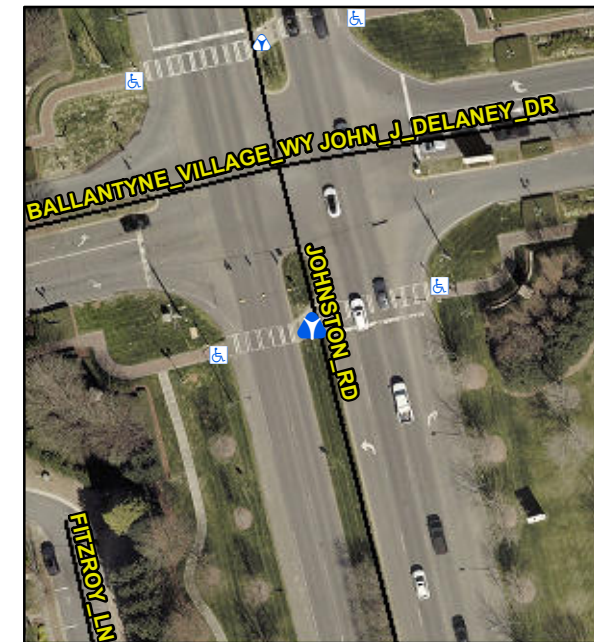
| ADA ID: 3E16521DE526 | Curb Cut Type: MedianRefuge2 | Initial Pass/Fail: Pass | Overall Compliance: No |
| Severity Score: 10.25 | | | |

| Compliance | Description | Data | Compliance | Description | Data |
|---|---|---|---|---|---|
| Yes | Refuge 1 Slope (%) | 2.3 | No | Gutter 1 Slope (%) | 8.1 |
| N/A | Road 1 X Slope (%) | 1.0 | No | DWS 1 Offset (In) | 4.0 |
| Yes | Refuge 2 Slope (%) | 3.4 | No | Gutter 2 Slope (%) | 5.5 |
| N/A | Road 2 X Slope (%) | 2.1 | No | DWS 2 Offset (In) | 4.0 |

**Remove & Replace Detectable Warning System. Remove & Replace Gutter.**

Total Cost: \$ 3100.00
