Access Compliance Report

Public Rights-of-Way

(Island Curb Cuts)

Intersection ID: 15064	Main Street: MONROE_RD	Cross Street: WASHBURN_AV	Location: NW
ADA ID: 40F4AF606D39	Curb Cut Type: IslandRefuge3	Initial Pass/Fail: Fail	Overall Compliance: No
Severity Score: 36.25			
Codes/Mitigation Info/Possible Solution		Field Measurements/Component Compliance

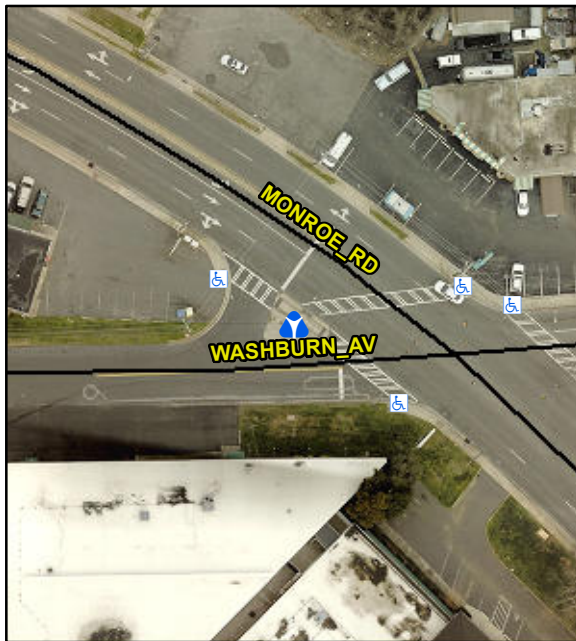
Compliance	Description	Data	Compliance	Description	Data
Yes	Refuge 1 Length (In)	95.0	N/A	Gutter 1 Ponding?	N/A
Yes	Refuge 1 Width (In)	75.5	N/A	Gutter 1 Lip Ht (In)	N/A
Yes	Refuge 1 Slope (%)	3.2	N/A	Gutter 1 Slope (%)	N/A
Yes	Refuge 1 X Slope (%)	3.2	N/A	Gutter 1 X Slope (%)	N/A
N/A	Painted X Walk1?	Yes	N/A	DWS 1 Provided?	N/A
N/A	X Walk 1 Direction	To E	N/A	DWS 1 Contrast?	N/A
N/A	X Walk 1 Width (In)	85.0	N/A	DWS 1 Length (In)	N/A
N/A	Road 1 Slope (%)	3.4	N/A	DWS 1 Full Width?	N/A
N/A	Road 1 X Slope (%)	0.2	N/A	DWS 1 Offset (In)	N/A
Yes	Refuge 2 Length (In)	154.0	N/A	Gutter 2 Ponding?	N/A
Yes	Refuge 2 Width (In)	74.5	N/A	Gutter 2 Lip Ht (In)	N/A
Yes	Refuge 2 Slope (%)	2.6	N/A	Gutter 2 Slope (%)	N/A
Yes	Refuge 2 X Slope (%)	2.8	N/A	Gutter 2 X Slope (%)	N/A
N/A	Painted X Walk2?	Yes	N/A	DWS 2 Provided?	N/A
N/A	X Walk 2 Direction	To N	N/A	DWS 2 Contrast?	N/A
N/A	X Walk 2 Width (In)	108.0	N/A	DWS 2 Length (In)	N/A

N/A	Road 2 Slope (%)	3.2	N/A	DWS 2 Full Width?	N/A
N/A	Road 2 X Slope (%)	0.3	N/A	DWS 2 Offset (In)	N/A
Yes	Refuge 3 Length (in)	122.0	N/A	Gutter 3 Ponding?	N/A
Yes	Refuge 3 Width (in)	74.5	N/A	Gutter 3 Lip Ht (in)	N/A
Yes	Refuge 3 Slope (%)	2.1	N/A	Gutter 3 Slope (%)	N/A
Yes	Refuge 3 XSlope (%)	0.1	N/A	Gutter 3 XSlope (%)	N/A
N/A	Painted X Walk3?	Yes	N/A	DWS 3 Provided?	N/A
N/A	X Walk 3 Direction	To SE	N/A	DWS 3 Contrast?	N/A
N/A	X Walk 3 Width (in)	94.0	N/A	DWS 3 Length (in)	N/A
N/A	Road 3 Slope (%)	0.8	N/A	DWS 3 Full Width?	N/A
N/A	Road 3 XSlope (%)	1.6	N/A	DWS 3 Offset (in)	N/A
Yes	Any Obstructions?	N/A	N/A	Storm Grate/Utility Hazard?	N/A
N/A	Obstruction Type		N/A	Storm Grate/Utility Type	
		N/A			N/A
N/A	Surface Condition	Good

Possible Solutions:

Remove & Replace Entire Refuge.

Total Cost: \$ 3000.00
