Access Compliance Report

Public Rights-of-Way

(Island Curb Cuts)

Intersection ID: N/A	Main Street: S CALDWELL ST	Cross Street: E STONEWALL ST	Location: W
ADA ID: 43FB4F22D7CC	Curb Cut Type: MedianRefuge2	Initial Pass/Fail: Fail	Overall Compliance: No
Severity Score: 1.25			
Codes/Mitigation Info/Possible Solution		Field Measurements/Component Compliance

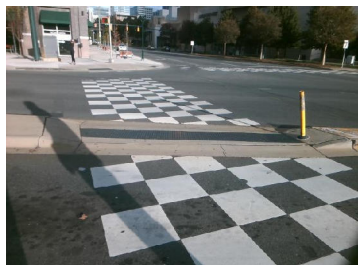
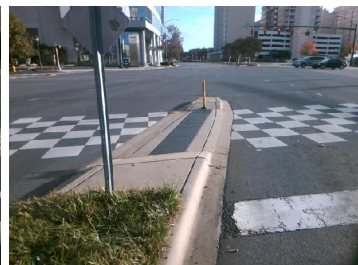
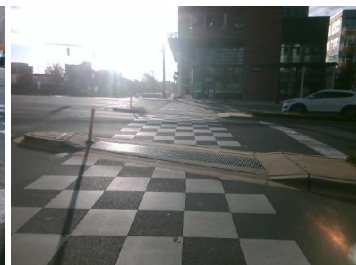
Compliance	Description	Data	Compliance	Description	Data
No	Refuge 1 Length (In)	44.0	N/A	Gutter 1 Ponding?	N/A
Yes	Refuge 1 Width (In)	165.0	N/A	Gutter 1 Lip Ht (In)	N/A
Yes	Refuge 1 Slope (%)	3.5	N/A	Gutter 1 Slope (%)	N/A
Yes	Refuge 1 X Slope (%)	2.4	N/A	Gutter 1 X Slope (%)	N/A
N/A	Painted X Walk1?	Yes	N/A	DWS 1 Provided?	N/A
N/A	X Walk 1 Direction	To SE	N/A	DWS 1 Contrast?	N/A
N/A	X Walk 1 Width (In)	144.0	N/A	DWS 1 Length (In)	N/A
N/A	Road 1 Slope (%)	0.8	N/A	DWS 1 Full Width?	N/A
N/A	Road 1 X Slope (%)	2.0	N/A	DWS 1 Offset (In)	N/A
No	Refuge 2 Length (In)	N/A	N/A	Gutter 2 Ponding?	N/A
Yes	Refuge 2 Width (In)	N/A	N/A	Gutter 2 Lip Ht (In)	N/A
No	Refuge 2 Slope (%)	N/A	N/A	Gutter 2 Slope (%)	N/A
No	Refuge 2 X Slope (%)	N/A	N/A	Gutter 2 X Slope (%)	N/A
N/A	Painted X Walk2?	Yes	N/A	DWS 2 Provided?	N/A
N/A	X Walk 2 Direction	To NW	N/A	DWS 2 Contrast?	N/A
N/A	X Walk 2 Width (In)	144.0	N/A	DWS 2 Length (In)	N/A

N/A	Road 2 Slope (%)	1.3	N/A	DWS 2 Full Width?	N/A
N/A	Road 2 X Slope (%)	3.0	N/A	DWS 2 Offset (In)	N/A
N/A	Refuge 3 Length (in)	N/A	N/A	Gutter 3 Ponding?	N/A
N/A	Refuge 3 Width (in)	N/A	N/A	Gutter 3 Lip Ht (in)	N/A
N/A	Refuge 3 Slope (%)	N/A	N/A	Gutter 3 Slope (%)	N/A
N/A	Refuge 3 XSlope (%)	N/A	N/A	Gutter 3 XSlope (%)	N/A
N/A	Painted X Walk3?	N/A	N/A	DWS 3 Provided?	N/A
N/A	X Walk 3 Direction	N/A	N/A	DWS 3 Contrast?	N/A
N/A	X Walk 3 Width (in)	N/A	N/A	DWS 3 Length (in)	N/A
N/A	Road 3 Slope (%)	N/A	N/A	DWS 3 Full Width?	N/A
N/A	Road 3 XSlope (%)	N/A	N/A	DWS 3 Offset (in)	N/A
Yes	Any Obstructions?	N/A	N/A	Storm Grate/Utility Hazard?	N/A
N/A	Obstruction Type		N/A	Storm Grate/Utility Type	
		N/A			N/A
N/A	Surface Condition	Good

Remove & Replace Entire Refuge.
