Access Compliance Report

Public Rights-of-Way

(Island Curb Cuts)

Intersection ID: 51491	Main Street: N_TRYON_ST	Cross Street: INSTITUTE_CR	Location: NW
ADA ID: 44AA13848D28	Curb Cut Type: MedianRefuge2	Initial Pass/Fail: Fail	Overall Compliance: No
Codes/Mitigation Info/Possible Solution		Field Measurements/Component Compliance

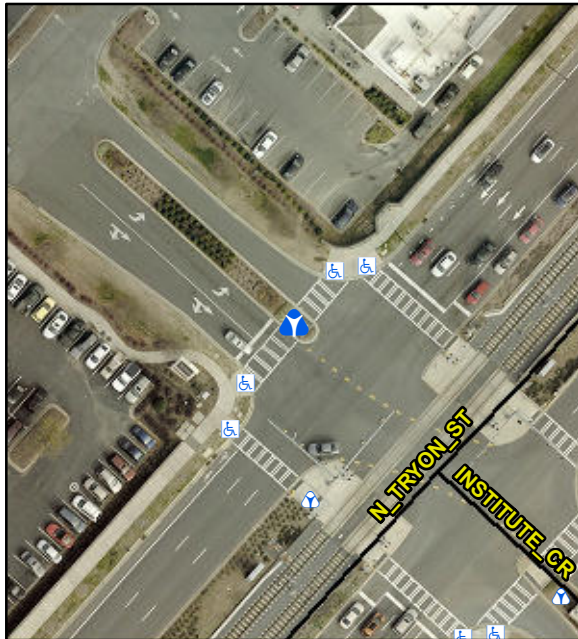
Compliance	Description	Data	Compliance	Description	Data
Yes	Refuge 1 Length (In)	72.0	Yes	Gutter 1 Ponding?	N/A
Yes	Refuge 1 Width (In)	90.0	No	Gutter 1 Lip Ht (In)	2.5
Yes	Refuge 1 Slope (%)	4.7	No	Gutter 1 Slope (%)	N/A
Yes	Refuge 1 X Slope (%)	2.2	No	Gutter 1 X Slope (%)	N/A
N/A	Painted X Walk1?	No	N/A	DWS 1 Provided?	N/A
N/A	X Walk 1 Direction	To NE	N/A	DWS 1 Contrast?	N/A
N/A	X Walk 1 Width (In)	N/A	N/A	DWS 1 Length (In)	N/A
N/A	Road 1 Slope (%)	0.5	N/A	DWS 1 Full Width?	N/A
N/A	Road 1 X Slope (%)	4.3	N/A	DWS 1 Offset (In)	N/A
Yes	Refuge 2 Length (In)	72.0	Yes	Gutter 2 Ponding?	N/A
Yes	Refuge 2 Width (In)	90.0	No	Gutter 2 Lip Ht (In)	2.5
Yes	Refuge 2 Slope (%)	4.2	No	Gutter 2 Slope (%)	N/A
Yes	Refuge 2 X Slope (%)	1.5	No	Gutter 2 X Slope (%)	N/A
N/A	Painted X Walk2?	No	N/A	DWS 2 Provided?	N/A
N/A	X Walk 2 Direction	To SW	N/A	DWS 2 Contrast?	N/A
N/A	X Walk 2 Width (In)	N/A	N/A	DWS 2 Length (In)	N/A
N/A	Road 2 Slope (%)	4.0	N/A	DWS 2 Full Width?	N/A

N/A	Road 2 X Slope (%)	3.3	N/A	DWS 2 Offset (In)	N/A
N/A	Refuge 3 Length (in)	N/A	N/A	Gutter 3 Ponding?	N/A
N/A	Refuge 3 Width (in)	N/A	N/A	Gutter 3 Lip Ht (in)	N/A
N/A	Refuge 3 Slope (%)	N/A	N/A	Gutter 3 Slope (%)	N/A
N/A	Refuge 3 XSlope (%)	N/A	N/A	Gutter 3 XSlope (%)	N/A
N/A	Painted X Walk3?	No	N/A	DWS 3 Provided?	N/A
N/A	X Walk 3 Direction	N/A	N/A	DWS 3 Contrast?	N/A
N/A	X Walk 3 Width (in)	N/A	N/A	DWS 3 Length (in)	N/A
N/A	Road 3 Slope (%)	N/A	N/A	DWS 3 Full Width?	N/A
N/A	Road 3 XSlope (%)	N/A	N/A	DWS 3 Offset (in)	N/A
Yes	Any Obstructions?	N/A	N/A	Storm Grate/Utility Hazard?	N/A
N/A	Obstruction Type		N/A	Storm Grate/Utility Type	
		N/A			N/A
No	Surface Condition	Poor

Remove & Replace Entire Refuge.
Remove & Replace Gutter.
