Access Compliance Report

Public Rights-of-Way

(Island Curb Cuts)

Intersection ID: 32449	Main Street: N_TRYON_ST	Cross Street: J_W_CLAY_BV	Location: W
ADA ID: 45033967FAF3	Curb Cut Type: MedianRefuge2	Initial Pass/Fail: Pass	Overall Compliance: No
Codes/Mitigation Info/Possible Solution		Field Measurements/Component Compliance	
Severity Score: 0.25

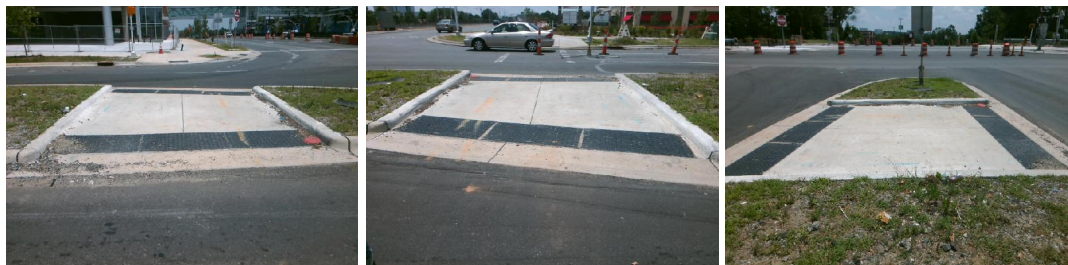
Compliance	Description	Data	Compliance	Description	Data
Yes	Refuge 1 Length (In)	75.0	No	Gutter 1 Ponding?	Yes
Yes	Refuge 1 Width (In)	148.0	Yes	Gutter 1 Lip Ht (In)	0.0
Yes	Refuge 1 Slope (%)	3.2	Yes	Gutter 1 Slope (%)	1.2
Yes	Refuge 1 X Slope (%)	1.8	Yes	Gutter 1 X Slope (%)	1.4
N/A	Painted X Walk1?	Yes	Yes	DWS 1 Provided?	Yes
N/A	X Walk 1 Direction	To SW	Yes	DWS 1 Contrast?	Yes
N/A	X Walk 1 Width (In)	136.0	Yes	DWS 1 Length (In)	24.0
N/A	Road 1 Slope (%)	1.3	Yes	DWS 1 Full Width?	Yes
N/A	Road 1 X Slope (%)	0.2	Yes	DWS 1 Offset (In)	0.0
Yes	Refuge 2 Length (In)	75.0	No	Gutter 2 Ponding?	Yes
Yes	Refuge 2 Width (In)	148.0	Yes	Gutter 2 Lip Ht (In)	0.0
Yes	Refuge 2 Slope (%)	4.8	Yes	Gutter 2 Slope (%)	1.5
Yes	Refuge 2 X Slope (%)	0.5	Yes	Gutter 2 X Slope (%)	1.0
N/A	Painted X Walk2?	Yes	Yes	DWS 2 Provided?	Yes
N/A	X Walk 2 Direction	To NE	Yes	DWS 2 Contrast?	Yes
N/A	X Walk 2 Width (In)	138.0	Yes	DWS 2 Length (In)	24.0

Possible Solutions:

Fix Gutter Ponding.
