Access Compliance Report

Public Rights-of-Way

(Island Curb Cuts)

Intersection ID: 10035582	Main Street: REAMES_RD	Cross Street: N/A	Location: N
ADA ID: 4A2A30A2204A	Curb Cut Type: MedianRefuge2	Initial Pass/Fail: Fail	Overall Compliance: No
Codes/Mitigation Info/Possible Solution		Field Measurements/Component Compliance

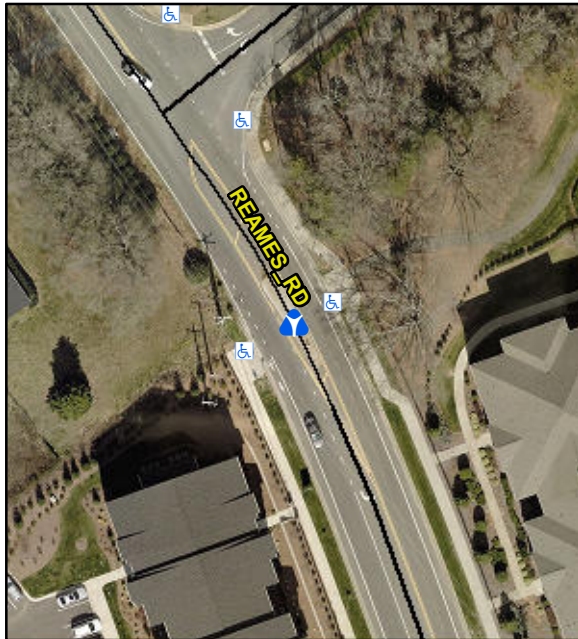
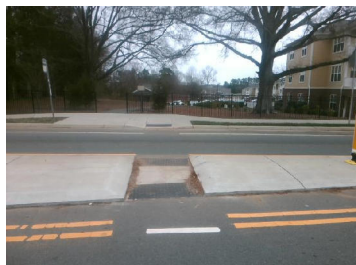
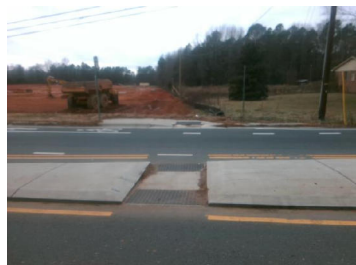
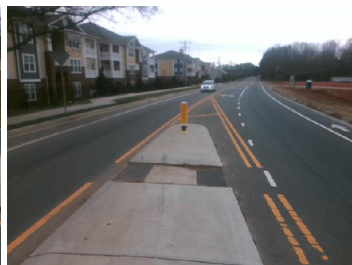
Compliance	Description	Data	Compliance	Description	Data
Yes	Refuge 1 Length (In)	43.5	N/A	Gutter 1 Ponding?	N/A
No	Refuge 1 Width (In)	50.0	N/A	Gutter 1 Lip Ht (In)	N/A
Yes	Refuge 1 Slope (%)	2.9	N/A	Gutter 1 Slope (%)	N/A
Yes	Refuge 1 X Slope (%)	1.4	N/A	Gutter 1 X Slope (%)	N/A
N/A	Painted X Walk1?	No	N/A	DWS 1 Provided?	N/A
N/A	X Walk 1 Direction	To E	N/A	DWS 1 Contrast?	N/A
N/A	X Walk 1 Width (In)	N/A	N/A	DWS 1 Length (In)	N/A
N/A	Road 1 Slope (%)	1.0	N/A	DWS 1 Full Width?	N/A
N/A	Road 1 X Slope (%)	0.9	N/A	DWS 1 Offset (In)	N/A
Yes	Refuge 2 Length (In)	43.5	N/A	Gutter 2 Ponding?	N/A
No	Refuge 2 Width (In)	50.0	N/A	Gutter 2 Lip Ht (In)	N/A
Yes	Refuge 2 Slope (%)	3.2	N/A	Gutter 2 Slope (%)	N/A
Yes	Refuge 2 X Slope (%)	0.3	N/A	Gutter 2 X Slope (%)	N/A
N/A	Painted X Walk2?	No	N/A	DWS 2 Provided?	N/A
N/A	X Walk 2 Direction	To W	N/A	DWS 2 Contrast?	N/A
N/A	X Walk 2 Width (In)	N/A	N/A	DWS 2 Length (In)	N/A

N/A	Road 2 Slope (%)	1.1	N/A	DWS 2 Full Width?	N/A
N/A	Road 2 X Slope (%)	4.7	N/A	DWS 2 Offset (In)	N/A
N/A	Refuge 3 Length (in)	N/A	N/A	Gutter 3 Ponding?	N/A
N/A	Refuge 3 Width (in)	N/A	N/A	Gutter 3 Lip Ht (in)	N/A
N/A	Refuge 3 Slope (%)	N/A	N/A	Gutter 3 Slope (%)	N/A
N/A	Refuge 3 XSlope (%)	N/A	N/A	Gutter 3 XSlope (%)	N/A
N/A	Painted X Walk3?	N/A	N/A	DWS 3 Provided?	N/A
N/A	X Walk 3 Direction	N/A	N/A	DWS 3 Contrast?	N/A
N/A	X Walk 3 Width (in)	N/A	N/A	DWS 3 Length (in)	N/A
N/A	Road 3 Slope (%)	N/A	N/A	DWS 3 Full Width?	N/A
N/A	Road 3 XSlope (%)	N/A	N/A	DWS 3 Offset (in)	N/A
Yes	Any Obstructions?	N/A	N/A	Storm Grate/Utility Hazard?	N/A
N/A	Obstruction Type		N/A	Storm Grate/Utility Type	
			N/A		N/A
N/A	Surface Condition	Good

Remove & Replace Entire Refuge.
