Access Compliance Report

Public Rights-of-Way

(Island Curb Cuts)

Intersection ID: 27806	Main Street: PARKS_FARM_LN	Cross Street: REA_RD	Location:	W
ADA ID: 4A376817CFD4	Curb Cut Type: MedianRefuge2	Initial Pass/Fail: Fail	Overall Compliance: No	Severity Score: 10
Codes/Mitigation Info/Possible Solution		Field Measurements/Component Compliance

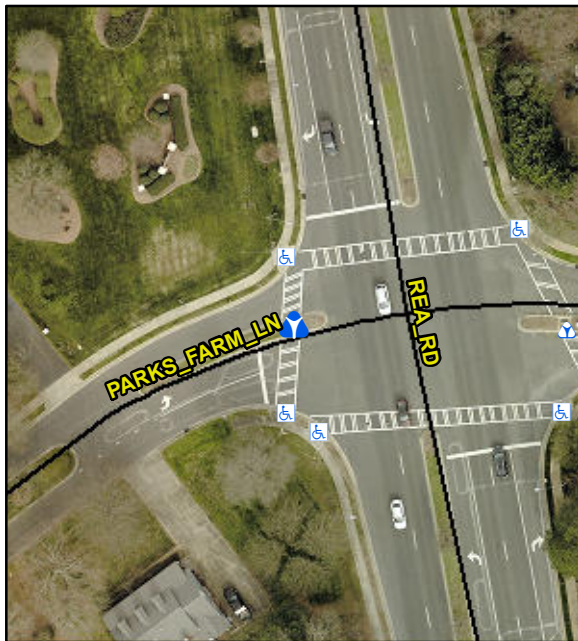
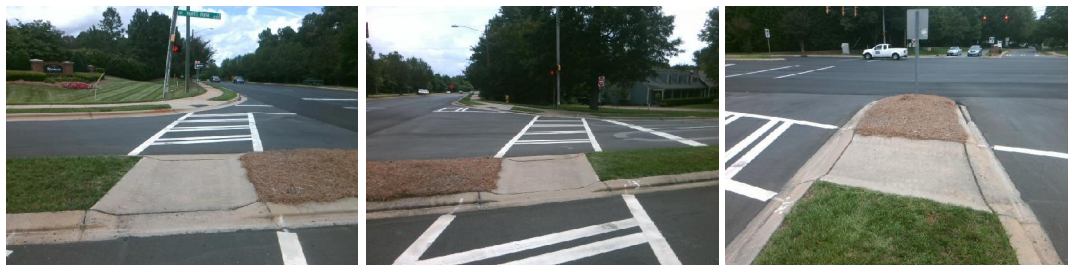
Compliance	Description	Data	Compliance	Description	Data
Yes	Refuge 1 Length (In)	42.0	N/A	Gutter 1 Ponding?	N/A
No	Refuge 1 Width (In)	57.0	N/A	Gutter 1 Lip Ht (In)	N/A
Yes	Refuge 1 Slope (%)	2.2	N/A	Gutter 1 Slope (%)	N/A
Yes	Refuge 1 X Slope (%)	2.8	N/A	Gutter 1 X Slope (%)	N/A
N/A	Painted X Walk1?	Yes	N/A	DWS 1 Provided?	N/A
N/A	X Walk 1 Direction	To N	N/A	DWS 1 Contrast?	N/A
N/A	X Walk 1 Width (In)	102.0	N/A	DWS 1 Length (In)	N/A
N/A	Road 1 Slope (%)	1.0	N/A	DWS 1 Full Width?	N/A
N/A	Road 1 X Slope (%)	3.0	N/A	DWS 1 Offset (In)	N/A
Yes	Refuge 2 Length (In)	42.0	N/A	Gutter 2 Ponding?	N/A
No	Refuge 2 Width (In)	57.0	N/A	Gutter 2 Lip Ht (In)	N/A
Yes	Refuge 2 Slope (%)	0.2	N/A	Gutter 2 Slope (%)	N/A
Yes	Refuge 2 X Slope (%)	0.6	N/A	Gutter 2 X Slope (%)	N/A
N/A	Painted X Walk2?	Yes	N/A	DWS 2 Provided?	N/A
N/A	X Walk 2 Direction	To S	N/A	DWS 2 Contrast?	N/A
N/A	X Walk 2 Width (In)	102.0	N/A	DWS 2 Length (In)	N/A

N/A	Road 2 Slope (%)	2.1	N/A	DWS 2 Full Width?	N/A
N/A	Road 2 X Slope (%)	0.7	N/A	DWS 2 Offset (In)	N/A
N/A	Refuge 3 Length (in)	N/A	N/A	Gutter 3 Ponding?	N/A
N/A	Refuge 3 Width (in)	N/A	N/A	Gutter 3 Lip Ht (in)	N/A
N/A	Refuge 3 Slope (%)	N/A	N/A	Gutter 3 Slope (%)	N/A
N/A	Refuge 3 XSlope (%)	N/A	N/A	Gutter 3 XSlope (%)	N/A
N/A	Painted X Walk3?	N/A	N/A	DWS 3 Provided?	N/A
N/A	X Walk 3 Direction	N/A	N/A	DWS 3 Contrast?	N/A
N/A	X Walk 3 Width (in)	N/A	N/A	DWS 3 Length (in)	N/A
N/A	Road 3 Slope (%)	N/A	N/A	DWS 3 Full Width?	N/A
N/A	Road 3 XSlope (%)	N/A	N/A	DWS 3 Offset (in)	N/A
Yes	Any Obstructions?	N/A	N/A	Storm Grate/Utility Hazard?	N/A
N/A	Obstruction Type		N/A	Storm Grate/Utility Type	
		N/A			N/A
N/A	Surface Condition	Good

Possible Solutions:

Remove & Replace Entire Refuge.

Total Cost: \$ 3000.00
