Access Compliance Report

Public Rights-of-Way

(Island Curb Cuts)

Intersection ID: 12517	Main Street: N_SHARON_AMITY_RD	Cross Street: SHAMROCK_DR	Location: NE
ADA ID: 4C9FDEB15B1D	Curb Cut Type: MedianRefuge2	Initial Pass/Fail: Fail	Overall Compliance: No
Severity Score: 8.75			
Codes/Mitigation Info/Possible Solution		Field Measurements/Component Compliance

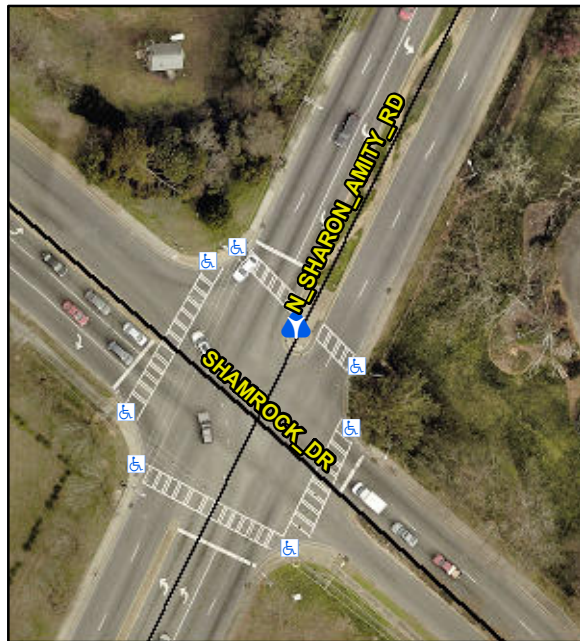
Compliance	Description	Data	Compliance	Description	Data
Yes	Refuge 1 Length (In)	84.0	N/A	Gutter 1 Ponding?	N/A
No	Refuge 1 Width (In)	48.0	N/A	Gutter 1 Lip Ht (In)	N/A
Yes	Refuge 1 Slope (%)	0.7	N/A	Gutter 1 Slope (%)	N/A
Yes	Refuge 1 X Slope (%)	0.4	N/A	Gutter 1 X Slope (%)	N/A
N/A	Painted X Walk1?	Yes	N/A	DWS 1 Provided?	N/A
N/A	X Walk 1 Direction	To SE	N/A	DWS 1 Contrast?	N/A
N/A	X Walk 1 Width (In)	95.0	N/A	DWS 1 Length (In)	N/A
N/A	Road 1 Slope (%)	0.5	N/A	DWS 1 Full Width?	N/A
N/A	Road 1 X Slope (%)	2.1	N/A	DWS 1 Offset (In)	N/A
Yes	Refuge 2 Length (In)	84.0	N/A	Gutter 2 Ponding?	N/A
No	Refuge 2 Width (In)	48.0	N/A	Gutter 2 Lip Ht (In)	N/A
Yes	Refuge 2 Slope (%)	0.5	N/A	Gutter 2 Slope (%)	N/A
Yes	Refuge 2 X Slope (%)	1.2	N/A	Gutter 2 X Slope (%)	N/A
N/A	Painted X Walk2?	Yes	N/A	DWS 2 Provided?	N/A
N/A	X Walk 2 Direction	To NW	N/A	DWS 2 Contrast?	N/A
N/A	X Walk 2 Width (In)	88.0	N/A	DWS 2 Length (In)	N/A

Remove & Replace Entire Refuge.

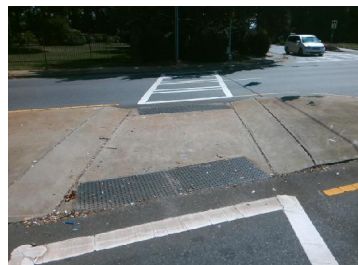
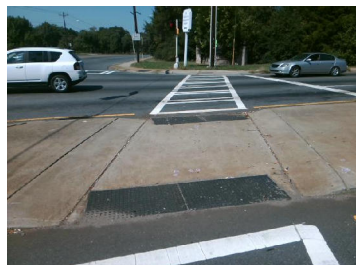
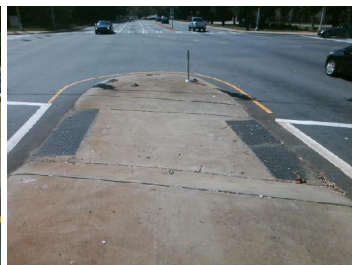
N/A	Road 2 Slope (%)	0.8	N/A	DWS 2 Full Width?	N/A
N/A	Road 2 X Slope (%)	2.9	N/A	DWS 2 Offset (In)	N/A
N/A	Refuge 3 Length (in)	N/A	N/A	Gutter 3 Ponding?	N/A
N/A	Refuge 3 Width (in)	N/A	N/A	Gutter 3 Lip Ht (in)	N/A
N/A	Refuge 3 Slope (%)	N/A	N/A	Gutter 3 Slope (%)	N/A
N/A	Refuge 3 XSlope (%)	N/A	N/A	Gutter 3 XSlope (%)	N/A
N/A	Painted X Walk3?	No	N/A	DWS 3 Provided?	N/A
N/A	X Walk 3 Direction	N/A	N/A	DWS 3 Contrast?	N/A
N/A	X Walk 3 Width (in)	N/A	N/A	DWS 3 Length (in)	N/A
N/A	Road 3 Slope (%)	N/A	N/A	DWS 3 Full Width?	N/A
N/A	Road 3 XSlope (%)	N/A	N/A	DWS 3 Offset (in)	N/A
Yes	Any Obstructions?	N/A	N/A	Storm Grate/Utility Hazard?	N/A
N/A	Obstruction Type		N/A	Storm Grate/Utility Type	
		N/A			N/A
N/A	Surface Condition	Good
