# Access Compliance Report

## Public Rights-of-Way

### (Island Curb Cuts)

Intersection ID: 10039270	Main Street: SUNSET_RD	Cross Street: N/A	Location: SW
ADA ID: 4F074FBFD901	Curb Cut Type: MedianRefuge2	Initial Pass/Fail: Pass	Overall Compliance: No
Codes/Mitigation Info/Possible Solution		Field Measurements/Component Compliance	
Severity Score: 15

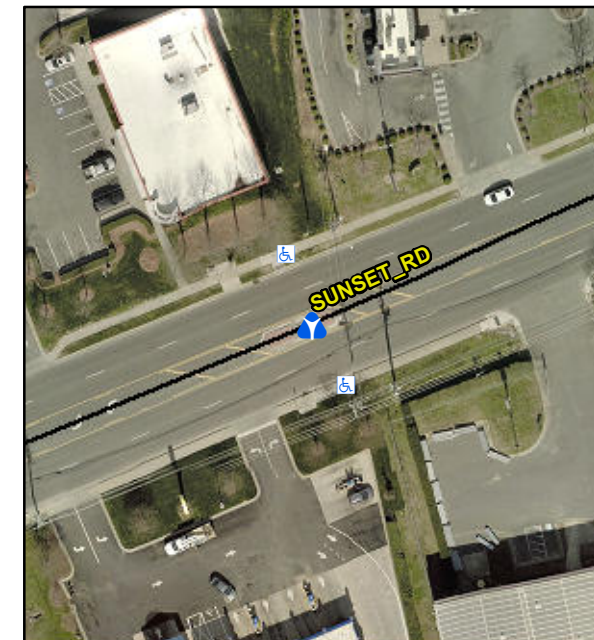
Compliance	Description	Data	Compliance	Description	Data
Yes	Refuge 1 Length (In)	42.0	Yes	Gutter 1 Ponding?	No
Yes	Refuge 1 Width (In)	98.0	Yes	Gutter 1 Lip Ht (In)	0.0
Yes	Refuge 1 Slope (%)	1.4	Yes	Gutter 1 Slope (%)	2.0
Yes	Refuge 1 X Slope (%)	1.8	Yes	Gutter 1 X Slope (%)	3.2
N/A	Painted X Walk1?	No	Yes	DWS 1 Provided?	Yes
N/A	X Walk 1 Direction	To N	Yes	DWS 1 Contrast?	Yes
N/A	X Walk 1 Width (In)	N/A	Yes	DWS 1 Length (In)	24.0
N/A	Road 1 Slope (%)	1.4	Yes	DWS 1 Full Width?	Yes
N/A	Road 1 X Slope (%)	3.3	Yes	DWS 1 Offset (In)	0.0
Yes	Refuge 2 Length (In)	42.0	Yes	Gutter 2 Ponding?	No
Yes	Refuge 2 Width (In)	98.0	No	Gutter 2 Lip Ht (In)	0.8
Yes	Refuge 2 Slope (%)	1.3	Yes	Gutter 2 Slope (%)	1.3
Yes	Refuge 2 X Slope (%)	0.7	Yes	Gutter 2 X Slope (%)	0.1
N/A	Painted X Walk2?	No	Yes	DWS 2 Provided?	Yes
N/A	X Walk 2 Direction	To S	Yes	DWS 2 Contrast?	Yes
N/A	X Walk 2 Width (In)	N/A	Yes	DWS 2 Length (In)	24.0

N/A	Road 2 Slope (%)	1.4	Yes	DWS 2 Full Width?	Yes
N/A	Road 2 X Slope (%)	0.5	Yes	DWS 2 Offset (In)	0.0
N/A	Refuge 3 Length (in)	N/A	N/A	Gutter 3 Ponding?	N/A
N/A	Refuge 3 Width (in)	N/A	N/A	Gutter 3 Lip Ht (in)	N/A
N/A	Refuge 3 Slope (%)	N/A	N/A	Gutter 3 Slope (%)	N/A
N/A	Refuge 3 XSlope (%)	N/A	N/A	Gutter 3 XSlope (%)	N/A
N/A	Painted X Walk3?	N/A	N/A	DWS 3 Provided?	N/A
N/A	X Walk 3 Direction	N/A	N/A	DWS 3 Contrast?	N/A
N/A	X Walk 3 Width (in)	N/A	N/A	DWS 3 Length (in)	N/A
N/A	Road 3 Slope (%)	N/A	N/A	DWS 3 Full Width?	N/A
N/A	Road 3 XSlope (%)	N/A	N/A	DWS 3 Offset (in)	N/A
Yes	Any Obstructions?	No	N/A	Storm Grate/Utility Hazard?	No
N/A	Obstruction Type		N/A	Storm Grate/Utility Type	
		N/A			N/A
N/A	Surface Condition	Good

Possible Solutions:

**Grind Gutter Lip.**
