Access Compliance Report

Public Rights-of-Way

(Island Curb Cuts)

Intersection ID: 18091	Main Street: ASHLEY_HALL_DR	Cross Street: IDLEWILD_RD	Location: NE
ADA ID: 548827E62428	Curb Cut Type: MedianRefuge2	Initial Pass/Fail: Fail	Overall Compliance: No
Codes/Mitigation Info/Possible Solution		Field Measurements/Component Compliance

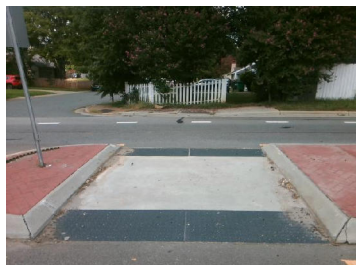
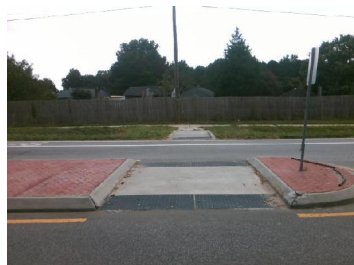
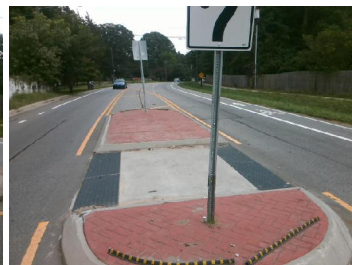
Compliance	Description	Data	Compliance	Description	Data
Yes	Refuge 1 Length (In)	66.0	N/A	Gutter 1 Ponding?	N/A
Yes	Refuge 1 Width (In)	119.0	N/A	Gutter 1 Lip Ht (In)	N/A
Yes	Refuge 1 Slope (%)	2.9	N/A	Gutter 1 Slope (%)	N/A
Yes	Refuge 1 X Slope (%)	3.5	N/A	Gutter 1 X Slope (%)	N/A
N/A	Painted X Walk1?	No	N/A	DWS 1 Provided?	N/A
N/A	X Walk 1 Direction	To NW	N/A	DWS 1 Contrast?	N/A
N/A	X Walk 1 Width (In)	N/A	N/A	DWS 1 Length (In)	N/A
N/A	Road 1 Slope (%)	4.3	N/A	DWS 1 Full Width?	N/A
N/A	Road 1 X Slope (%)	3.7	N/A	DWS 1 Offset (In)	N/A
Yes	Refuge 2 Length (In)	66.0	N/A	Gutter 2 Ponding?	N/A
Yes	Refuge 2 Width (In)	119.0	N/A	Gutter 2 Lip Ht (In)	N/A
Yes	Refuge 2 Slope (%)	3.7	N/A	Gutter 2 Slope (%)	N/A
Yes	Refuge 2 X Slope (%)	2.9	N/A	Gutter 2 X Slope (%)	N/A
N/A	Painted X Walk2?	No	N/A	DWS 2 Provided?	N/A
N/A	X Walk 2 Direction	To SE	N/A	DWS 2 Contrast?	N/A
N/A	X Walk 2 Width (In)	N/A	N/A	DWS 2 Length (In)	N/A

N/A	Road 2 Slope (%)	2.7	N/A	DWS 2 Full Width?	N/A
N/A	Road 2 X Slope (%)	4.5	N/A	DWS 2 Offset (In)	N/A
N/A	Refuge 3 Length (in)	N/A	N/A	Gutter 3 Ponding?	N/A
N/A	Refuge 3 Width (in)	N/A	N/A	Gutter 3 Lip Ht (in)	N/A
N/A	Refuge 3 Slope (%)	N/A	N/A	Gutter 3 Slope (%)	N/A
N/A	Refuge 3 XSlope (%)	N/A	N/A	Gutter 3 XSlope (%)	N/A
N/A	Painted X Walk3?	N/A	N/A	DWS 3 Provided?	N/A
N/A	X Walk 3 Direction	N/A	N/A	DWS 3 Contrast?	N/A
N/A	X Walk 3 Width (in)	N/A	N/A	DWS 3 Length (in)	N/A
N/A	Road 3 Slope (%)	N/A	N/A	DWS 3 Full Width?	N/A
N/A	Road 3 XSlope (%)	N/A	N/A	DWS 3 Offset (in)	N/A
Yes	Any Obstructions?	N/A	N/A	Storm Grate/Utility Hazard?	N/A
N/A	Obstruction Type		N/A	Storm Grate/Utility Type	
		N/A			N/A
N/A	Surface Condition	Good

Remove & Replace Entire Refuge.

\$ 3000.00
