# Access Compliance Report

## Public Rights-of-Way

### (Island Curb Cuts)

Intersection ID: 53421	Main Street: ARDREY_KELL_RD	Cross Street: N/A	Location: S
ADA ID: 56976FD91119	Curb Cut Type: MedianRefuge2	Initial Pass/Fail: Fail	Overall Compliance: No
		Severity Score: 0

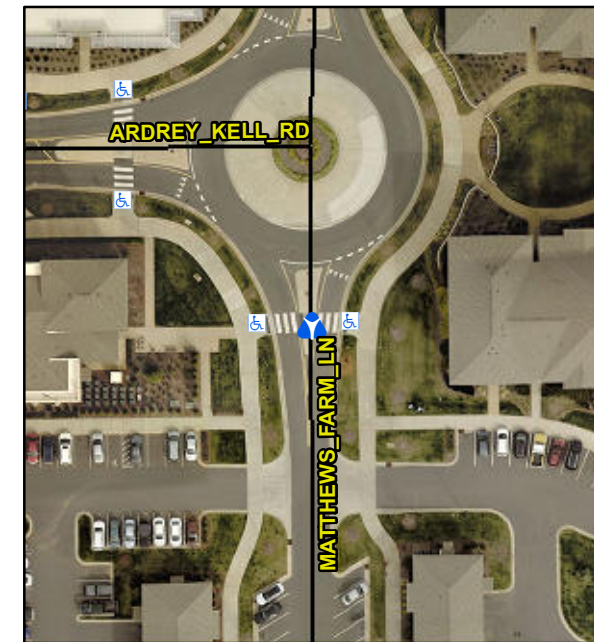
Compliance	Description	Data	Compliance	Description	Data
Yes	Refuge 1 Length (In)	36.0	N/A	Gutter 1 Ponding?	N/A
Yes	Refuge 1 Width (In)	119.0	N/A	Gutter 1 Lip Ht (In)	N/A
Yes	Refuge 1 Slope (%)	0.0	N/A	Gutter 1 Slope (%)	N/A
Yes	Refuge 1 X Slope (%)	4.3	N/A	Gutter 1 X Slope (%)	N/A
N/A	Painted X Walk1?	Yes	N/A	DWS 1 Provided?	N/A
N/A	X Walk 1 Direction	To W	N/A	DWS 1 Contrast?	N/A
N/A	X Walk 1 Width (In)	121.0	N/A	DWS 1 Length (In)	N/A
N/A	Road 1 Slope (%)	2.8	N/A	DWS 1 Full Width?	N/A
N/A	Road 1 X Slope (%)	1.8	N/A	DWS 1 Offset (In)	N/A
Yes	Refuge 2 Length (In)	36.0	N/A	Gutter 2 Ponding?	N/A
Yes	Refuge 2 Width (In)	119.0	N/A	Gutter 2 Lip Ht (In)	N/A
Yes	Refuge 2 Slope (%)	0.7	N/A	Gutter 2 Slope (%)	N/A
Yes	Refuge 2 X Slope (%)	3.4	N/A	Gutter 2 X Slope (%)	N/A
N/A	Painted X Walk2?	Yes	N/A	DWS 2 Provided?	N/A
N/A	X Walk 2 Direction	To E	N/A	DWS 2 Contrast?	N/A
N/A	X Walk 2 Width (In)	121.0	N/A	DWS 2 Length (In)	N/A

N/A	Road 2 Slope (%)	2.4	N/A	DWS 2 Full Width?	N/A
N/A	Road 2 X Slope (%)	2.6	N/A	DWS 2 Offset (In)	N/A
N/A	Refuge 3 Length (in)	N/A	N/A	Gutter 3 Ponding?	N/A
N/A	Refuge 3 Width (in)	N/A	N/A	Gutter 3 Lip Ht (in)	N/A
N/A	Refuge 3 Slope (%)	N/A	N/A	Gutter 3 Slope (%)	N/A
N/A	Refuge 3 XSlope (%)	N/A	N/A	Gutter 3 XSlope (%)	N/A
N/A	Painted X Walk3?	N/A	N/A	DWS 3 Provided?	N/A
N/A	X Walk 3 Direction	N/A	N/A	DWS 3 Contrast?	N/A
N/A	X Walk 3 Width (in)	N/A	N/A	DWS 3 Length (in)	N/A
N/A	Road 3 Slope (%)	N/A	N/A	DWS 3 Full Width?	N/A
N/A	Road 3 XSlope (%)	N/A	N/A	DWS 3 Offset (in)	N/A
Yes	Any Obstructions?	N/A	N/A	Storm Grate/Utility Hazard?	N/A
N/A	Obstruction Type		N/A	Storm Grate/Utility Type	
		N/A			N/A
N/A	Surface Condition	Good

**Remove & Replace Entire Refuge.**
