# Access Compliance Report

## Public Rights-of-Way

### (Island Curb Cuts)

Intersection ID: N/A	Main Street: S CALDWELL ST	Cross Street: E STONEWALL ST	Location: W
ADA ID: 599B02F907A4	Curb Cut Type: MedianRefuge2	Initial Pass/Fail: Fail	Overall Compliance: No
Codes/Mitigation Info/Possible Solution		Field Measurements/Component Compliance	
Severity Score: 0

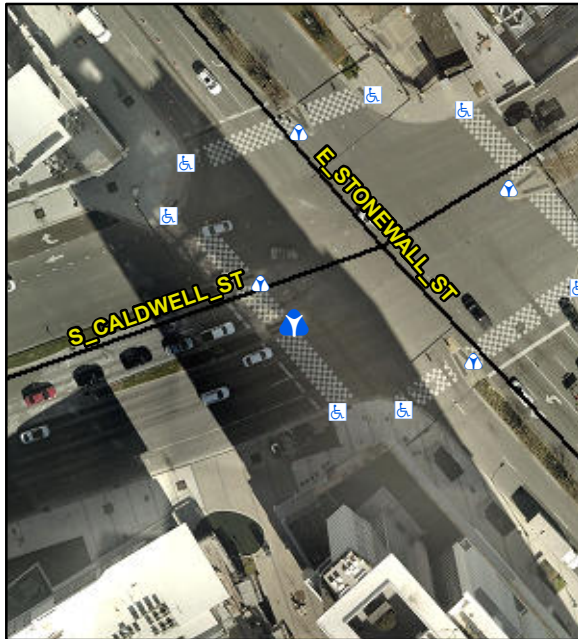
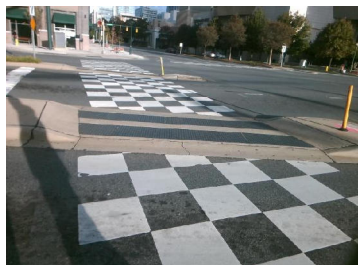
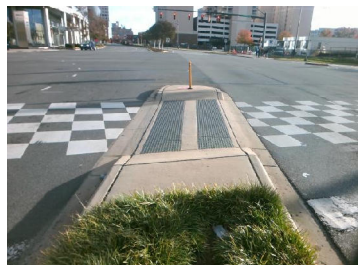
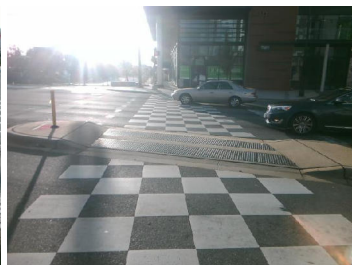
Compliance	Description	Data	Compliance	Description	Data
No	Refuge 1 Length (In)	34.5	N/A	Gutter 1 Ponding?	N/A
Yes	Refuge 1 Width (In)	165.0	N/A	Gutter 1 Lip Ht (In)	N/A
Yes	Refuge 1 Slope (%)	1.1	N/A	Gutter 1 Slope (%)	N/A
Yes	Refuge 1 X Slope (%)	2.5	N/A	Gutter 1 X Slope (%)	N/A
N/A	Painted X Walk1?	Yes	N/A	DWS 1 Provided?	N/A
N/A	X Walk 1 Direction	To SE	N/A	DWS 1 Contrast?	N/A
N/A	X Walk 1 Width (In)	144.0	N/A	DWS 1 Length (In)	N/A
N/A	Road 1 Slope (%)	3.7	N/A	DWS 1 Full Width?	N/A
N/A	Road 1 X Slope (%)	2.1	N/A	DWS 1 Offset (In)	N/A
No	Refuge 2 Length (In)	34.5	N/A	Gutter 2 Ponding?	N/A
Yes	Refuge 2 Width (In)	165.0	N/A	Gutter 2 Lip Ht (In)	N/A
Yes	Refuge 2 Slope (%)	1.2	N/A	Gutter 2 Slope (%)	N/A
Yes	Refuge 2 X Slope (%)	1.7	N/A	Gutter 2 X Slope (%)	N/A
N/A	Painted X Walk2?	Yes	N/A	DWS 2 Provided?	N/A
N/A	X Walk 2 Direction	To NW	N/A	DWS 2 Contrast?	N/A
N/A	X Walk 2 Width (In)	144.0	N/A	DWS 2 Length (In)	N/A

N/A	Road 2 Slope (%)	2.8	N/A	DWS 2 Full Width?	N/A
N/A	Road 2 X Slope (%)	1.6	N/A	DWS 2 Offset (In)	N/A
N/A	Refuge 3 Length (in)	N/A	N/A	Gutter 3 Ponding?	N/A
N/A	Refuge 3 Width (in)	N/A	N/A	Gutter 3 Lip Ht (in)	N/A
N/A	Refuge 3 Slope (%)	N/A	N/A	Gutter 3 Slope (%)	N/A
N/A	Refuge 3 XSlope (%)	N/A	N/A	Gutter 3 XSlope (%)	N/A
N/A	Painted X Walk3?	N/A	N/A	DWS 3 Provided?	N/A
N/A	X Walk 3 Direction	N/A	N/A	DWS 3 Contrast?	N/A
N/A	X Walk 3 Width (in)	N/A	N/A	DWS 3 Length (in)	N/A
N/A	Road 3 Slope (%)	N/A	N/A	DWS 3 Full Width?	N/A
N/A	Road 3 XSlope (%)	N/A	N/A	DWS 3 Offset (in)	N/A
Yes	Any Obstructions?	N/A	N/A	Storm Grate/Utility Hazard?	N/A
N/A	Obstruction Type		N/A	Storm Grate/Utility Type	
		N/A			N/A
N/A	Surface Condition	Good

Possible Solutions:

**Remove & Replace Entire Refuge.**
