Access Compliance Report

Public Rights-of-Way

(Island Curb Cuts)

Intersection ID: 11331	Main Street: E_W_T_HARRIS_BV	Cross Street: MEADOW_ROSE_LN	Location: N
ADA ID: 5BF07A9FFFD5	Curb Cut Type: MedianRefuge2	Initial Pass/Fail: Fail	Overall Compliance: No
Severity Score: 1.25			
Codes/Mitigation Info/Possible Solution		Field Measurements/Component Compliance

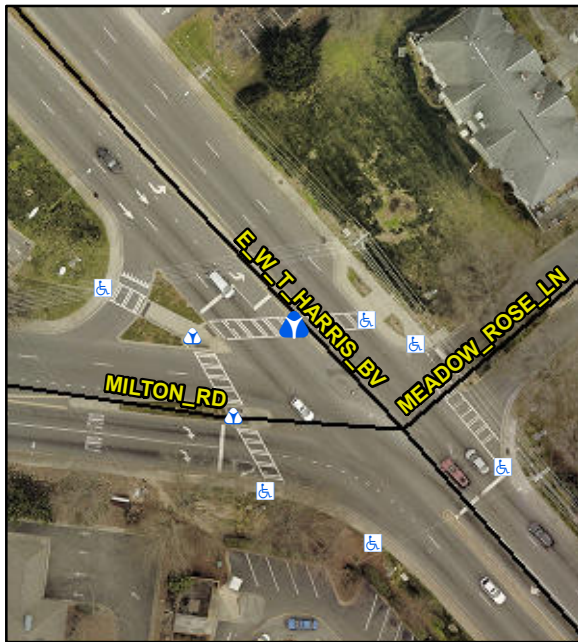
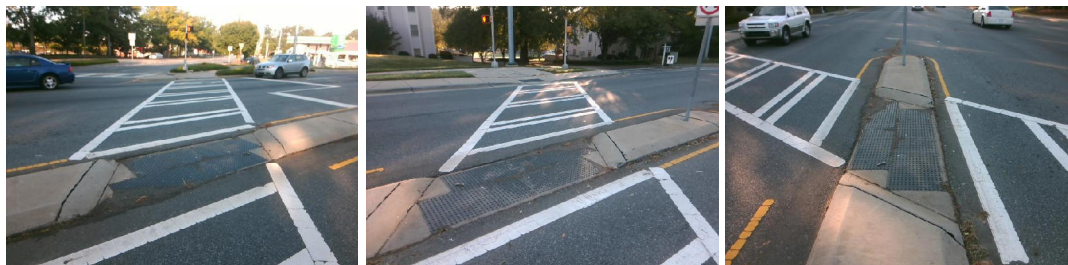
Compliance	Description	Data	Compliance	Description	Data
No	Refuge 1 Length (In)	23.5	N/A	Gutter 1 Ponding?	N/A
Yes	Refuge 1 Width (In)	115.0	N/A	Gutter 1 Lip Ht (In)	N/A
Yes	Refuge 1 Slope (%)	0.9	N/A	Gutter 1 Slope (%)	N/A
Yes	Refuge 1 X Slope (%)	1.9	N/A	Gutter 1 X Slope (%)	N/A
N/A	Painted X Walk1?	Yes	N/A	DWS 1 Provided?	N/A
N/A	X Walk 1 Direction	To W	N/A	DWS 1 Contrast?	N/A
N/A	X Walk 1 Width (In)	141.0	N/A	DWS 1 Length (In)	N/A
N/A	Road 1 Slope (%)	1.7	N/A	DWS 1 Full Width?	N/A
N/A	Road 1 X Slope (%)	0.6	N/A	DWS 1 Offset (In)	N/A
No	Refuge 2 Length (In)	23.5	N/A	Gutter 2 Ponding?	N/A
Yes	Refuge 2 Width (In)	115.0	N/A	Gutter 2 Lip Ht (In)	N/A
Yes	Refuge 2 Slope (%)	2.8	N/A	Gutter 2 Slope (%)	N/A
Yes	Refuge 2 X Slope (%)	2.2	N/A	Gutter 2 X Slope (%)	N/A
N/A	Painted X Walk2?	Yes	N/A	DWS 2 Provided?	N/A
N/A	X Walk 2 Direction	To E	N/A	DWS 2 Contrast?	N/A
N/A	X Walk 2 Width (In)	126.5	N/A	DWS 2 Length (In)	N/A

N/A	Road 2 Slope (%)	1.9	N/A	DWS 2 Full Width?	N/A
N/A	Road 2 X Slope (%)	1.5	N/A	DWS 2 Offset (In)	N/A
N/A	Refuge 3 Length (in)	N/A	N/A	Gutter 3 Ponding?	N/A
N/A	Refuge 3 Width (in)	N/A	N/A	Gutter 3 Lip Ht (in)	N/A
N/A	Refuge 3 Slope (%)	N/A	N/A	Gutter 3 Slope (%)	N/A
N/A	Refuge 3 XSlope (%)	N/A	N/A	Gutter 3 XSlope (%)	N/A
N/A	Painted X Walk3?	No	N/A	DWS 3 Provided?	N/A
N/A	X Walk 3 Direction	N/A	N/A	DWS 3 Contrast?	N/A
N/A	X Walk 3 Width (in)	N/A	N/A	DWS 3 Length (in)	N/A
N/A	Road 3 Slope (%)	N/A	N/A	DWS 3 Full Width?	N/A
N/A	Road 3 XSlope (%)	N/A	N/A	DWS 3 Offset (in)	N/A
Yes	Any Obstructions?	N/A	N/A	Storm Grate/Utility Hazard?	N/A
N/A	Obstruction Type		N/A	Storm Grate/Utility Type	
		N/A			N/A
N/A	Surface Condition	Good

Remove & Replace Entire Refuge.
