# Access Compliance Report

## Public Rights-of-Way

### (Island Curb Cuts)

Intersection ID: 17986	Main Street: E_INDEPENDENCE_BV	Cross Street: DION_AV	Location: NE
ADA ID: 5C0B03B26186	Curb Cut Type: MedianRefuge2	Initial Pass/Fail: Fail	Overall Compliance: No
Severity Score: 1.25			
Codes/Mitigation Info/Possible Solution		Field Measurements/Component Compliance

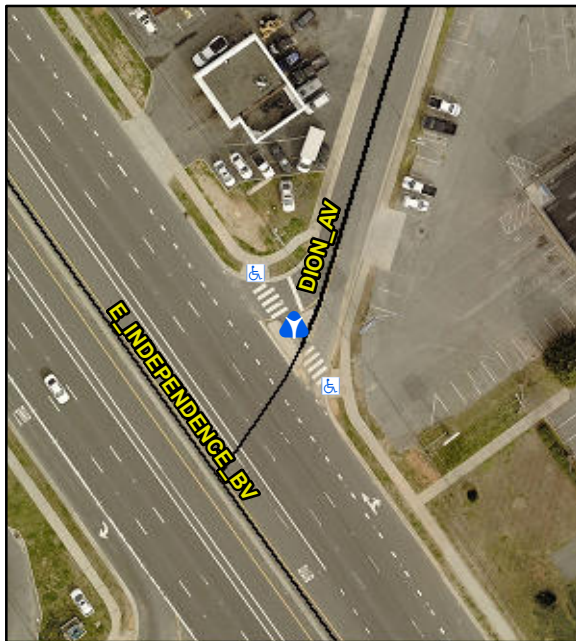
Compliance	Description	Data	Compliance	Description	Data
Yes	Refuge 1 Length (In)	87.5	N/A	Gutter 1 Ponding?	N/A
Yes	Refuge 1 Width (In)	71.0	N/A	Gutter 1 Lip Ht (In)	N/A
Yes	Refuge 1 Slope (%)	0.4	N/A	Gutter 1 Slope (%)	N/A
Yes	Refuge 1 X Slope (%)	3.7	N/A	Gutter 1 X Slope (%)	N/A
N/A	Painted X Walk1?	Yes	N/A	DWS 1 Provided?	N/A
N/A	X Walk 1 Direction	To SE	N/A	DWS 1 Contrast?	N/A
N/A	X Walk 1 Width (In)	118.0	N/A	DWS 1 Length (In)	N/A
N/A	Road 1 Slope (%)	1.8	N/A	DWS 1 Full Width?	N/A
N/A	Road 1 X Slope (%)	3.0	N/A	DWS 1 Offset (In)	N/A
Yes	Refuge 2 Length (In)	87.5	N/A	Gutter 2 Ponding?	N/A
Yes	Refuge 2 Width (In)	71.0	N/A	Gutter 2 Lip Ht (In)	N/A
Yes	Refuge 2 Slope (%)	3.5	N/A	Gutter 2 Slope (%)	N/A
Yes	Refuge 2 X Slope (%)	3.5	N/A	Gutter 2 X Slope (%)	N/A
N/A	Painted X Walk2?	Yes	N/A	DWS 2 Provided?	N/A
N/A	X Walk 2 Direction	To NW	N/A	DWS 2 Contrast?	N/A
N/A	X Walk 2 Width (In)	119.0	N/A	DWS 2 Length (In)	N/A

N/A	Road 2 Slope (%)	2.3	N/A	DWS 2 Full Width?	N/A
N/A	Road 2 X Slope (%)	1.2	N/A	DWS 2 Offset (In)	N/A
N/A	Refuge 3 Length (in)	N/A	N/A	Gutter 3 Ponding?	N/A
N/A	Refuge 3 Width (in)	N/A	N/A	Gutter 3 Lip Ht (in)	N/A
N/A	Refuge 3 Slope (%)	N/A	N/A	Gutter 3 Slope (%)	N/A
N/A	Refuge 3 XSlope (%)	N/A	N/A	Gutter 3 XSlope (%)	N/A
N/A	Painted X Walk3?	N/A	N/A	DWS 3 Provided?	N/A
N/A	X Walk 3 Direction	N/A	N/A	DWS 3 Contrast?	N/A
N/A	X Walk 3 Width (in)	N/A	N/A	DWS 3 Length (in)	N/A
N/A	Road 3 Slope (%)	N/A	N/A	DWS 3 Full Width?	N/A
N/A	Road 3 XSlope (%)	N/A	N/A	DWS 3 Offset (in)	N/A
Yes	Any Obstructions?	N/A	N/A	Storm Grate/Utility Hazard?	N/A
N/A	Obstruction Type		N/A	Storm Grate/Utility Type	
		N/A			N/A
N/A	Surface Condition	Good

**Remove & Replace Entire Refuge.**

Total Cost: \$ 3000.00
