Access Compliance Report

Public Rights-of-Way

(Island Curb Cuts)

Intersection ID: 10035790	Main Street: REMOUNT_RD	Cross Street: N/A	Location: W
ADA ID: 5D380167A90E	Curb Cut Type: MedianRefuge2	Initial Pass/Fail: Fail	Overall Compliance: No
Codes/Mitigation Info/Possible Solution		Field Measurements/Component Compliance	
		Severity Score: 0

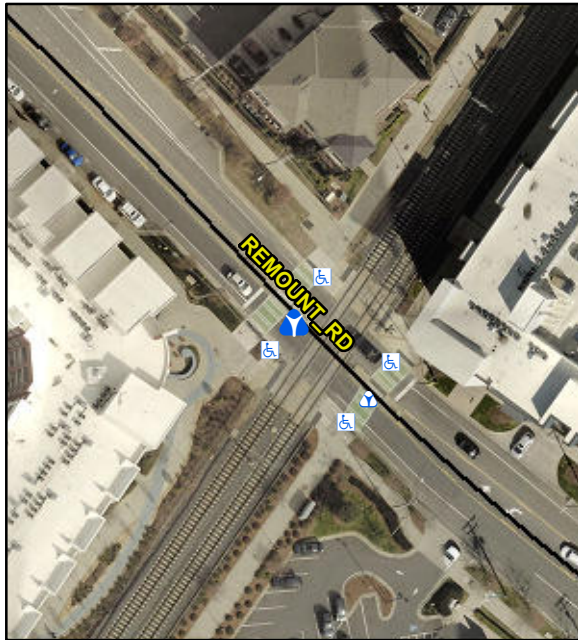
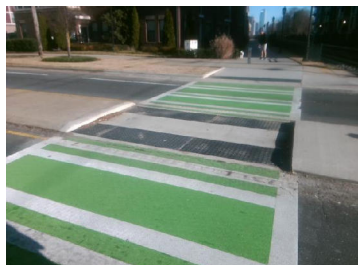
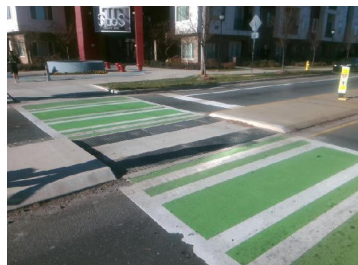
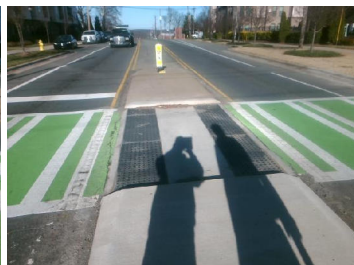
Compliance	Description	Data	Compliance	Description	Data
Yes	Refuge 1 Length (In)	40.5	N/A	Gutter 1 Ponding?	N/A
Yes	Refuge 1 Width (In)	143.0	N/A	Gutter 1 Lip Ht (In)	N/A
Yes	Refuge 1 Slope (%)	0.1	N/A	Gutter 1 Slope (%)	N/A
Yes	Refuge 1 X Slope (%)	3.1	N/A	Gutter 1 X Slope (%)	N/A
N/A	Painted X Walk1?	Yes	N/A	DWS 1 Provided?	N/A
N/A	X Walk 1 Direction	To N	N/A	DWS 1 Contrast?	N/A
N/A	X Walk 1 Width (In)	136.0	N/A	DWS 1 Length (In)	N/A
N/A	Road 1 Slope (%)	0.6	N/A	DWS 1 Full Width?	N/A
N/A	Road 1 X Slope (%)	2.4	N/A	DWS 1 Offset (In)	N/A
Yes	Refuge 2 Length (In)	40.5	N/A	Gutter 2 Ponding?	N/A
Yes	Refuge 2 Width (In)	143.0	N/A	Gutter 2 Lip Ht (In)	N/A
Yes	Refuge 2 Slope (%)	0.7	N/A	Gutter 2 Slope (%)	N/A
Yes	Refuge 2 X Slope (%)	3.4	N/A	Gutter 2 X Slope (%)	N/A
N/A	Painted X Walk2?	Yes	N/A	DWS 2 Provided?	N/A
N/A	X Walk 2 Direction	To S	N/A	DWS 2 Contrast?	N/A
N/A	X Walk 2 Width (In)	136.0	N/A	DWS 2 Length (In)	N/A

N/A	Road 2 Slope (%)	0.3	N/A	DWS 2 Full Width?	N/A
N/A	Road 2 X Slope (%)	2.6	N/A	DWS 2 Offset (In)	N/A
N/A	Refuge 3 Length (in)	N/A	N/A	Gutter 3 Ponding?	N/A
N/A	Refuge 3 Width (in)	N/A	N/A	Gutter 3 Lip Ht (in)	N/A
N/A	Refuge 3 Slope (%)	N/A	N/A	Gutter 3 Slope (%)	N/A
N/A	Refuge 3 XSlope (%)	N/A	N/A	Gutter 3 XSlope (%)	N/A
N/A	Painted X Walk3?	N/A	N/A	DWS 3 Provided?	N/A
N/A	X Walk 3 Direction	N/A	N/A	DWS 3 Contrast?	N/A
N/A	X Walk 3 Width (in)	N/A	N/A	DWS 3 Length (in)	N/A
N/A	Road 3 Slope (%)	N/A	N/A	DWS 3 Full Width?	N/A
N/A	Road 3 XSlope (%)	N/A	N/A	DWS 3 Offset (in)	N/A
Yes	Any Obstructions?	N/A	N/A	Storm Grate/Utility Hazard?	N/A
N/A	Obstruction Type		N/A	Storm Grate/Utility Type	
		N/A			N/A
N/A	Surface Condition	Good

Remove & Replace Entire Refuge.
