Access Compliance Report

Public Rights-of-Way

(Island Curb Cuts)

Intersection ID: 10040504	Main Street: W_4TH_ST_EXT	Cross Street: N/A	Location: W
ADA ID: 5EB789B16575	Curb Cut Type: MedianRefuge2	Initial Pass/Fail: Fail	Overall Compliance: No
			Severity Score: 12.5

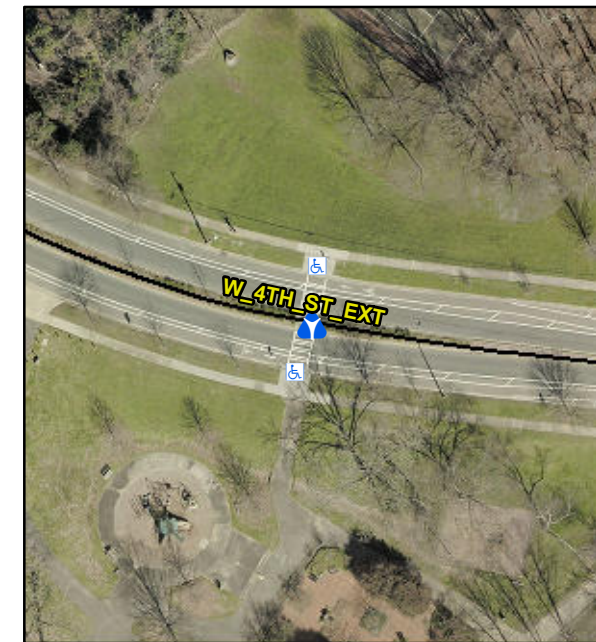
Compliance	Description	Data	Compliance	Description	Data
Yes	Refuge 1 Length (In)	46.5	N/A	Gutter 1 Ponding?	N/A
Yes	Refuge 1 Width (In)	96.0	N/A	Gutter 1 Lip Ht (In)	N/A
Yes	Refuge 1 Slope (%)	3.8	N/A	Gutter 1 Slope (%)	N/A
Yes	Refuge 1 X Slope (%)	1.0	N/A	Gutter 1 X Slope (%)	N/A
N/A	Painted X Walk1?	Yes	N/A	DWS 1 Provided?	N/A
N/A	X Walk 1 Direction	To S	N/A	DWS 1 Contrast?	N/A
N/A	X Walk 1 Width (In)	111.0	N/A	DWS 1 Length (In)	N/A
N/A	Road 1 Slope (%)	1.6	N/A	DWS 1 Full Width?	N/A
N/A	Road 1 X Slope (%)	6.3	N/A	DWS 1 Offset (In)	N/A
Yes	Refuge 2 Length (In)	46.5	N/A	Gutter 2 Ponding?	N/A
Yes	Refuge 2 Width (In)	96.0	N/A	Gutter 2 Lip Ht (In)	N/A
No	Refuge 2 Slope (%)	6.1	N/A	Gutter 2 Slope (%)	N/A
Yes	Refuge 2 X Slope (%)	1.3	N/A	Gutter 2 X Slope (%)	N/A
N/A	Painted X Walk2?	Yes	N/A	DWS 2 Provided?	N/A
N/A	X Walk 2 Direction	To N	N/A	DWS 2 Contrast?	N/A
N/A	X Walk 2 Width (In)	108.0	N/A	DWS 2 Length (In)	N/A

N/A	Road 2 Slope (%)	1.8	N/A	DWS 2 Full Width?	N/A
N/A	Road 2 X Slope (%)	5.6	N/A	DWS 2 Offset (In)	N/A
N/A	Refuge 3 Length (in)	N/A	N/A	Gutter 3 Ponding?	N/A
N/A	Refuge 3 Width (in)	N/A	N/A	Gutter 3 Lip Ht (in)	N/A
N/A	Refuge 3 Slope (%)	N/A	N/A	Gutter 3 Slope (%)	N/A
N/A	Refuge 3 XSlope (%)	N/A	N/A	Gutter 3 XSlope (%)	N/A
N/A	Painted X Walk3?	N/A	N/A	DWS 3 Provided?	N/A
N/A	X Walk 3 Direction	N/A	N/A	DWS 3 Contrast?	N/A
N/A	X Walk 3 Width (in)	N/A	N/A	DWS 3 Length (in)	N/A
N/A	Road 3 Slope (%)	N/A	N/A	DWS 3 Full Width?	N/A
N/A	Road 3 XSlope (%)	N/A	N/A	DWS 3 Offset (in)	N/A
Yes	Any Obstructions?	N/A	N/A	Storm Grate/Utility Hazard?	N/A
N/A	Obstruction Type		N/A	Storm Grate/Utility Type	
		N/A			N/A
N/A	Surface Condition	Good

Remove & Replace Entire Refuge.

\$ 3000.00
