Access Compliance Report

Public Rights-of-Way

(Island Curb Cuts)

Intersection ID: 42838	Main Street: SARDIS_OAKS_RD	Cross Street: SARDIS_RD_NORTH	Location:	W
ADA ID: 5F634FDE7E8A	Curb Cut Type: MedianRefuge2	Initial Pass/Fail: Pass	Overall Compliance: No	Severity Score: 10.25

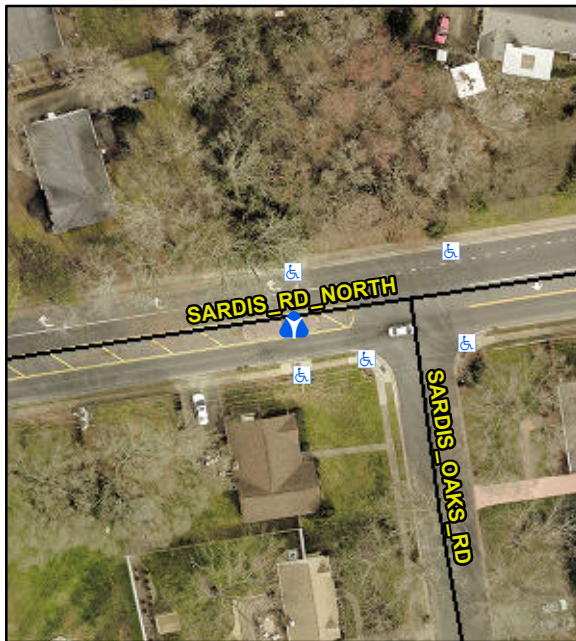
Compliance	Description	Data	Compliance	Description	Data
Yes	Refuge 1 Length (In)	54.0	Yes	Gutter 1 Ponding?	No
Yes	Refuge 1 Width (In)	98.0	Yes	Gutter 1 Lip Ht (In)	0.0
Yes	Refuge 1 Slope (%)	0.6	No	Gutter 1 Slope (%)	6.3
Yes	Refuge 1 X Slope (%)	0.6	Yes	Gutter 1 X Slope (%)	1.6
N/A	Painted X Walk1?	No	Yes	DWS 1 Provided?	Yes
N/A	X Walk 1 Direction	To S	Yes	DWS 1 Contrast?	Yes
N/A	X Walk 1 Width (In)	N/A	Yes	DWS 1 Length (In)	24.0
N/A	Road 1 Slope (%)	0.8	Yes	DWS 1 Full Width?	Yes
N/A	Road 1 X Slope (%)	7.4	Yes	DWS 1 Offset (In)	0.0
Yes	Refuge 2 Length (In)	54.0	Yes	Gutter 2 Ponding?	No
Yes	Refuge 2 Width (In)	98.0	Yes	Gutter 2 Lip Ht (In)	0.0
Yes	Refuge 2 Slope (%)	2.2	Yes	Gutter 2 Slope (%)	3.9
Yes	Refuge 2 X Slope (%)	1.0	Yes	Gutter 2 X Slope (%)	0.1
N/A	Painted X Walk2?	No	Yes	DWS 2 Provided?	Yes
N/A	X Walk 2 Direction	To N	Yes	DWS 2 Contrast?	Yes
N/A	X Walk 2 Width (In)	N/A	Yes	DWS 2 Length (In)	24.0

N/A	Road 2 Slope (%)	0.6	Yes	DWS 2 Full Width?	Yes
N/A	Road 2 X Slope (%)	4.8	Yes	DWS 2 Offset (In)	0.0
N/A	Refuge 3 Length (in)	N/A	N/A	Gutter 3 Ponding?	N/A
N/A	Refuge 3 Width (in)	N/A	N/A	Gutter 3 Lip Ht (in)	N/A
N/A	Refuge 3 Slope (%)	N/A	N/A	Gutter 3 Slope (%)	N/A
N/A	Refuge 3 XSlope (%)	N/A	N/A	Gutter 3 XSlope (%)	N/A
N/A	Painted X Walk3?	N/A	N/A	DWS 3 Provided?	N/A
N/A	X Walk 3 Direction	N/A	N/A	DWS 3 Contrast?	N/A
N/A	X Walk 3 Width (in)	N/A	N/A	DWS 3 Length (in)	N/A
N/A	Road 3 Slope (%)	N/A	N/A	DWS 3 Full Width?	N/A
N/A	Road 3 XSlope (%)	N/A	N/A	DWS 3 Offset (in)	N/A
Yes	Any Obstructions?	N/A	N/A	Storm Grate/Utility Hazard?	No
N/A	Obstruction Type		N/A	Storm Grate/Utility Type	
		N/A			N/A
N/A	Surface Condition	Good

Possible Solutions:

Remove & Replace Gutter.
