# Access Compliance Report

## Public Rights-of-Way

### (Island Curb Cuts)

Intersection ID: 20410	Main Street: CARMEL_RD	Cross Street: FAIRVIEW_RD	Location: SW
ADA ID: 634F3294A3DB	Curb Cut Type: MedianRefuge2	Initial Pass/Fail: Fail	Overall Compliance: No
Severity Score: 13.75			
Codes/Mitigation Info/Possible Solution		Field Measurements/Component Compliance

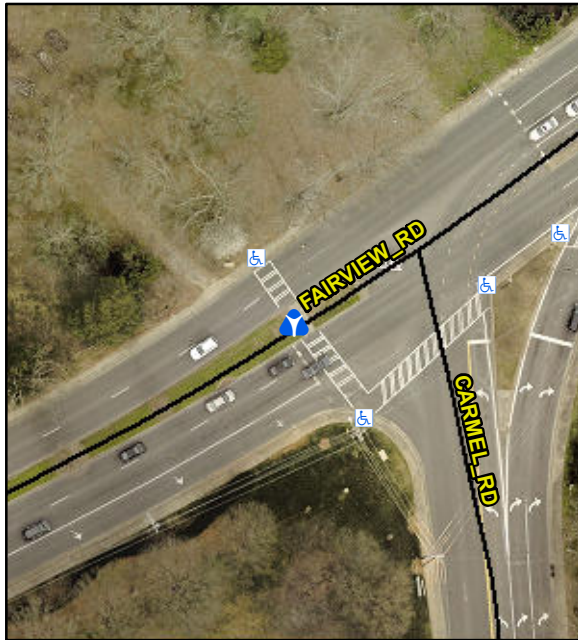
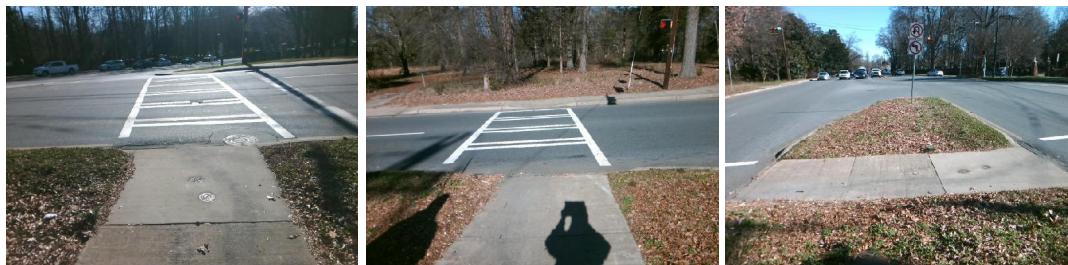
Compliance	Description	Data	Compliance	Description	Data
Yes	Refuge 1 Length (In)	104.5	N/A	Gutter 1 Ponding?	N/A
Yes	Refuge 1 Width (In)	78.0	N/A	Gutter 1 Lip Ht (In)	N/A
Yes	Refuge 1 Slope (%)	2.1	N/A	Gutter 1 Slope (%)	N/A
Yes	Refuge 1 X Slope (%)	0.4	N/A	Gutter 1 X Slope (%)	N/A
N/A	Painted X Walk1?	Yes	N/A	DWS 1 Provided?	N/A
N/A	X Walk 1 Direction	To SE	N/A	DWS 1 Contrast?	N/A
N/A	X Walk 1 Width (In)	112.0	N/A	DWS 1 Length (In)	N/A
N/A	Road 1 Slope (%)	1.8	N/A	DWS 1 Full Width?	N/A
N/A	Road 1 X Slope (%)	2.2	N/A	DWS 1 Offset (In)	N/A
Yes	Refuge 2 Length (In)	104.5	N/A	Gutter 2 Ponding?	N/A
Yes	Refuge 2 Width (In)	78.0	N/A	Gutter 2 Lip Ht (In)	N/A
Yes	Refuge 2 Slope (%)	0.2	N/A	Gutter 2 Slope (%)	N/A
No	Refuge 2 X Slope (%)	7.5	N/A	Gutter 2 X Slope (%)	N/A
N/A	Painted X Walk2?	Yes	N/A	DWS 2 Provided?	N/A
N/A	X Walk 2 Direction	To NW	N/A	DWS 2 Contrast?	N/A
N/A	X Walk 2 Width (In)	112.0	N/A	DWS 2 Length (In)	N/A

N/A	Road 2 Slope (%)	1.6	N/A	DWS 2 Full Width?	N/A
N/A	Road 2 X Slope (%)	3.0	N/A	DWS 2 Offset (In)	N/A
N/A	Refuge 3 Length (in)	N/A	N/A	Gutter 3 Ponding?	N/A
N/A	Refuge 3 Width (in)	N/A	N/A	Gutter 3 Lip Ht (in)	N/A
N/A	Refuge 3 Slope (%)	N/A	N/A	Gutter 3 Slope (%)	N/A
N/A	Refuge 3 XSlope (%)	N/A	N/A	Gutter 3 XSlope (%)	N/A
N/A	Painted X Walk3?	N/A	N/A	DWS 3 Provided?	N/A
N/A	X Walk 3 Direction	N/A	N/A	DWS 3 Contrast?	N/A
N/A	X Walk 3 Width (in)	N/A	N/A	DWS 3 Length (in)	N/A
N/A	Road 3 Slope (%)	N/A	N/A	DWS 3 Full Width?	N/A
N/A	Road 3 XSlope (%)	N/A	N/A	DWS 3 Offset (in)	N/A
Yes	Any Obstructions?	N/A	N/A	Storm Grate/Utility Hazard?	N/A
N/A	Obstruction Type		N/A	Storm Grate/Utility Type	
		N/A			N/A
N/A	Surface Condition	Good

Possible Solutions:

**Remove & Replace Entire Refuge.**

Total Cost: \$ 3000.00
