# Access Compliance Report

## Public Rights-of-Way

### (Island Curb Cuts)

Intersection ID: 3125	Main Street: JOHNSTON_OEHLER_RD	Cross Street: MOURNING_DOVE_LN	Location: S
ADA ID: 636702BAD7AF	Curb Cut Type: MedianRefuge2	Initial Pass/Fail: Fail	Overall Compliance: No
Codes/Mitigation Info/Possible Solution		Field Measurements/Component Compliance	
Severity Score: 25

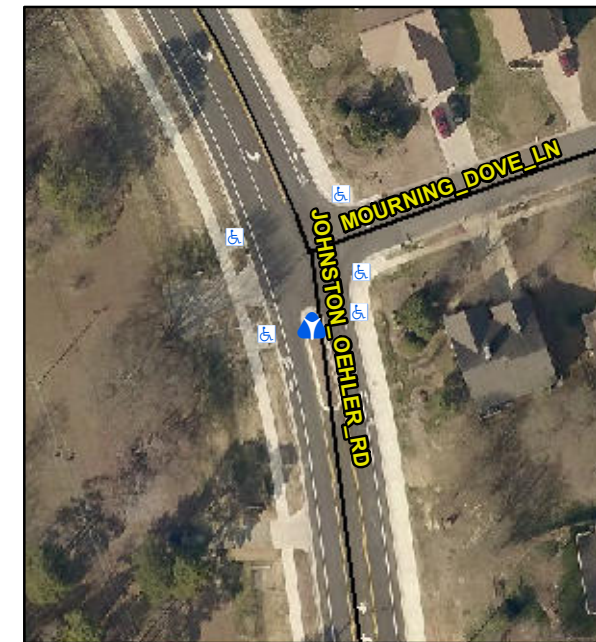
Compliance	Description	Data	Compliance	Description	Data
Yes	Refuge 1 Length (In)	47.0	N/A	Gutter 1 Ponding?	N/A
Yes	Refuge 1 Width (In)	95.0	N/A	Gutter 1 Lip Ht (In)	N/A
No	Refuge 1 Slope (%)	6.2	N/A	Gutter 1 Slope (%)	N/A
Yes	Refuge 1 X Slope (%)	2.2	N/A	Gutter 1 X Slope (%)	N/A
N/A	Painted X Walk1?	No	N/A	DWS 1 Provided?	N/A
N/A	X Walk 1 Direction	To W	N/A	DWS 1 Contrast?	N/A
N/A	X Walk 1 Width (In)	N/A	N/A	DWS 1 Length (In)	N/A
N/A	Road 1 Slope (%)	2.2	N/A	DWS 1 Full Width?	N/A
N/A	Road 1 X Slope (%)	3.0	N/A	DWS 1 Offset (In)	N/A
Yes	Refuge 2 Length (In)	47.0	N/A	Gutter 2 Ponding?	N/A
Yes	Refuge 2 Width (In)	95.0	N/A	Gutter 2 Lip Ht (In)	N/A
No	Refuge 2 Slope (%)	7.2	N/A	Gutter 2 Slope (%)	N/A
Yes	Refuge 2 X Slope (%)	2.5	N/A	Gutter 2 X Slope (%)	N/A
N/A	Painted X Walk2?	No	N/A	DWS 2 Provided?	N/A
N/A	X Walk 2 Direction	To E	N/A	DWS 2 Contrast?	N/A
N/A	X Walk 2 Width (In)	N/A	N/A	DWS 2 Length (In)	N/A

N/A	Road 2 Slope (%)	2.2	N/A	DWS 2 Full Width?	N/A
N/A	Road 2 X Slope (%)	3.1	N/A	DWS 2 Offset (In)	N/A
N/A	Refuge 3 Length (in)	N/A	N/A	Gutter 3 Ponding?	N/A
N/A	Refuge 3 Width (in)	N/A	N/A	Gutter 3 Lip Ht (in)	N/A
N/A	Refuge 3 Slope (%)	N/A	N/A	Gutter 3 Slope (%)	N/A
N/A	Refuge 3 XSlope (%)	N/A	N/A	Gutter 3 XSlope (%)	N/A
N/A	Painted X Walk3?	No	N/A	DWS 3 Provided?	N/A
N/A	X Walk 3 Direction	N/A	N/A	DWS 3 Contrast?	N/A
N/A	X Walk 3 Width (in)	N/A	N/A	DWS 3 Length (in)	N/A
N/A	Road 3 Slope (%)	N/A	N/A	DWS 3 Full Width?	N/A
N/A	Road 3 XSlope (%)	N/A	N/A	DWS 3 Offset (in)	N/A
Yes	Any Obstructions?	N/A	N/A	Storm Grate/Utility Hazard?	N/A
N/A	Obstruction Type		N/A	Storm Grate/Utility Type	
		N/A			N/A
N/A	Surface Condition	Good

**Remove & Replace Entire Refuge.**

**\$ 3000.00**
