Access Compliance Report

Public Rights-of-Way

(Island Curb Cuts)

Intersection ID: 10038262	Main Street: SMITH_RD	Cross Street: N/A	Location: N
ADA ID: 63F0FC32DFAF	Curb Cut Type: MedianRefuge2	Initial Pass/Fail: Fail	Overall Compliance: No
Codes/Mitigation Info/Possible Solution		Field Measurements/Component Compliance	
Severity Score: 12.5

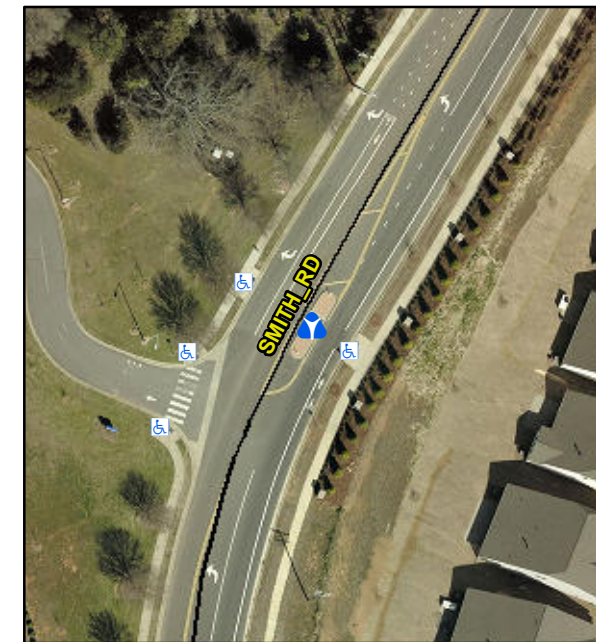
Compliance	Description	Data	Compliance	Description	Data
Yes	Refuge 1 Length (In)	46.5	N/A	Gutter 1 Ponding?	N/A
Yes	Refuge 1 Width (In)	97.0	N/A	Gutter 1 Lip Ht (In)	N/A
Yes	Refuge 1 Slope (%)	1.9	N/A	Gutter 1 Slope (%)	N/A
No	Refuge 1 X Slope (%)	5.7	N/A	Gutter 1 X Slope (%)	N/A
N/A	Painted X Walk1?	No	N/A	DWS 1 Provided?	N/A
N/A	X Walk 1 Direction	To NW	N/A	DWS 1 Contrast?	N/A
N/A	X Walk 1 Width (In)	N/A	N/A	DWS 1 Length (In)	N/A
N/A	Road 1 Slope (%)	5.7	N/A	DWS 1 Full Width?	N/A
N/A	Road 1 X Slope (%)	3.6	N/A	DWS 1 Offset (In)	N/A
Yes	Refuge 2 Length (In)	46.5	N/A	Gutter 2 Ponding?	N/A
Yes	Refuge 2 Width (In)	97.0	N/A	Gutter 2 Lip Ht (In)	N/A
Yes	Refuge 2 Slope (%)	0.9	N/A	Gutter 2 Slope (%)	N/A
Yes	Refuge 2 X Slope (%)	2.1	N/A	Gutter 2 X Slope (%)	N/A
N/A	Painted X Walk2?	No	N/A	DWS 2 Provided?	N/A
N/A	X Walk 2 Direction	To SE	N/A	DWS 2 Contrast?	N/A
N/A	X Walk 2 Width (In)	N/A	N/A	DWS 2 Length (In)	N/A

Possible Solutions:

Remove & Replace Entire Refuge.
