Access Compliance Report

Public Rights-of-Way

(Island Curb Cuts)

Intersection ID: N/A	Main Street: S DAVIDSON ST	Cross Street: E STONEWALL ST	Location: SE
ADA ID: 6609CEC44DC7	Curb Cut Type: MedianRefuge2	Initial Pass/Fail: Fail	Overall Compliance: No
Codes/Mitigation Info/Possible Solution		Field Measurements/Component Compliance	
Severity Score: 0

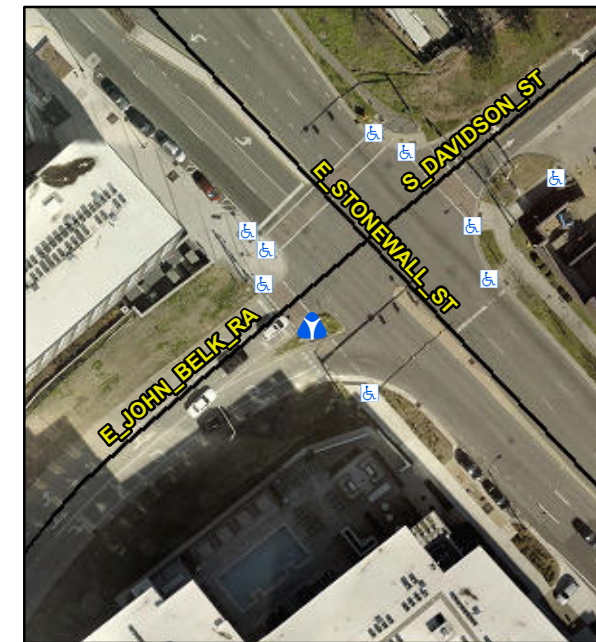
Compliance	Description	Data	Compliance	Description	Data
Yes	Refuge 1 Length (In)	58.5	N/A	Gutter 1 Ponding?	N/A
Yes	Refuge 1 Width (In)	137.0	N/A	Gutter 1 Lip Ht (In)	N/A
Yes	Refuge 1 Slope (%)	1.6	N/A	Gutter 1 Slope (%)	N/A
Yes	Refuge 1 X Slope (%)	3.3	N/A	Gutter 1 X Slope (%)	N/A
N/A	Painted X Walk1?	Yes	N/A	DWS 1 Provided?	N/A
N/A	X Walk 1 Direction	To SE	N/A	DWS 1 Contrast?	N/A
N/A	X Walk 1 Width (In)	126.0	N/A	DWS 1 Length (In)	N/A
N/A	Road 1 Slope (%)	4.0	N/A	DWS 1 Full Width?	N/A
N/A	Road 1 X Slope (%)	1.5	N/A	DWS 1 Offset (In)	N/A
Yes	Refuge 2 Length (In)	58.5	N/A	Gutter 2 Ponding?	N/A
Yes	Refuge 2 Width (In)	137.0	N/A	Gutter 2 Lip Ht (In)	N/A
Yes	Refuge 2 Slope (%)	0.1	N/A	Gutter 2 Slope (%)	N/A
Yes	Refuge 2 X Slope (%)	2.8	N/A	Gutter 2 X Slope (%)	N/A
N/A	Painted X Walk2?	Yes	N/A	DWS 2 Provided?	N/A
N/A	X Walk 2 Direction	To NW	N/A	DWS 2 Contrast?	N/A
N/A	X Walk 2 Width (In)	123.0	N/A	DWS 2 Length (In)	N/A

N/A	Road 2 Slope (%)	2.7	N/A	DWS 2 Full Width?	N/A
N/A	Road 2 X Slope (%)	0.1	N/A	DWS 2 Offset (In)	N/A
N/A	Refuge 3 Length (in)	N/A	N/A	Gutter 3 Ponding?	N/A
N/A	Refuge 3 Width (in)	N/A	N/A	Gutter 3 Lip Ht (in)	N/A
N/A	Refuge 3 Slope (%)	N/A	N/A	Gutter 3 Slope (%)	N/A
N/A	Refuge 3 XSlope (%)	N/A	N/A	Gutter 3 XSlope (%)	N/A
N/A	Painted X Walk3?	N/A	N/A	DWS 3 Provided?	N/A
N/A	X Walk 3 Direction	N/A	N/A	DWS 3 Contrast?	N/A
N/A	X Walk 3 Width (in)	N/A	N/A	DWS 3 Length (in)	N/A
N/A	Road 3 Slope (%)	N/A	N/A	DWS 3 Full Width?	N/A
N/A	Road 3 XSlope (%)	N/A	N/A	DWS 3 Offset (in)	N/A
Yes	Any Obstructions?	N/A	N/A	Storm Grate/Utility Hazard?	N/A
N/A	Obstruction Type		N/A	Storm Grate/Utility Type	
		N/A			N/A
N/A	Surface Condition	Good

Remove & Replace Entire Refuge.

Total Cost: \$ 3000.00
