# Access Compliance Report

## Public Rights-of-Way

### (Island Curb Cuts)

Intersection ID: 28389	Main Street: ARDREY_KELL_RD	Cross Street: LANCASTER_HY	Location: S
ADA ID: 676F5CE5234D	Curb Cut Type: MedianRefuge2	Initial Pass/Fail: Fail	Overall Compliance: No
Codes/Mitigation Info/Possible Solution		Field Measurements/Component Compliance	
Severity Score: 0

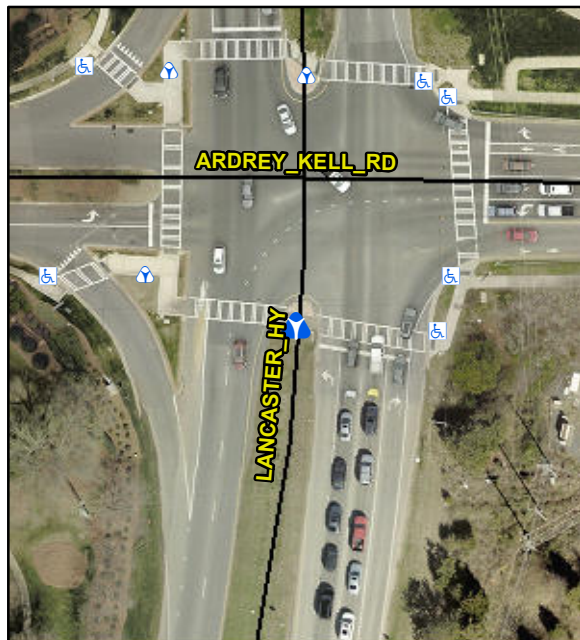
Compliance	Description	Data	Compliance	Description	Data
Yes	Refuge 1 Length (In)	80.0	N/A	Gutter 1 Ponding?	N/A
Yes	Refuge 1 Width (In)	87.0	N/A	Gutter 1 Lip Ht (In)	N/A
Yes	Refuge 1 Slope (%)	2.0	N/A	Gutter 1 Slope (%)	N/A
Yes	Refuge 1 X Slope (%)	1.9	N/A	Gutter 1 X Slope (%)	N/A
N/A	Painted X Walk1?	Yes	N/A	DWS 1 Provided?	N/A
N/A	X Walk 1 Direction	To W	N/A	DWS 1 Contrast?	N/A
N/A	X Walk 1 Width (In)	113.0	N/A	DWS 1 Length (In)	N/A
N/A	Road 1 Slope (%)	1.4	N/A	DWS 1 Full Width?	N/A
N/A	Road 1 X Slope (%)	0.2	N/A	DWS 1 Offset (In)	N/A
Yes	Refuge 2 Length (In)	80.0	N/A	Gutter 2 Ponding?	Yes
Yes	Refuge 2 Width (In)	87.0	N/A	Gutter 2 Lip Ht (In)	N/A
Yes	Refuge 2 Slope (%)	0.5	N/A	Gutter 2 Slope (%)	N/A
Yes	Refuge 2 X Slope (%)	2.4	N/A	Gutter 2 X Slope (%)	N/A
N/A	Painted X Walk2?	Yes	N/A	DWS 2 Provided?	N/A
N/A	X Walk 2 Direction	To E	N/A	DWS 2 Contrast?	N/A
N/A	X Walk 2 Width (In)	110.0	N/A	DWS 2 Length (In)	N/A

N/A	Road 2 Slope (%)	0.4	N/A	DWS 2 Full Width?	N/A
N/A	Road 2 X Slope (%)	6.1	N/A	DWS 2 Offset (In)	N/A
N/A	Refuge 3 Length (in)	N/A	N/A	Gutter 3 Ponding?	N/A
N/A	Refuge 3 Width (in)	N/A	N/A	Gutter 3 Lip Ht (in)	N/A
N/A	Refuge 3 Slope (%)	N/A	N/A	Gutter 3 Slope (%)	N/A
N/A	Refuge 3 XSlope (%)	N/A	N/A	Gutter 3 XSlope (%)	N/A
N/A	Painted X Walk3?	N/A	N/A	DWS 3 Provided?	N/A
N/A	X Walk 3 Direction	N/A	N/A	DWS 3 Contrast?	N/A
N/A	X Walk 3 Width (in)	N/A	N/A	DWS 3 Length (in)	N/A
N/A	Road 3 Slope (%)	N/A	N/A	DWS 3 Full Width?	N/A
N/A	Road 3 XSlope (%)	N/A	N/A	DWS 3 Offset (in)	N/A
Yes	Any Obstructions?	N/A	N/A	Storm Grate/Utility Hazard?	N/A
N/A	Obstruction Type		N/A	Storm Grate/Utility Type	
		N/A			N/A
N/A	Surface Condition	Good

**Remove & Replace Entire Refuge.**

Total Cost: \$ 3000.00
