Access Compliance Report

Public Rights-of-Way

(Island Curb Cuts)

Intersection ID: 9703	Main Street: SHANNONHOUSE_DR	Cross Street: THE_PLAZA	Location: E
ADA ID: 6770BFD4BAEA	Curb Cut Type: MedianRefuge2	Initial Pass/Fail: Pass	Overall Compliance: No
Codes/Mitigation Info/Possible Solution			Severity Score: 30
			Field Measurements/Component Compliance

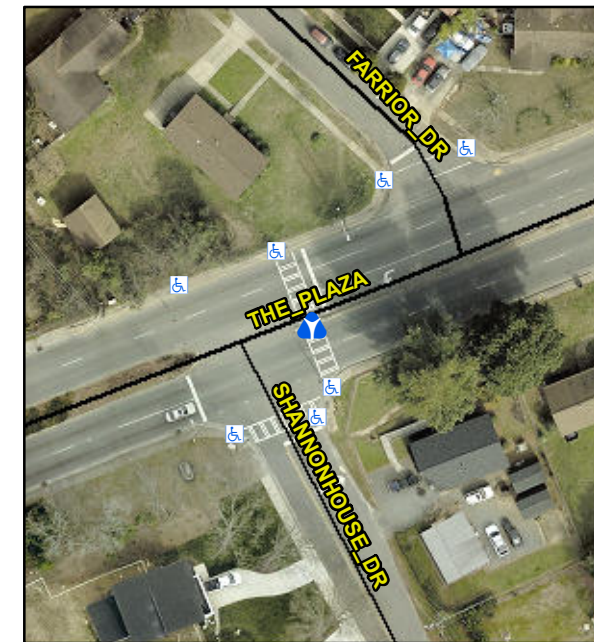
Compliance	Description	Data	Compliance	Description	Data
No	Refuge 1 Length (In)	30.0	Yes	Gutter 1 Ponding?	No
Yes	Refuge 1 Width (In)	103.0	No	Gutter 1 Lip Ht (In)	2.0
Yes	Refuge 1 Slope (%)	1.8	Yes	Gutter 1 Slope (%)	0.9
Yes	Refuge 1 X Slope (%)	2.0	Yes	Gutter 1 X Slope (%)	0.9
N/A	Painted X Walk1?	Yes	Yes	DWS 1 Provided?	No
N/A	X Walk 1 Direction	To N	N/A	DWS 1 Contrast?	No
N/A	X Walk 1 Width (In)	103.0	N/A	DWS 1 Length (In)	N/A
N/A	Road 1 Slope (%)	0.9	N/A	DWS 1 Full Width?	No
N/A	Road 1 X Slope (%)	0.7	N/A	DWS 1 Offset (In)	N/A
No	Refuge 2 Length (In)	N/A	Yes	Gutter 2 Ponding?	No
Yes	Refuge 2 Width (In)	N/A	No	Gutter 2 Lip Ht (In)	3.0
No	Refuge 2 Slope (%)	N/A	Yes	Gutter 2 Slope (%)	0.7
No	Refuge 2 X Slope (%)	N/A	Yes	Gutter 2 X Slope (%)	2.0
N/A	Painted X Walk2?	Yes	Yes	DWS 2 Provided?	No
N/A	X Walk 2 Direction	To S	N/A	DWS 2 Contrast?	No
N/A	X Walk 2 Width (In)	103.0	N/A	DWS 2 Length (In)	N/A
N/A	Road 2 Slope (%)	1.2	N/A	DWS 2 Full Width?	No

N/A	Road 2 X Slope (%)	1.9	N/A	DWS 2 Offset (In)	N/A
N/A	Refuge 3 Length (in)	N/A	N/A	Gutter 3 Ponding?	N/A
N/A	Refuge 3 Width (in)	N/A	N/A	Gutter 3 Lip Ht (in)	N/A
N/A	Refuge 3 Slope (%)	N/A	N/A	Gutter 3 Slope (%)	N/A
N/A	Refuge 3 XSlope (%)	N/A	N/A	Gutter 3 XSlope (%)	N/A
N/A	Painted X Walk3?	N/A	N/A	DWS 3 Provided?	N/A
N/A	X Walk 3 Direction	N/A	N/A	DWS 3 Contrast?	N/A
N/A	X Walk 3 Width (in)	N/A	N/A	DWS 3 Length (in)	N/A
N/A	Road 3 Slope (%)	N/A	N/A	DWS 3 Full Width?	N/A
N/A	Road 3 XSlope (%)	N/A	N/A	DWS 3 Offset (in)	N/A
Yes	Any Obstructions?	N/A	N/A	Storm Grate/Utility Hazard?	No
N/A	Obstruction Type		N/A	Storm Grate/Utility Type	
		N/A			N/A
N/A	Surface Condition	Good

Possible Solutions:

**Remove & Replace Entire Refuge.
Grind Gutter Lip.**

Total Cost: \$ 3400.00
