# Access Compliance Report

## Public Rights-of-Way

### (Island Curb Cuts)

Intersection ID: 10040759	Main Street: W_TYVOLA_RD	Cross Street: N/A	Location:	N/A
ADA ID: 6ABBBE014847	Curb Cut Type: MedianRefuge2	Initial Pass/Fail: Fail	Overall Compliance: No	Severity Score: 25
Codes/Mitigation Info/Possible Solution		Field Measurements/Component Compliance

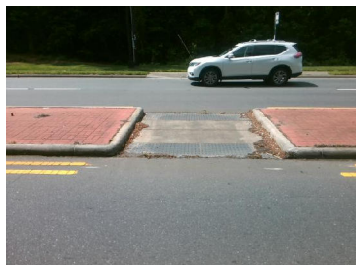
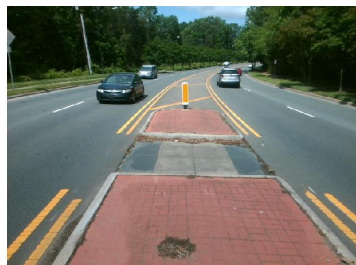
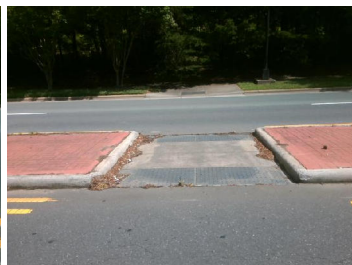
Compliance	Description	Data	Compliance	Description	Data
Yes	Refuge 1 Length (In)	54	N/A	Gutter 1 Ponding?	N/A
Yes	Refuge 1 Width (In)	101	N/A	Gutter 1 Lip Ht (In)	N/A
No	Refuge 1 Slope (%)	5.5	N/A	Gutter 1 Slope (%)	N/A
Yes	Refuge 1 X Slope (%)	1.5	N/A	Gutter 1 X Slope (%)	N/A
N/A	Painted X Walk1?	No	N/A	DWS 1 Provided?	N/A
N/A	X Walk 1 Direction	To S	N/A	DWS 1 Contrast?	N/A
N/A	X Walk 1 Width (In)	N/A	N/A	DWS 1 Length (In)	N/A
N/A	Road 1 Slope (%)	2.3	N/A	DWS 1 Full Width?	N/A
N/A	Road 1 X Slope (%)	5.8	N/A	DWS 1 Offset (In)	N/A
Yes	Refuge 2 Length (In)	54	N/A	Gutter 2 Ponding?	N/A
Yes	Refuge 2 Width (In)	101	N/A	Gutter 2 Lip Ht (In)	N/A
No	Refuge 2 Slope (%)	7.2	N/A	Gutter 2 Slope (%)	N/A
Yes	Refuge 2 X Slope (%)	1.0	N/A	Gutter 2 X Slope (%)	N/A
N/A	Painted X Walk2?	No	N/A	DWS 2 Provided?	N/A
N/A	X Walk 2 Direction	To N	N/A	DWS 2 Contrast?	N/A
N/A	X Walk 2 Width (In)	N/A	N/A	DWS 2 Length (In)	N/A
N/A	Road 2 Slope (%)	0.2	N/A	DWS 2 Full Width?	N/A

N/A	Road 2 X Slope (%)	5.5	N/A	DWS 2 Offset (In)	N/A
N/A	Refuge 3 Length (in)	N/A	N/A	Gutter 3 Ponding?	N/A
N/A	Refuge 3 Width (in)	N/A	N/A	Gutter 3 Lip Ht (in)	N/A
N/A	Refuge 3 Slope (%)	N/A	N/A	Gutter 3 Slope (%)	N/A
N/A	Refuge 3 XSlope (%)	N/A	N/A	Gutter 3 XSlope (%)	N/A
N/A	Painted X Walk3?	N/A	N/A	DWS 3 Provided?	N/A
N/A	X Walk 3 Direction	N/A	N/A	DWS 3 Contrast?	N/A
N/A	X Walk 3 Width (in)	N/A	N/A	DWS 3 Length (in)	N/A
N/A	Road 3 Slope (%)	N/A	N/A	DWS 3 Full Width?	N/A
N/A	Road 3 XSlope (%)	N/A	N/A	DWS 3 Offset (in)	N/A
Yes	Any Obstructions?	N/A	N/A	Storm Grate/Utility Hazard?	N/A
N/A	Obstruction Type		N/A	Storm Grate/Utility Type	
		N/A			N/A
N/A	Surface Condition	Good

**Remove & Replace Entire Refuge.**

**\$ 3000.00**
