# Access Compliance Report

## Public Rights-of-Way

### (Island Curb Cuts)

Intersection ID: 25815	Main Street: REA_RD	Cross Street: PINEVILLE-MATTHEWS_RD	Location: S
ADA ID: 6B9C6423D6D6	Curb Cut Type: MedianRefuge2	Initial Pass/Fail: Fail	Overall Compliance: No
Severity Score: 0			
Codes/Mitigation Info/Possible Solution		Field Measurements/Component Compliance

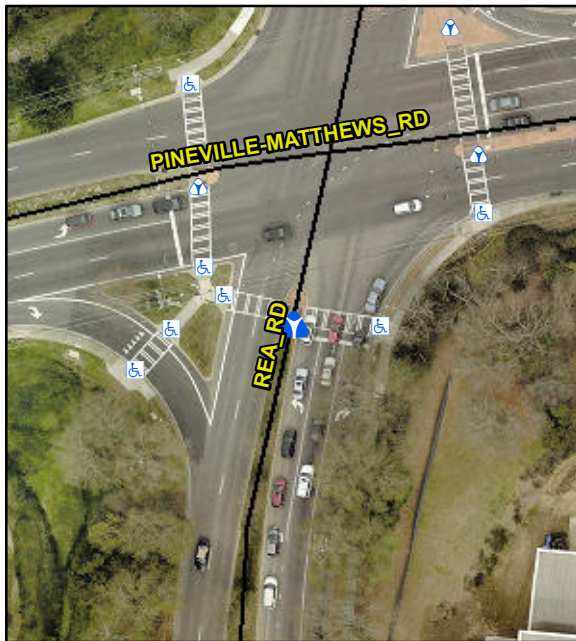
Compliance	Description	Data	Compliance	Description	Data
Yes	Refuge 1 Length (In)	66.0	N/A	Gutter 1 Ponding?	N/A
Yes	Refuge 1 Width (In)	107.0	N/A	Gutter 1 Lip Ht (In)	N/A
Yes	Refuge 1 Slope (%)	1.5	N/A	Gutter 1 Slope (%)	N/A
Yes	Refuge 1 X Slope (%)	2.9	N/A	Gutter 1 X Slope (%)	N/A
N/A	Painted X Walk1?	Yes	N/A	DWS 1 Provided?	N/A
N/A	X Walk 1 Direction	To W	N/A	DWS 1 Contrast?	N/A
N/A	X Walk 1 Width (In)	111.0	N/A	DWS 1 Length (In)	N/A
N/A	Road 1 Slope (%)	1.7	N/A	DWS 1 Full Width?	N/A
N/A	Road 1 X Slope (%)	0.6	N/A	DWS 1 Offset (In)	N/A
Yes	Refuge 2 Length (In)	66.0	N/A	Gutter 2 Ponding?	N/A
Yes	Refuge 2 Width (In)	107.0	N/A	Gutter 2 Lip Ht (In)	N/A
Yes	Refuge 2 Slope (%)	0.6	N/A	Gutter 2 Slope (%)	N/A
Yes	Refuge 2 X Slope (%)	1.4	N/A	Gutter 2 X Slope (%)	N/A
N/A	Painted X Walk2?	Yes	N/A	DWS 2 Provided?	N/A
N/A	X Walk 2 Direction	To E	N/A	DWS 2 Contrast?	N/A
N/A	X Walk 2 Width (In)	109.0	N/A	DWS 2 Length (In)	N/A

N/A	Road 2 Slope (%)	1.7	N/A	DWS 2 Full Width?	N/A
N/A	Road 2 X Slope (%)	6.6	N/A	DWS 2 Offset (In)	N/A
N/A	Refuge 3 Length (in)	N/A	N/A	Gutter 3 Ponding?	N/A
N/A	Refuge 3 Width (in)	N/A	N/A	Gutter 3 Lip Ht (in)	N/A
N/A	Refuge 3 Slope (%)	N/A	N/A	Gutter 3 Slope (%)	N/A
N/A	Refuge 3 XSlope (%)	N/A	N/A	Gutter 3 XSlope (%)	N/A
N/A	Painted X Walk3?	N/A	N/A	DWS 3 Provided?	N/A
N/A	X Walk 3 Direction	N/A	N/A	DWS 3 Contrast?	N/A
N/A	X Walk 3 Width (in)	N/A	N/A	DWS 3 Length (in)	N/A
N/A	Road 3 Slope (%)	N/A	N/A	DWS 3 Full Width?	N/A
N/A	Road 3 XSlope (%)	N/A	N/A	DWS 3 Offset (in)	N/A
Yes	Any Obstructions?	N/A	N/A	Storm Grate/Utility Hazard?	N/A
N/A	Obstruction Type		N/A	Storm Grate/Utility Type	
		N/A			N/A
N/A	Surface Condition	Good

**Remove & Replace Entire Refuge.**

Total Cost: \$ 3000.00
