# Access Compliance Report

## Public Rights-of-Way

### (Island Curb Cuts)

Intersection ID: 48197	Main Street: BLAKENEY_PARK_DR	Cross Street: ARDREY_KELL_RD	Location: S
ADA ID: 6D27FAF3D870	Curb Cut Type: MedianRefuge2	Initial Pass/Fail: Fail	Overall Compliance: No
Severity Score: 13.75			
Codes/Mitigation Info/Possible Solution		Field Measurements/Component Compliance

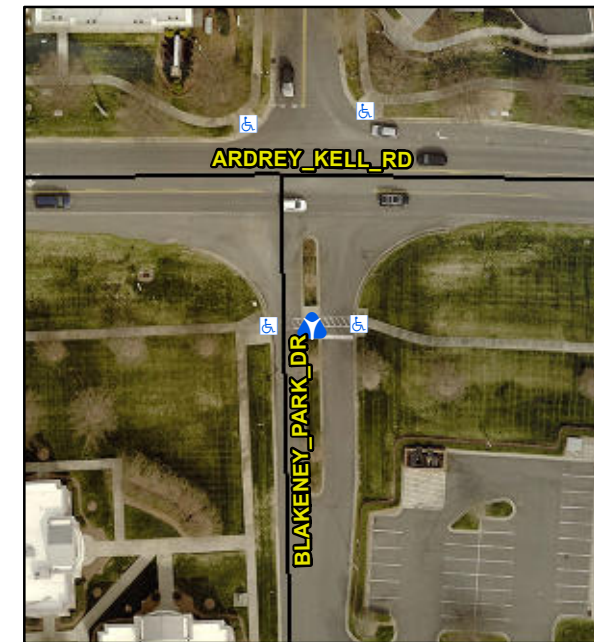
Compliance	Description	Data	Compliance	Description	Data
Yes	Refuge 1 Length (In)	41.0	N/A	Gutter 1 Ponding?	N/A
Yes	Refuge 1 Width (In)	62.0	N/A	Gutter 1 Lip Ht (In)	N/A
Yes	Refuge 1 Slope (%)	3.1	N/A	Gutter 1 Slope (%)	N/A
Yes	Refuge 1 X Slope (%)	3.5	N/A	Gutter 1 X Slope (%)	N/A
N/A	Painted X Walk1?	Yes	N/A	DWS 1 Provided?	N/A
N/A	X Walk 1 Direction	To E	N/A	DWS 1 Contrast?	N/A
N/A	X Walk 1 Width (In)	52.0	N/A	DWS 1 Length (In)	N/A
N/A	Road 1 Slope (%)	4.9	N/A	DWS 1 Full Width?	N/A
N/A	Road 1 X Slope (%)	0.3	N/A	DWS 1 Offset (In)	N/A
Yes	Refuge 2 Length (In)	41.0	N/A	Gutter 2 Ponding?	N/A
Yes	Refuge 2 Width (In)	62.0	N/A	Gutter 2 Lip Ht (In)	N/A
Yes	Refuge 2 Slope (%)	2.4	N/A	Gutter 2 Slope (%)	N/A
No	Refuge 2 X Slope (%)	6.1	N/A	Gutter 2 X Slope (%)	N/A
N/A	Painted X Walk2?	Yes	N/A	DWS 2 Provided?	N/A
N/A	X Walk 2 Direction	To W	N/A	DWS 2 Contrast?	N/A
N/A	X Walk 2 Width (In)	52.0	N/A	DWS 2 Length (In)	N/A

N/A	Road 2 Slope (%)	4.5	N/A	DWS 2 Full Width?	N/A
N/A	Road 2 X Slope (%)	2.1	N/A	DWS 2 Offset (In)	N/A
N/A	Refuge 3 Length (in)	N/A	N/A	Gutter 3 Ponding?	N/A
N/A	Refuge 3 Width (in)	N/A	N/A	Gutter 3 Lip Ht (in)	N/A
N/A	Refuge 3 Slope (%)	N/A	N/A	Gutter 3 Slope (%)	N/A
N/A	Refuge 3 XSlope (%)	N/A	N/A	Gutter 3 XSlope (%)	N/A
N/A	Painted X Walk3?	N/A	N/A	DWS 3 Provided?	N/A
N/A	X Walk 3 Direction	N/A	N/A	DWS 3 Contrast?	N/A
N/A	X Walk 3 Width (in)	N/A	N/A	DWS 3 Length (in)	N/A
N/A	Road 3 Slope (%)	N/A	N/A	DWS 3 Full Width?	N/A
N/A	Road 3 XSlope (%)	N/A	N/A	DWS 3 Offset (in)	N/A
Yes	Any Obstructions?	N/A	N/A	Storm Grate/Utility Hazard?	N/A
N/A	Obstruction Type		N/A	Storm Grate/Utility Type	
		N/A			N/A
N/A	Surface Condition	Good

**Remove & Replace Entire Refuge.**

Total Cost: \$ 3000.00
