Access Compliance Report

Public Rights-of-Way

(Island Curb Cuts)

Intersection ID: 44555	Main Street: UNIVERSITY_CITY_BV	Cross Street: N_TRYON_ST	Location: NE
ADA ID: 6FF3B937754C	Curb Cut Type: IslandRefuge3	Initial Pass/Fail: Pass	Overall Compliance: No
Codes/Mitigation Info/Possible Solution		Field Measurements/Component Compliance	
Severity Score: 20

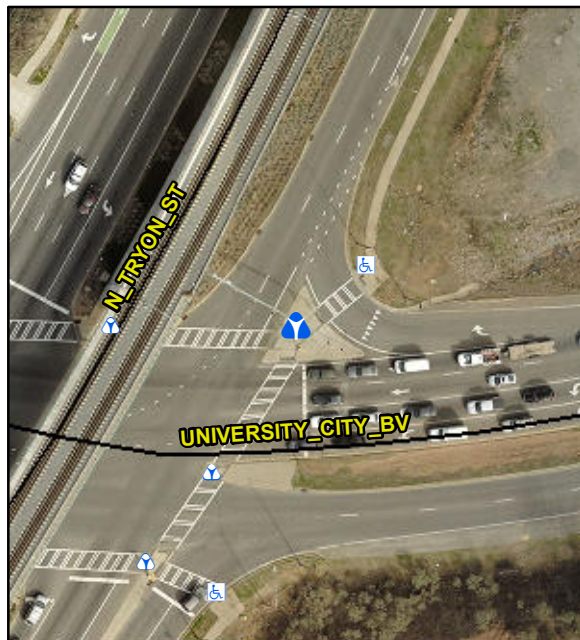
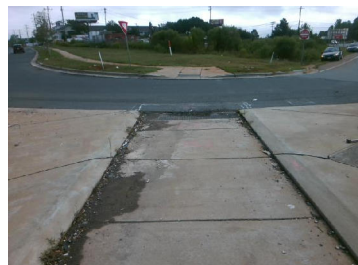
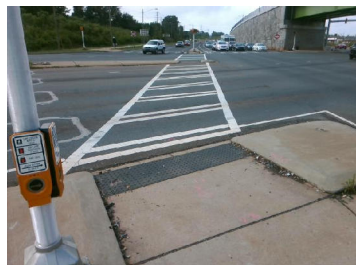
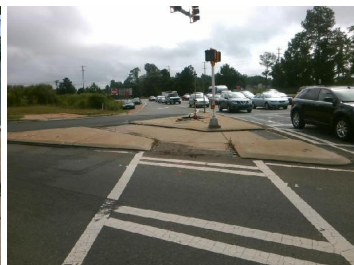
Compliance	Description	Data	Compliance	Description	Data
Yes	Refuge 1 Length (In)	244.0	No	Gutter 1 Ponding?	Yes
Yes	Refuge 1 Width (In)	95.0	No	Gutter 1 Lip Ht (In)	1.25
Yes	Refuge 1 Slope (%)	0.7	Yes	Gutter 1 Slope (%)	0.3
Yes	Refuge 1 X Slope (%)	0.9	Yes	Gutter 1 X Slope (%)	1.6
N/A	Painted X Walk1?	No	Yes	DWS 1 Provided?	Yes
N/A	X Walk 1 Direction	To NE	Yes	DWS 1 Contrast?	Yes
N/A	X Walk 1 Width (In)	N/A	Yes	DWS 1 Length (In)	24.0
N/A	Road 1 Slope (%)	0.6	Yes	DWS 1 Full Width?	Yes
N/A	Road 1 X Slope (%)	1.2	No	DWS 1 Offset (In)	6.0
Yes	Refuge 2 Length (In)	80.0	No	Gutter 2 Ponding?	Yes
Yes	Refuge 2 Width (In)	95.0	Yes	Gutter 2 Lip Ht (In)	0.0
Yes	Refuge 2 Slope (%)	0.6	Yes	Gutter 2 Slope (%)	0.7
Yes	Refuge 2 X Slope (%)	1.1	Yes	Gutter 2 X Slope (%)	0.4
N/A	Painted X Walk2?	Yes	Yes	DWS 2 Provided?	Yes
N/A	X Walk 2 Direction	To S	Yes	DWS 2 Contrast?	Yes
N/A	X Walk 2 Width (In)	116.0	Yes	DWS 2 Length (In)	24.0

N/A	Road 2 Slope (%)	1.0	Yes	DWS 2 Full Width?	Yes
N/A	Road 2 X Slope (%)	2.1	No	DWS 2 Offset (In)	5.0
Yes	Refuge 3 Length (in)	74.0	No	Gutter 3 Ponding?	Yes
Yes	Refuge 3 Width (in)	104.0	Yes	Gutter 3 Lip Ht (in)	0.0
Yes	Refuge 3 Slope (%)	1.4	Yes	Gutter 3 Slope (%)	3.9
Yes	Refuge 3 XSlope (%)	1.6	Yes	Gutter 3 XSlope (%)	0.0
N/A	Painted X Walk3?	Yes	Yes	DWS 3 Provided?	Yes
N/A	X Walk 3 Direction	To W	Yes	DWS 3 Contrast?	Yes
N/A	X Walk 3 Width (in)	117.0	Yes	DWS 3 Length (in)	24.0
N/A	Road 3 Slope (%)	0.2	Yes	DWS 3 Full Width?	Yes
N/A	Road 3 XSlope (%)	2.6	No	DWS 3 Offset (in)	4.0
Yes	Any Obstructions?	No	N/A	Storm Grate/Utility Hazard?	No
N/A	Obstruction Type		N/A	Storm Grate/Utility Type	
N/A	Surface Condition	Good	N/A		N/A

Remove & Replace Detectable Warning System. Fix Gutter Ponding. Grind Gutter Lip.
