Access Compliance Report

Public Rights-of-Way

(Island Curb Cuts)

Intersection ID: 44419	Main Street: ARDREY_KELL_RD	Cross Street: PROVIDENCE_RD	Location: N
ADA ID: 762A7F2628A9	Curb Cut Type: MedianRefuge2	Initial Pass/Fail: Fail	Overall Compliance: No
Codes/Mitigation Info/Possible Solution		Field Measurements/Component Compliance	
Severity Score: 1.25

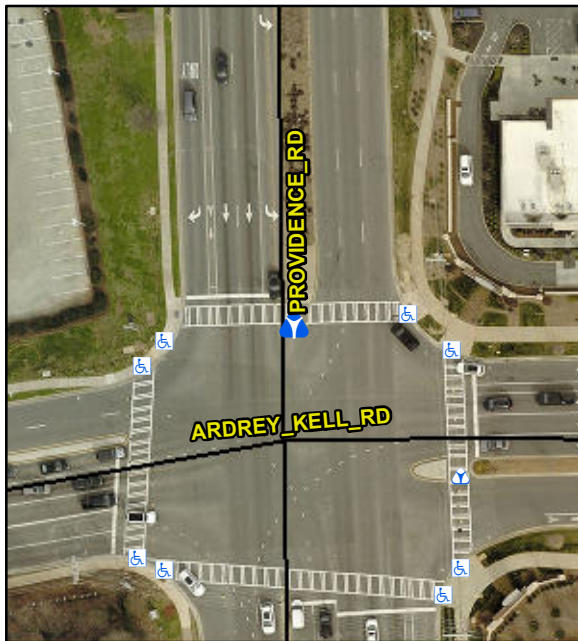
Compliance	Description	Data	Compliance	Description	Data
Yes	Refuge 1 Length (In)	44.5	N/A	Gutter 1 Ponding?	N/A
Yes	Refuge 1 Width (In)	131.0	N/A	Gutter 1 Lip Ht (In)	N/A
Yes	Refuge 1 Slope (%)	2.2	N/A	Gutter 1 Slope (%)	N/A
Yes	Refuge 1 X Slope (%)	3.2	N/A	Gutter 1 X Slope (%)	N/A
N/A	Painted X Walk1?	Yes	N/A	DWS 1 Provided?	N/A
N/A	X Walk 1 Direction	To E	N/A	DWS 1 Contrast?	N/A
N/A	X Walk 1 Width (In)	112.0	N/A	DWS 1 Length (In)	N/A
N/A	Road 1 Slope (%)	2.3	N/A	DWS 1 Full Width?	N/A
N/A	Road 1 X Slope (%)	2.1	N/A	DWS 1 Offset (In)	N/A
Yes	Refuge 2 Length (In)	44.5	N/A	Gutter 2 Ponding?	N/A
Yes	Refuge 2 Width (In)	131.0	N/A	Gutter 2 Lip Ht (In)	N/A
Yes	Refuge 2 Slope (%)	0.8	N/A	Gutter 2 Slope (%)	N/A
Yes	Refuge 2 X Slope (%)	1.9	N/A	Gutter 2 X Slope (%)	N/A
N/A	Painted X Walk2?	Yes	N/A	DWS 2 Provided?	N/A
N/A	X Walk 2 Direction	To W	N/A	DWS 2 Contrast?	N/A
N/A	X Walk 2 Width (In)	113.0	N/A	DWS 2 Length (In)	N/A

N/A	Road 2 Slope (%)	1.1	N/A	DWS 2 Full Width?	N/A
N/A	Road 2 X Slope (%)	4.6	N/A	DWS 2 Offset (In)	N/A
N/A	Refuge 3 Length (in)	N/A	N/A	Gutter 3 Ponding?	N/A
N/A	Refuge 3 Width (in)	N/A	N/A	Gutter 3 Lip Ht (in)	N/A
N/A	Refuge 3 Slope (%)	N/A	N/A	Gutter 3 Slope (%)	N/A
N/A	Refuge 3 XSlope (%)	N/A	N/A	Gutter 3 XSlope (%)	N/A
N/A	Painted X Walk3?	N/A	N/A	DWS 3 Provided?	N/A
N/A	X Walk 3 Direction	N/A	N/A	DWS 3 Contrast?	N/A
N/A	X Walk 3 Width (in)	N/A	N/A	DWS 3 Length (in)	N/A
N/A	Road 3 Slope (%)	N/A	N/A	DWS 3 Full Width?	N/A
N/A	Road 3 XSlope (%)	N/A	N/A	DWS 3 Offset (in)	N/A
Yes	Any Obstructions?	N/A	N/A	Storm Grate/Utility Hazard?	N/A
N/A	Obstruction Type		N/A	Storm Grate/Utility Type	
		N/A			N/A
N/A	Surface Condition	Good

Remove & Replace Entire Refuge.
