# Access Compliance Report

## Public Rights-of-Way

### (Island Curb Cuts)

Intersection ID: 10032380	Main Street: MT_HOLLY-HUNTERSVILLE_RD	Cross Street: N/A	Location: NW
ADA ID: 7671A1AE3CC4	Curb Cut Type: MedianRefuge2	Initial Pass/Fail: Fail	Overall Compliance: No
Codes/Mitigation Info/Possible Solution		Field Measurements/Component Compliance	
Severity Score: 25

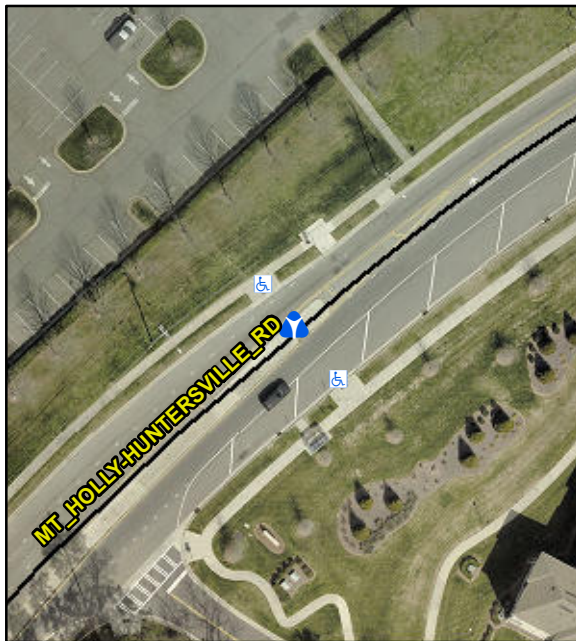
Compliance	Description	Data	Compliance	Description	Data
Yes	Refuge 1 Length (In)	62.0	N/A	Gutter 1 Ponding?	N/A
Yes	Refuge 1 Width (In)	71.0	N/A	Gutter 1 Lip Ht (In)	N/A
No	Refuge 1 Slope (%)	9.2	N/A	Gutter 1 Slope (%)	N/A
Yes	Refuge 1 X Slope (%)	1.4	N/A	Gutter 1 X Slope (%)	N/A
N/A	Painted X Walk1?	No	N/A	DWS 1 Provided?	N/A
N/A	X Walk 1 Direction	To NW	N/A	DWS 1 Contrast?	N/A
N/A	X Walk 1 Width (In)	N/A	N/A	DWS 1 Length (In)	N/A
N/A	Road 1 Slope (%)	2.2	N/A	DWS 1 Full Width?	N/A
N/A	Road 1 X Slope (%)	4.2	N/A	DWS 1 Offset (In)	N/A
Yes	Refuge 2 Length (In)	62.0	N/A	Gutter 2 Ponding?	N/A
Yes	Refuge 2 Width (In)	71.0	N/A	Gutter 2 Lip Ht (In)	N/A
No	Refuge 2 Slope (%)	9.2	N/A	Gutter 2 Slope (%)	N/A
Yes	Refuge 2 X Slope (%)	1.3	N/A	Gutter 2 X Slope (%)	N/A
N/A	Painted X Walk2?	No	N/A	DWS 2 Provided?	N/A
N/A	X Walk 2 Direction	To SE	N/A	DWS 2 Contrast?	N/A
N/A	X Walk 2 Width (In)	N/A	N/A	DWS 2 Length (In)	N/A

N/A	Road 2 Slope (%)	1.4	N/A	DWS 2 Full Width?	N/A
N/A	Road 2 X Slope (%)	10.3	N/A	DWS 2 Offset (In)	N/A
N/A	Refuge 3 Length (in)	N/A	N/A	Gutter 3 Ponding?	N/A
N/A	Refuge 3 Width (in)	N/A	N/A	Gutter 3 Lip Ht (in)	N/A
N/A	Refuge 3 Slope (%)	N/A	N/A	Gutter 3 Slope (%)	N/A
N/A	Refuge 3 XSlope (%)	N/A	N/A	Gutter 3 XSlope (%)	N/A
N/A	Painted X Walk3?	N/A	N/A	DWS 3 Provided?	N/A
N/A	X Walk 3 Direction	N/A	N/A	DWS 3 Contrast?	N/A
N/A	X Walk 3 Width (in)	N/A	N/A	DWS 3 Length (in)	N/A
N/A	Road 3 Slope (%)	N/A	N/A	DWS 3 Full Width?	N/A
N/A	Road 3 XSlope (%)	N/A	N/A	DWS 3 Offset (in)	N/A
Yes	Any Obstructions?	N/A	N/A	Storm Grate/Utility Hazard?	N/A
N/A	Obstruction Type		N/A	Storm Grate/Utility Type	
N/A	Surface Condition	Good	N/A		N/A

**Remove & Replace Entire Refuge.**

**\$ 3000.00**
