Access Compliance Report

Public Rights-of-Way

(Island Curb Cuts)

Intersection ID: 8289	Main Street: GRIER_RD	Cross Street: NEWELL-HICKORY_GROVE_RD	Location: SE
ADA ID: 7AED33E252EB	Curb Cut Type: MedianRefuge2	Initial Pass/Fail: Fail	Overall Compliance: No
		Severity Score: 1.25

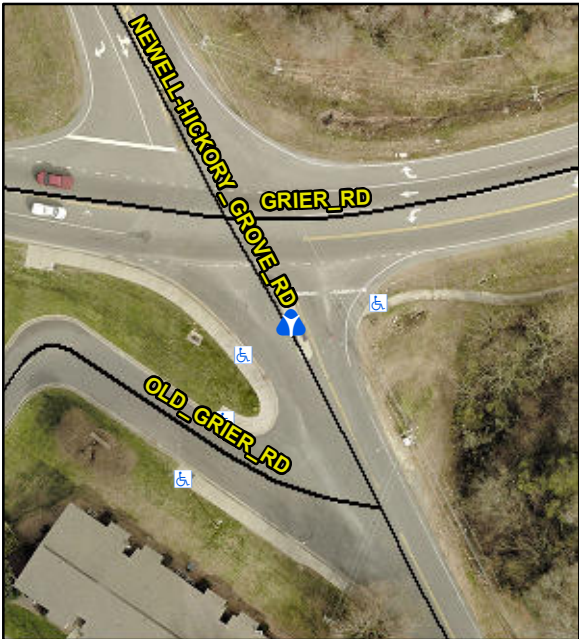
Possible Solutions:		Compliance	Description	Data	Compliance	Description	Data
	Remove & Replace Entire Refuge.		Yes	Refuge 1 Length (In)	42.5	N/A	Gutter 1 Ponding?	N/A
			Yes	Refuge 1 Width (In)	96.0	N/A	Gutter 1 Lip Ht (In)	N/A
			Yes	Refuge 1 Slope (%)	2.0	N/A	Gutter 1 Slope (%)	N/A
			Yes	Refuge 1 X Slope (%)	2.9	N/A	Gutter 1 X Slope (%)	N/A
			N/A	Painted X Walk1?	No	N/A	DWS 1 Provided?	N/A
			N/A	X Walk 1 Direction	To W	N/A	DWS 1 Contrast?	N/A
			N/A	X Walk 1 Width (In)	N/A	N/A	DWS 1 Length (In)	N/A
			N/A	Road 1 Slope (%)	1.5	N/A	DWS 1 Full Width?	N/A
			N/A	Road 1 X Slope (%)	1.0	N/A	DWS 1 Offset (In)	N/A
Surveyor Notes: N/A			Yes	Refuge 2 Length (In)	42.5	N/A	Gutter 2 Ponding?	N/A
			Yes	Refuge 2 Width (In)	96.0	N/A	Gutter 2 Lip Ht (In)	N/A
			Yes	Refuge 2 Slope (%)	4.8	N/A	Gutter 2 Slope (%)	N/A
			Yes	Refuge 2 X Slope (%)	3.8	N/A	Gutter 2 X Slope (%)	N/A

N/A	Painted X Walk2?	No	N/A	DWS 2 Provided?	N/A
			N/A	X Walk 2 Direction	To E	N/A	DWS 2 Contrast?	N/A
			N/A	X Walk 2 Width (In)	N/A	N/A	DWS 2 Length (In)	N/A
			N/A	Road 2 Slope (%)	2.5	N/A	DWS 2 Full Width?	N/A
			N/A	Road 2 X Slope (%)	2.4	N/A	DWS 2 Offset (In)	N/A
			N/A	Refuge 3 Length (in)	N/A	N/A	Gutter 3 Ponding?	N/A
PROW/ADA: N/A			N/A	Refuge 3 Width (in)	N/A	N/A	Gutter 3 Lip Ht (in)	N/A
			N/A	Refuge 3 Slope (%)	N/A	N/A	Gutter 3 Slope (%)	N/A
			N/A	Refuge 3 XSlope (%)	N/A	N/A	Gutter 3 XSlope (%)	N/A
			N/A	Painted X Walk3?	No	N/A	DWS 3 Provided?	N/A
			N/A	X Walk 3 Direction	N/A	N/A	DWS 3 Contrast?	N/A
			N/A	X Walk 3 Width (in)	N/A	N/A	DWS 3 Length (in)	N/A
			N/A	Road 3 Slope (%)	N/A	N/A	DWS 3 Full Width?	N/A
			N/A	Road 3 XSlope (%)	N/A	N/A	DWS 3 Offset (in)	N/A
			Yes	Any Obstructions?	N/A	N/A	Storm Grate/Utility Hazard?	N/A
			N/A	Obstruction Type		N/A	Storm Grate/Utility Type	
Total Cost: \$ 3000.00					N/A			N/A

N/A	Surface Condition	Good
