Access Compliance Report

Public Rights-of-Way

(Island Curb Cuts)

Intersection ID: 25815	Main Street: REA_RD	Cross Street: PINEVILLE-MATTHEWS_RD	Location: E
ADA ID: 7BE5D2F515CD	Curb Cut Type: MedianRefuge2	Initial Pass/Fail: Fail	Overall Compliance: No
Severity Score: 0			
Codes/Mitigation Info/Possible Solution		Field Measurements/Component Compliance

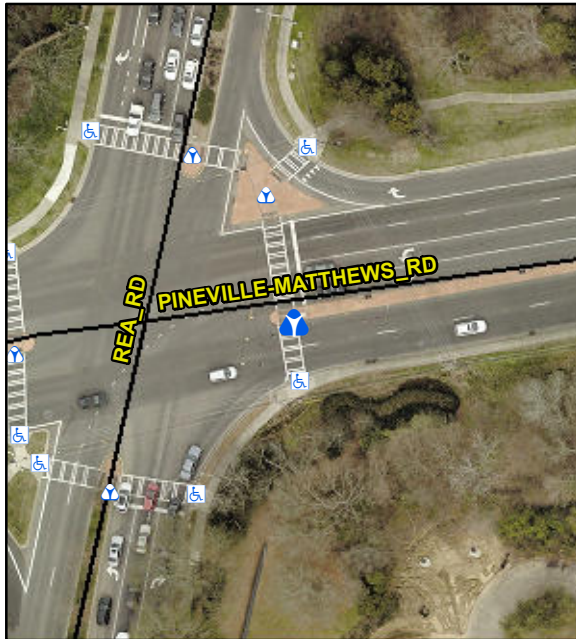
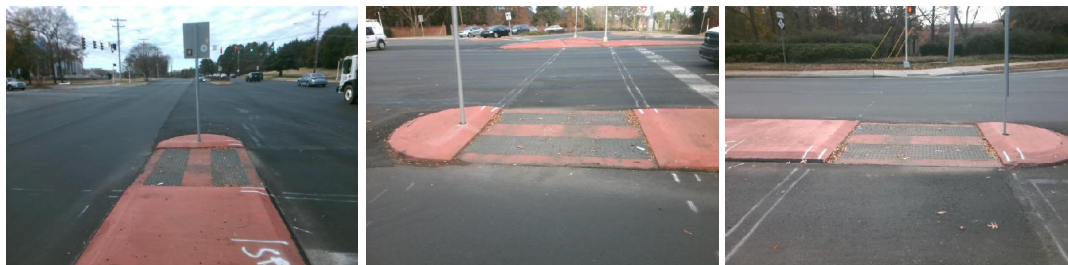
Compliance	Description	Data	Compliance	Description	Data
Yes	Refuge 1 Length (In)	43.5	N/A	Gutter 1 Ponding?	N/A
Yes	Refuge 1 Width (In)	96.0	N/A	Gutter 1 Lip Ht (In)	N/A
Yes	Refuge 1 Slope (%)	0.8	N/A	Gutter 1 Slope (%)	N/A
Yes	Refuge 1 X Slope (%)	0.8	N/A	Gutter 1 X Slope (%)	N/A
N/A	Painted X Walk1?	Yes	N/A	DWS 1 Provided?	N/A
N/A	X Walk 1 Direction	To N	N/A	DWS 1 Contrast?	N/A
N/A	X Walk 1 Width (In)	104.0	N/A	DWS 1 Length (In)	N/A
N/A	Road 1 Slope (%)	1.3	N/A	DWS 1 Full Width?	N/A
N/A	Road 1 X Slope (%)	1.2	N/A	DWS 1 Offset (In)	N/A
Yes	Refuge 2 Length (In)	43.5	N/A	Gutter 2 Ponding?	N/A
Yes	Refuge 2 Width (In)	96.0	N/A	Gutter 2 Lip Ht (In)	N/A
Yes	Refuge 2 Slope (%)	1.4	N/A	Gutter 2 Slope (%)	N/A
Yes	Refuge 2 X Slope (%)	3.8	N/A	Gutter 2 X Slope (%)	N/A
N/A	Painted X Walk2?	No	N/A	DWS 2 Provided?	N/A
N/A	X Walk 2 Direction	To S	N/A	DWS 2 Contrast?	N/A
N/A	X Walk 2 Width (In)	N/A	N/A	DWS 2 Length (In)	N/A

N/A	Road 2 Slope (%)	0.2	N/A	DWS 2 Full Width?	N/A
N/A	Road 2 X Slope (%)	1.8	N/A	DWS 2 Offset (In)	N/A
N/A	Refuge 3 Length (in)	N/A	N/A	Gutter 3 Ponding?	N/A
N/A	Refuge 3 Width (in)	N/A	N/A	Gutter 3 Lip Ht (in)	N/A
N/A	Refuge 3 Slope (%)	N/A	N/A	Gutter 3 Slope (%)	N/A
N/A	Refuge 3 XSlope (%)	N/A	N/A	Gutter 3 XSlope (%)	N/A
N/A	Painted X Walk3?	N/A	N/A	DWS 3 Provided?	N/A
N/A	X Walk 3 Direction	N/A	N/A	DWS 3 Contrast?	N/A
N/A	X Walk 3 Width (in)	N/A	N/A	DWS 3 Length (in)	N/A
N/A	Road 3 Slope (%)	N/A	N/A	DWS 3 Full Width?	N/A
N/A	Road 3 XSlope (%)	N/A	N/A	DWS 3 Offset (in)	N/A
Yes	Any Obstructions?	N/A	N/A	Storm Grate/Utility Hazard?	N/A
N/A	Obstruction Type		N/A	Storm Grate/Utility Type	
		N/A			N/A
N/A	Surface Condition	Good

Possible Solutions:

Remove & Replace Entire Refuge.

Total Cost: \$ 3000.00
