Access Compliance Report

Public Rights-of-Way

(Island Curb Cuts)

Intersection ID: 10013834	Main Street: IKEA_BV	Cross Street: N/A	Location: W
ADA ID: 7F11FDFFF482	Curb Cut Type: MedianRefuge2	Initial Pass/Fail: Fail	Overall Compliance: No
Codes/Mitigation Info/Possible Solution		Field Measurements/Component Compliance	
Severity Score: 1.25

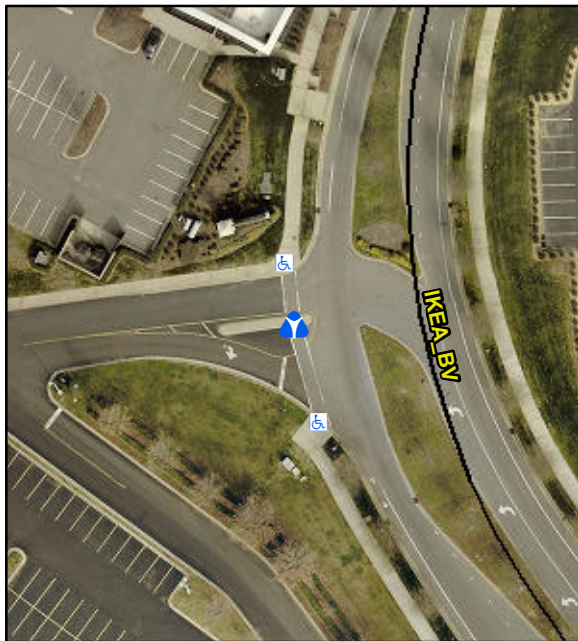
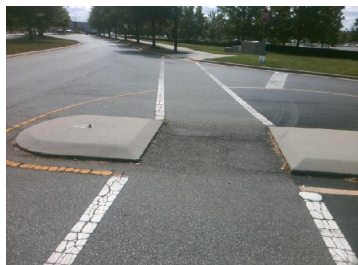
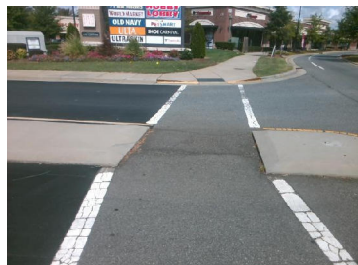
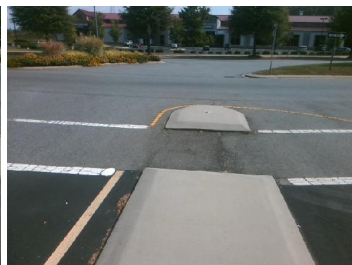
Compliance	Description	Data	Compliance	Description	Data
No	Refuge 1 Length (In)	35.5	N/A	Gutter 1 Ponding?	N/A
Yes	Refuge 1 Width (In)	78.5	N/A	Gutter 1 Lip Ht (In)	N/A
Yes	Refuge 1 Slope (%)	0.5	N/A	Gutter 1 Slope (%)	N/A
Yes	Refuge 1 X Slope (%)	2.3	N/A	Gutter 1 X Slope (%)	N/A
N/A	Painted X Walk1?	Yes	N/A	DWS 1 Provided?	N/A
N/A	X Walk 1 Direction	To N	N/A	DWS 1 Contrast?	N/A
N/A	X Walk 1 Width (In)	79.5	N/A	DWS 1 Length (In)	N/A
N/A	Road 1 Slope (%)	2.3	N/A	DWS 1 Full Width?	N/A
N/A	Road 1 X Slope (%)	1.7	N/A	DWS 1 Offset (In)	N/A
No	Refuge 2 Length (In)	35.5	N/A	Gutter 2 Ponding?	N/A
Yes	Refuge 2 Width (In)	78.5	N/A	Gutter 2 Lip Ht (In)	N/A
Yes	Refuge 2 Slope (%)	3.1	N/A	Gutter 2 Slope (%)	N/A
Yes	Refuge 2 X Slope (%)	1.4	N/A	Gutter 2 X Slope (%)	N/A
N/A	Painted X Walk2?	Yes	N/A	DWS 2 Provided?	N/A
N/A	X Walk 2 Direction	To S	N/A	DWS 2 Contrast?	N/A
N/A	X Walk 2 Width (In)	77.0	N/A	DWS 2 Length (In)	N/A

N/A	Road 2 Slope (%)	1.8	N/A	DWS 2 Full Width?	N/A
N/A	Road 2 X Slope (%)	0.1	N/A	DWS 2 Offset (In)	N/A
N/A	Refuge 3 Length (in)	N/A	N/A	Gutter 3 Ponding?	N/A
N/A	Refuge 3 Width (in)	N/A	N/A	Gutter 3 Lip Ht (in)	N/A
N/A	Refuge 3 Slope (%)	N/A	N/A	Gutter 3 Slope (%)	N/A
N/A	Refuge 3 XSlope (%)	N/A	N/A	Gutter 3 XSlope (%)	N/A
N/A	Painted X Walk3?	N/A	N/A	DWS 3 Provided?	N/A
N/A	X Walk 3 Direction	N/A	N/A	DWS 3 Contrast?	N/A
N/A	X Walk 3 Width (in)	N/A	N/A	DWS 3 Length (in)	N/A
N/A	Road 3 Slope (%)	N/A	N/A	DWS 3 Full Width?	N/A
N/A	Road 3 XSlope (%)	N/A	N/A	DWS 3 Offset (in)	N/A
Yes	Any Obstructions?	N/A	N/A	Storm Grate/Utility Hazard?	N/A
N/A	Obstruction Type		N/A	Storm Grate/Utility Type	
		N/A			N/A
N/A	Surface Condition	Good

Possible Solutions:

Remove & Replace Entire Refuge.
