Access Compliance Report

Public Rights-of-Way

(Island Curb Cuts)

Intersection ID: 5574	Main Street: BANNER_ELK_DR	Cross Street: SUNSET_RD	Location: NE
ADA ID: 82F164C7E72C	Curb Cut Type: MedianRefuge2	Initial Pass/Fail: Fail	Overall Compliance: No
Codes/Mitigation Info/Possible Solution		Field Measurements/Component Compliance	
Severity Score: 0

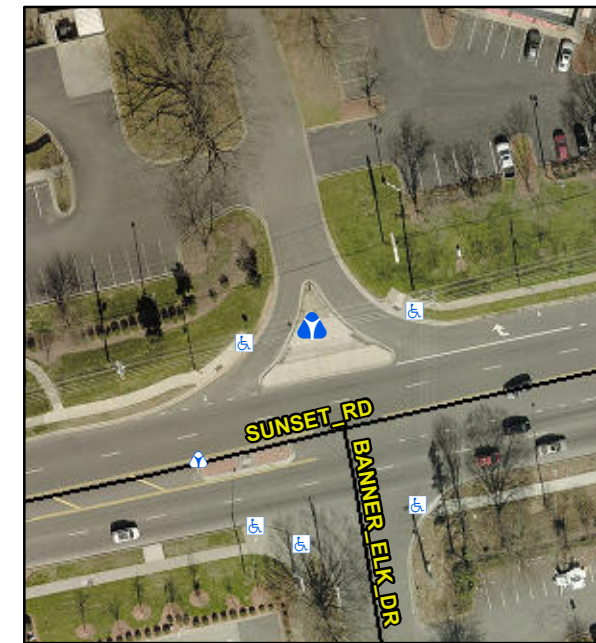
Compliance	Description	Data	Compliance	Description	Data
Yes	Refuge 1 Length (In)	210.0	N/A	Gutter 1 Ponding?	N/A
Yes	Refuge 1 Width (In)	86.0	N/A	Gutter 1 Lip Ht (In)	N/A
Yes	Refuge 1 Slope (%)	1.9	N/A	Gutter 1 Slope (%)	N/A
Yes	Refuge 1 X Slope (%)	0.9	N/A	Gutter 1 X Slope (%)	N/A
N/A	Painted X Walk1?	No	N/A	DWS 1 Provided?	N/A
N/A	X Walk 1 Direction	To NE	N/A	DWS 1 Contrast?	N/A
N/A	X Walk 1 Width (In)	N/A	N/A	DWS 1 Length (In)	N/A
N/A	Road 1 Slope (%)	4.1	N/A	DWS 1 Full Width?	N/A
N/A	Road 1 X Slope (%)	0.7	N/A	DWS 1 Offset (In)	N/A
Yes	Refuge 2 Length (In)	210.0	N/A	Gutter 2 Ponding?	N/A
Yes	Refuge 2 Width (In)	86.0	N/A	Gutter 2 Lip Ht (In)	N/A
Yes	Refuge 2 Slope (%)	1.7	N/A	Gutter 2 Slope (%)	N/A
Yes	Refuge 2 X Slope (%)	2.3	N/A	Gutter 2 X Slope (%)	N/A
N/A	Painted X Walk2?	No	N/A	DWS 2 Provided?	N/A
N/A	X Walk 2 Direction	To W	N/A	DWS 2 Contrast?	N/A
N/A	X Walk 2 Width (In)	N/A	N/A	DWS 2 Length (In)	N/A

N/A	Road 2 Slope (%)	0.7	N/A	DWS 2 Full Width?	N/A
N/A	Road 2 X Slope (%)	1.3	N/A	DWS 2 Offset (In)	N/A
N/A	Refuge 3 Length (in)	N/A	N/A	Gutter 3 Ponding?	N/A
N/A	Refuge 3 Width (in)	N/A	N/A	Gutter 3 Lip Ht (in)	N/A
N/A	Refuge 3 Slope (%)	N/A	N/A	Gutter 3 Slope (%)	N/A
N/A	Refuge 3 XSlope (%)	N/A	N/A	Gutter 3 XSlope (%)	N/A
N/A	Painted X Walk3?	N/A	N/A	DWS 3 Provided?	N/A
N/A	X Walk 3 Direction	N/A	N/A	DWS 3 Contrast?	N/A
N/A	X Walk 3 Width (in)	N/A	N/A	DWS 3 Length (in)	N/A
N/A	Road 3 Slope (%)	N/A	N/A	DWS 3 Full Width?	N/A
N/A	Road 3 XSlope (%)	N/A	N/A	DWS 3 Offset (in)	N/A
Yes	Any Obstructions?	N/A	N/A	Storm Grate/Utility Hazard?	N/A
N/A	Obstruction Type		N/A	Storm Grate/Utility Type	
		N/A			N/A
N/A	Surface Condition	Good

Possible Solutions:

Remove & Replace Entire Refuge.
