Access Compliance Report

Public Rights-of-Way

(Island Curb Cuts)

Intersection ID: 25815	Main Street: REA_RD	Cross Street: PINEVILLE-MATTHEWS_RD	Location: N
ADA ID: 83063A1D3871	Curb Cut Type: MedianRefuge2	Initial Pass/Fail: Fail	Overall Compliance: No
Severity Score: 1.25			
Codes/Mitigation Info/Possible Solution		Field Measurements/Component Compliance

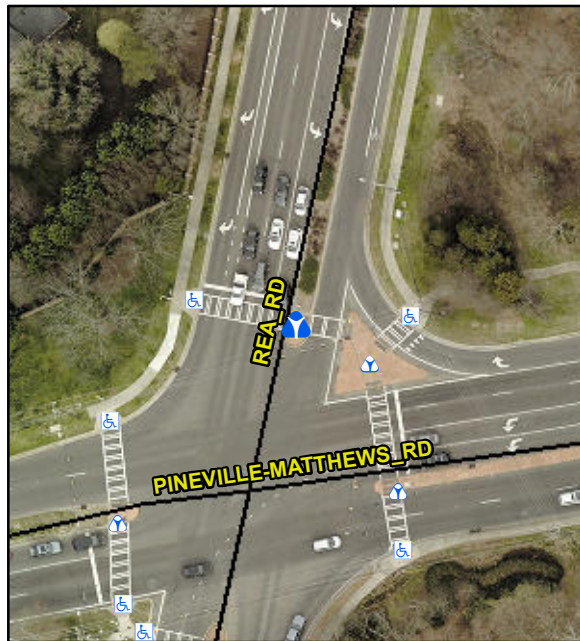
Compliance	Description	Data	Compliance	Description	Data
Yes	Refuge 1 Length (In)	65.0	N/A	Gutter 1 Ponding?	N/A
Yes	Refuge 1 Width (In)	110.0	N/A	Gutter 1 Lip Ht (In)	N/A
Yes	Refuge 1 Slope (%)	2.1	N/A	Gutter 1 Slope (%)	N/A
Yes	Refuge 1 X Slope (%)	2.8	N/A	Gutter 1 X Slope (%)	N/A
N/A	Painted X Walk1?	Yes	N/A	DWS 1 Provided?	N/A
N/A	X Walk 1 Direction	To SE	N/A	DWS 1 Contrast?	N/A
N/A	X Walk 1 Width (In)	108.0	N/A	DWS 1 Length (In)	N/A
N/A	Road 1 Slope (%)	0.9	N/A	DWS 1 Full Width?	N/A
N/A	Road 1 X Slope (%)	4.1	N/A	DWS 1 Offset (In)	N/A
Yes	Refuge 2 Length (In)	65.0	N/A	Gutter 2 Ponding?	N/A
Yes	Refuge 2 Width (In)	110.0	N/A	Gutter 2 Lip Ht (In)	N/A
Yes	Refuge 2 Slope (%)	0.3	N/A	Gutter 2 Slope (%)	N/A
Yes	Refuge 2 X Slope (%)	1.4	N/A	Gutter 2 X Slope (%)	N/A
N/A	Painted X Walk2?	Yes	N/A	DWS 2 Provided?	N/A
N/A	X Walk 2 Direction	To NW	N/A	DWS 2 Contrast?	N/A
N/A	X Walk 2 Width (In)	112.0	N/A	DWS 2 Length (In)	N/A

N/A	Road 2 Slope (%)	1.0	N/A	DWS 2 Full Width?	N/A
N/A	Road 2 X Slope (%)	0.9	N/A	DWS 2 Offset (In)	N/A
N/A	Refuge 3 Length (in)	N/A	N/A	Gutter 3 Ponding?	N/A
N/A	Refuge 3 Width (in)	N/A	N/A	Gutter 3 Lip Ht (in)	N/A
N/A	Refuge 3 Slope (%)	N/A	N/A	Gutter 3 Slope (%)	N/A
N/A	Refuge 3 XSlope (%)	N/A	N/A	Gutter 3 XSlope (%)	N/A
N/A	Painted X Walk3?	N/A	N/A	DWS 3 Provided?	N/A
N/A	X Walk 3 Direction	N/A	N/A	DWS 3 Contrast?	N/A
N/A	X Walk 3 Width (in)	N/A	N/A	DWS 3 Length (in)	N/A
N/A	Road 3 Slope (%)	N/A	N/A	DWS 3 Full Width?	N/A
N/A	Road 3 XSlope (%)	N/A	N/A	DWS 3 Offset (in)	N/A
Yes	Any Obstructions?	N/A	N/A	Storm Grate/Utility Hazard?	N/A
N/A	Obstruction Type		N/A	Storm Grate/Utility Type	
		N/A			N/A
N/A	Surface Condition	Good

Possible Solutions:

Remove & Replace Entire Refuge.

Total Cost: \$ 3000.00
