Access Compliance Report

Public Rights-of-Way

(Island Curb Cuts)

Intersection ID: 10033483	Main Street: OLD_PINEVILLE_RD	Cross Street: N/A	Location: E
ADA ID: 8460295CA5D6	Curb Cut Type: MedianRefuge2	Initial Pass/Fail: Fail	Overall Compliance: No
Codes/Mitigation Info/Possible Solution		Field Measurements/Component Compliance	
Severity Score: 0

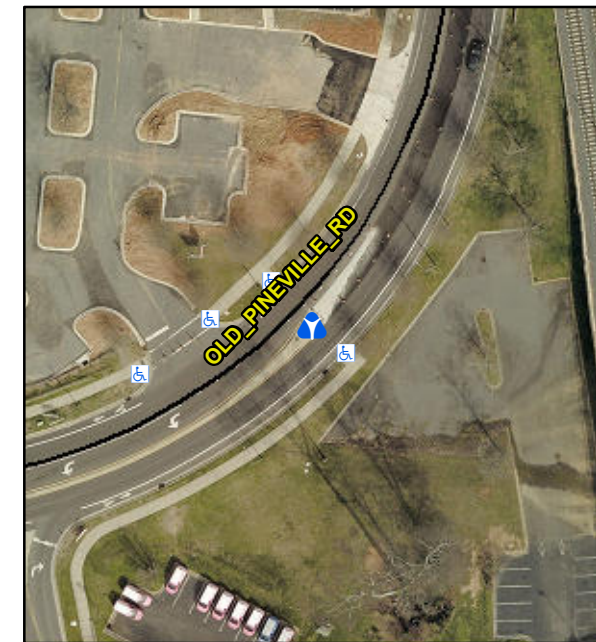
Compliance	Description	Data	Compliance	Description	Data
Yes	Refuge 1 Length (In)	44.0	N/A	Gutter 1 Ponding?	N/A
Yes	Refuge 1 Width (In)	96.0	N/A	Gutter 1 Lip Ht (In)	N/A
Yes	Refuge 1 Slope (%)	0.4	N/A	Gutter 1 Slope (%)	N/A
Yes	Refuge 1 X Slope (%)	2.3	N/A	Gutter 1 X Slope (%)	N/A
N/A	Painted X Walk1?	No	N/A	DWS 1 Provided?	N/A
N/A	X Walk 1 Direction	To NW	N/A	DWS 1 Contrast?	N/A
N/A	X Walk 1 Width (In)	N/A	N/A	DWS 1 Length (In)	N/A
N/A	Road 1 Slope (%)	2.6	N/A	DWS 1 Full Width?	N/A
N/A	Road 1 X Slope (%)	2.5	N/A	DWS 1 Offset (In)	N/A
Yes	Refuge 2 Length (In)	44.0	N/A	Gutter 2 Ponding?	N/A
Yes	Refuge 2 Width (In)	96.0	N/A	Gutter 2 Lip Ht (In)	N/A
Yes	Refuge 2 Slope (%)	0.9	N/A	Gutter 2 Slope (%)	N/A
Yes	Refuge 2 X Slope (%)	2.8	N/A	Gutter 2 X Slope (%)	N/A
N/A	Painted X Walk2?	No	N/A	DWS 2 Provided?	N/A
N/A	X Walk 2 Direction	To SE	N/A	DWS 2 Contrast?	N/A
N/A	X Walk 2 Width (In)	N/A	N/A	DWS 2 Length (In)	N/A

N/A	Road 2 Slope (%)	3.2	N/A	DWS 2 Full Width?	N/A
N/A	Road 2 X Slope (%)	2.6	N/A	DWS 2 Offset (In)	N/A
N/A	Refuge 3 Length (in)	N/A	N/A	Gutter 3 Ponding?	N/A
N/A	Refuge 3 Width (in)	N/A	N/A	Gutter 3 Lip Ht (in)	N/A
N/A	Refuge 3 Slope (%)	N/A	N/A	Gutter 3 Slope (%)	N/A
N/A	Refuge 3 XSlope (%)	N/A	N/A	Gutter 3 XSlope (%)	N/A
N/A	Painted X Walk3?	N/A	N/A	DWS 3 Provided?	N/A
N/A	X Walk 3 Direction	N/A	N/A	DWS 3 Contrast?	N/A
N/A	X Walk 3 Width (in)	N/A	N/A	DWS 3 Length (in)	N/A
N/A	Road 3 Slope (%)	N/A	N/A	DWS 3 Full Width?	N/A
N/A	Road 3 XSlope (%)	N/A	N/A	DWS 3 Offset (in)	N/A
Yes	Any Obstructions?	N/A	N/A	Storm Grate/Utility Hazard?	N/A
N/A	Obstruction Type		N/A	Storm Grate/Utility Type	
		N/A			N/A
N/A	Surface Condition	Good

Possible Solutions:

Remove & Replace Entire Refuge.

\$ 3000.00
