# Access Compliance Report

## Public Rights-of-Way

### (Island Curb Cuts)

Intersection ID: 18109	Main Street: DREXEL_PL	Cross Street: PARK_RD	Location: W
ADA ID: 85AF50ED1003	Curb Cut Type: MedianRefuge2	Initial Pass/Fail: Fail	Overall Compliance: No
Codes/Mitigation Info/Possible Solution		Field Measurements/Component Compliance

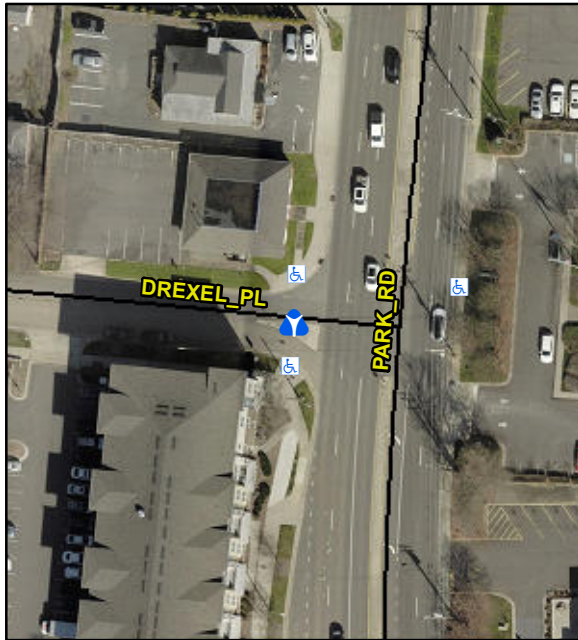
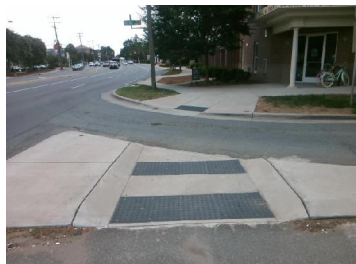
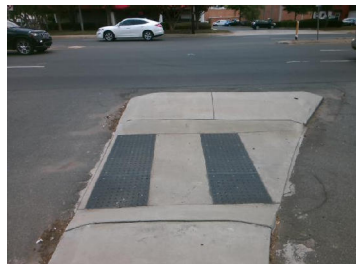
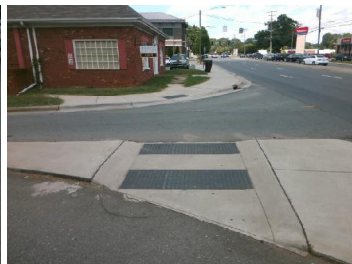
Compliance	Description	Data	Compliance	Description	Data
Yes	Refuge 1 Length (In)	40.0	N/A	Gutter 1 Ponding?	N/A
Yes	Refuge 1 Width (In)	71.0	N/A	Gutter 1 Lip Ht (In)	N/A
Yes	Refuge 1 Slope (%)	2.8	N/A	Gutter 1 Slope (%)	N/A
Yes	Refuge 1 X Slope (%)	2.8	N/A	Gutter 1 X Slope (%)	N/A
N/A	Painted X Walk1?	No	N/A	DWS 1 Provided?	N/A
N/A	X Walk 1 Direction	To S	N/A	DWS 1 Contrast?	N/A
N/A	X Walk 1 Width (In)	N/A	N/A	DWS 1 Length (In)	N/A
N/A	Road 1 Slope (%)	0.5	N/A	DWS 1 Full Width?	N/A
N/A	Road 1 X Slope (%)	1.3	N/A	DWS 1 Offset (In)	N/A
Yes	Refuge 2 Length (In)	40.0	N/A	Gutter 2 Ponding?	N/A
Yes	Refuge 2 Width (In)	71.0	N/A	Gutter 2 Lip Ht (In)	N/A
Yes	Refuge 2 Slope (%)	1.5	N/A	Gutter 2 Slope (%)	N/A
Yes	Refuge 2 X Slope (%)	0.6	N/A	Gutter 2 X Slope (%)	N/A
N/A	Painted X Walk2?	No	N/A	DWS 2 Provided?	N/A
N/A	X Walk 2 Direction	To N	N/A	DWS 2 Contrast?	N/A
N/A	X Walk 2 Width (In)	N/A	N/A	DWS 2 Length (In)	N/A

N/A	Road 2 Slope (%)	0.3	N/A	DWS 2 Full Width?	N/A
N/A	Road 2 X Slope (%)	0.2	N/A	DWS 2 Offset (In)	N/A
N/A	Refuge 3 Length (in)	N/A	N/A	Gutter 3 Ponding?	N/A
N/A	Refuge 3 Width (in)	N/A	N/A	Gutter 3 Lip Ht (in)	N/A
N/A	Refuge 3 Slope (%)	N/A	N/A	Gutter 3 Slope (%)	N/A
N/A	Refuge 3 XSlope (%)	N/A	N/A	Gutter 3 XSlope (%)	N/A
N/A	Painted X Walk3?	N/A	N/A	DWS 3 Provided?	N/A
N/A	X Walk 3 Direction	N/A	N/A	DWS 3 Contrast?	N/A
N/A	X Walk 3 Width (in)	N/A	N/A	DWS 3 Length (in)	N/A
N/A	Road 3 Slope (%)	N/A	N/A	DWS 3 Full Width?	N/A
N/A	Road 3 XSlope (%)	N/A	N/A	DWS 3 Offset (in)	N/A
Yes	Any Obstructions?	N/A	N/A	Storm Grate/Utility Hazard?	N/A
N/A	Obstruction Type		N/A	Storm Grate/Utility Type	
		N/A			N/A
N/A	Surface Condition	Good

Possible Solutions:

**Remove & Replace Entire Refuge.**

Total Cost:

**\$ 3000.00**
