Access Compliance Report

Public Rights-of-Way

(Island Curb Cuts)

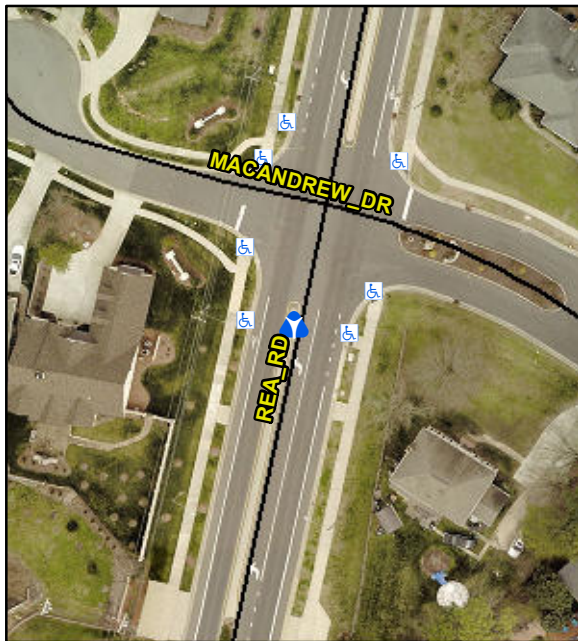
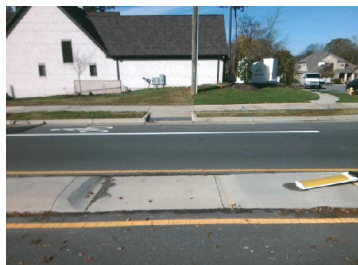
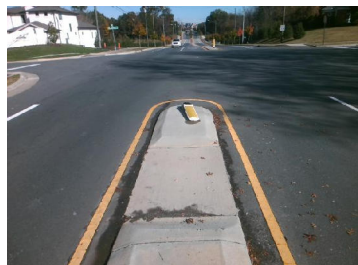
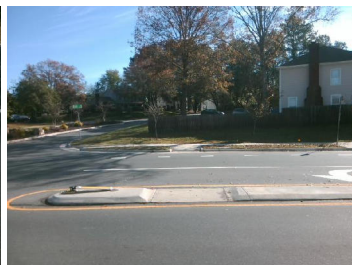
Intersection ID: 24840	Main Street: REA_RD	Cross Street: MACANDREW_DR	Location: SW
ADA ID: 867B99627F06	Curb Cut Type: MedianRefuge2	Initial Pass/Fail: Fail	Overall Compliance: No
Codes/Mitigation Info/Possible Solution		Field Measurements/Component Compliance	
Severity Score: 0

Compliance	Description	Data	Compliance	Description	Data
No	Refuge 1 Length (In)	24.0	N/A	Gutter 1 Ponding?	N/A
Yes	Refuge 1 Width (In)	72.0	N/A	Gutter 1 Lip Ht (In)	N/A
Yes	Refuge 1 Slope (%)	1.8	N/A	Gutter 1 Slope (%)	N/A
Yes	Refuge 1 X Slope (%)	2.3	N/A	Gutter 1 X Slope (%)	N/A
N/A	Painted X Walk1?	No	N/A	DWS 1 Provided?	N/A
N/A	X Walk 1 Direction	To NW	N/A	DWS 1 Contrast?	N/A
N/A	X Walk 1 Width (In)	N/A	N/A	DWS 1 Length (In)	N/A
N/A	Road 1 Slope (%)	0.1	N/A	DWS 1 Full Width?	N/A
N/A	Road 1 X Slope (%)	3.0	N/A	DWS 1 Offset (In)	N/A
No	Refuge 2 Length (In)	24.0	N/A	Gutter 2 Ponding?	N/A
Yes	Refuge 2 Width (In)	72.0	N/A	Gutter 2 Lip Ht (In)	N/A
Yes	Refuge 2 Slope (%)	1.4	N/A	Gutter 2 Slope (%)	N/A
Yes	Refuge 2 X Slope (%)	1.9	N/A	Gutter 2 X Slope (%)	N/A
N/A	Painted X Walk2?	No	N/A	DWS 2 Provided?	N/A
N/A	X Walk 2 Direction	To SE	N/A	DWS 2 Contrast?	N/A
N/A	X Walk 2 Width (In)	N/A	N/A	DWS 2 Length (In)	N/A

Remove & Replace Entire Refuge.
