Access Compliance Report

Public Rights-of-Way

(Island Curb Cuts)

Intersection ID: 10022596	Main Street: CARMEL_RD	Cross Street: N/A	Location: SW
ADA ID: 875F5C92E87A	Curb Cut Type: MedianRefuge2	Initial Pass/Fail: Fail	Overall Compliance: No
Codes/Mitigation Info/Possible Solution		Field Measurements/Component Compliance

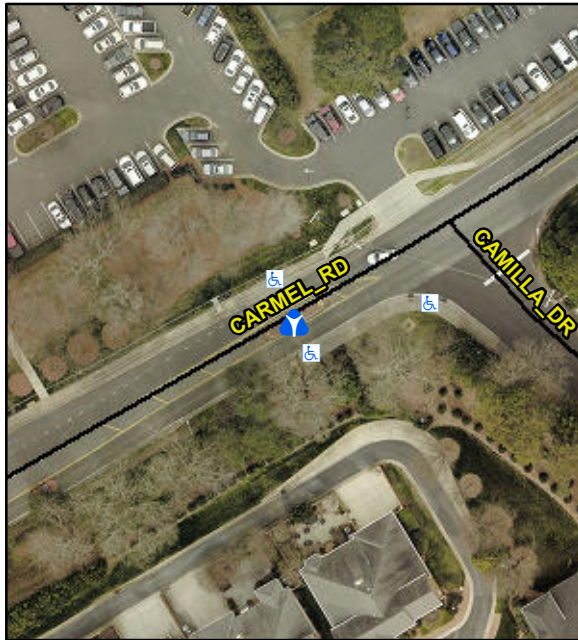
Compliance	Description	Data	Compliance	Description	Data
Yes	Refuge 1 Length (In)	48.0	N/A	Gutter 1 Ponding?	N/A
Yes	Refuge 1 Width (In)	94.0	N/A	Gutter 1 Lip Ht (In)	N/A
Yes	Refuge 1 Slope (%)	2.3	N/A	Gutter 1 Slope (%)	N/A
Yes	Refuge 1 X Slope (%)	2.7	N/A	Gutter 1 X Slope (%)	N/A
N/A	Painted X Walk1?	No	N/A	DWS 1 Provided?	N/A
N/A	X Walk 1 Direction	To NW	N/A	DWS 1 Contrast?	N/A
N/A	X Walk 1 Width (In)	N/A	N/A	DWS 1 Length (In)	N/A
N/A	Road 1 Slope (%)	0.5	N/A	DWS 1 Full Width?	N/A
N/A	Road 1 X Slope (%)	3.9	N/A	DWS 1 Offset (In)	N/A
Yes	Refuge 2 Length (In)	48.0	N/A	Gutter 2 Ponding?	N/A
Yes	Refuge 2 Width (In)	94.0	N/A	Gutter 2 Lip Ht (In)	N/A
Yes	Refuge 2 Slope (%)	2.6	N/A	Gutter 2 Slope (%)	N/A
Yes	Refuge 2 X Slope (%)	1.3	N/A	Gutter 2 X Slope (%)	N/A
N/A	Painted X Walk2?	No	N/A	DWS 2 Provided?	N/A
N/A	X Walk 2 Direction	To SE	N/A	DWS 2 Contrast?	N/A
N/A	X Walk 2 Width (In)	N/A	N/A	DWS 2 Length (In)	N/A

N/A	Road 2 Slope (%)	0.7	N/A	DWS 2 Full Width?	N/A
N/A	Road 2 X Slope (%)	0.2	N/A	DWS 2 Offset (In)	N/A
N/A	Refuge 3 Length (in)	N/A	N/A	Gutter 3 Ponding?	N/A
N/A	Refuge 3 Width (in)	N/A	N/A	Gutter 3 Lip Ht (in)	N/A
N/A	Refuge 3 Slope (%)	N/A	N/A	Gutter 3 Slope (%)	N/A
N/A	Refuge 3 XSlope (%)	N/A	N/A	Gutter 3 XSlope (%)	N/A
N/A	Painted X Walk3?	N/A	N/A	DWS 3 Provided?	N/A
N/A	X Walk 3 Direction	N/A	N/A	DWS 3 Contrast?	N/A
N/A	X Walk 3 Width (in)	N/A	N/A	DWS 3 Length (in)	N/A
N/A	Road 3 Slope (%)	N/A	N/A	DWS 3 Full Width?	N/A
N/A	Road 3 XSlope (%)	N/A	N/A	DWS 3 Offset (in)	N/A
Yes	Any Obstructions?	N/A	N/A	Storm Grate/Utility Hazard?	N/A
N/A	Obstruction Type		N/A	Storm Grate/Utility Type	
		N/A			N/A
N/A	Surface Condition	Good

Possible Solutions:

Remove & Replace Entire Refuge.

Total Cost: \$ 3000.00
